Evaluation of Cracked Soft Rock on In-Situ Test Results

The base rock expected to be used for the foundation of a railway arch bridge(180m span) currently in the planning stage is heavily-cracked auto-brecciated andesite (rock grade about C_M - C_L -Rock classification of dam foundation in Japan). There was a need to accurately evaluate the bearing capacity, since a load amounting to as much as about 2.1kN (normal condition) would be applied to the base rock at each bridge pier. Since being an arch bridge, there was a desire to restrain support point displacement of the foundation to the utmost, and since it was also necessary to take into consideration the reduction in bearing capacity due to the effect of slopes due to the fact that the foundation would be constructed on slopes facing the river. We thus conducted block-shear tests as a way of improving the accuracy of the shear constant. We evaluated bearing capacity of the base rock and shear constants (c , ϕ), analyzed the test results as well as the results of prior tests on the same type of base rock and determined the material values to be used in design. And we explained various methods for evaluating the bearing capacity,

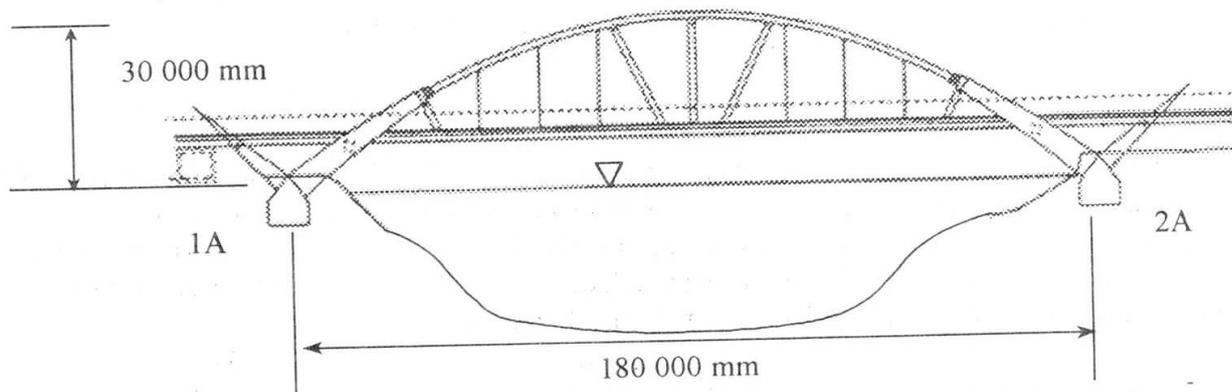
Fig.1 Outline view of the bridge

We will next give an explanation of the strata composition in the vicinity of the foundation. Side 2A is characterized by surface deposits (fill, old surface soil) with an N-value of about 5 to a depth of GL-4m, and terraced deposits (sand and gravel mixed with cobblestone) at a depth of GL-7-9m with soft stone tuff-breccia with heavily-cracked auto-brecciated andesite intrusions) at depths greater than GL-9m (refer to Fig.1 and Table 1).

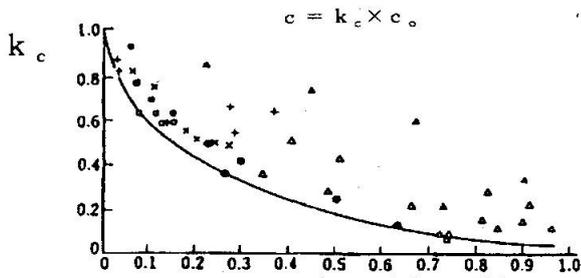
Fig. 2 Relationship of C_r and k_c

In addition, Figs. 2 & 3 indicate data compiled by the Japan Roadway Public Corporation relating to the relationship between the cracking index and the reduction index of cohesion strength and the angle of internal friction. This data included the test data of the Railway Technical Research Institute of the National Railway. It is possible to estimate the values of c and ϕ by means of a curve that takes the lower limits of variation indicated in Fig. 2 & 3. In other words:

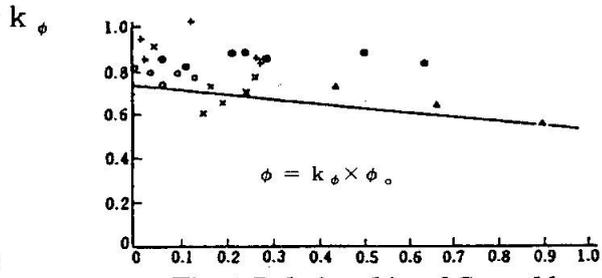
Fig. 3 Relationship of C_r and k_ϕ

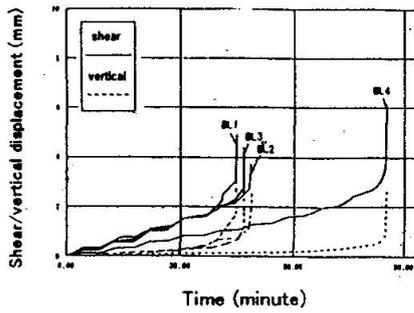
Fig.7 Relationship between time and shear/vertical displacement (average)

* Relationship between time and shear/vertical displacement (average)

Failure took 2-3 times longer with BL4 than with BL1-3.

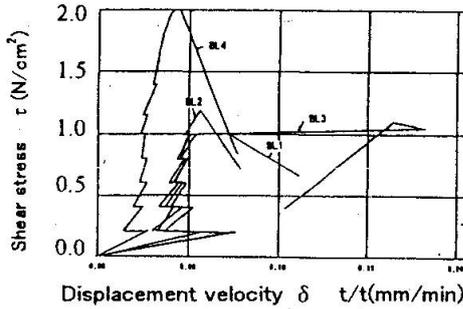
Fig.8 Relationship between shear stress and displacement velocity

* Relationship between shear stress and displacement velocity

The displacement velocity of BL4 was about 1/2 that of BL1-3 and the progress of the displacement was slow.

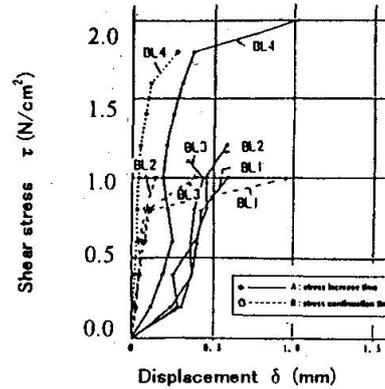
Fig.9 Relationship between shear stress and the amount of shear displacement

* Relationship between shear stress and amount of shear displacement (average.)

The amount of shear displacement was about 1/2 that of BL1-3 for both stress increase time and continuation time. This would indicate that the base rock of BL4 is hard and that fractures are closed.

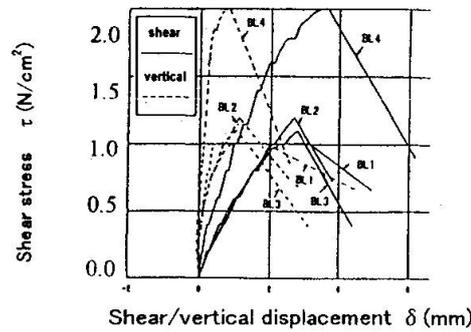
Fig.10 Relationship between shear stress and shear/vertical displacement (average)

The conditions of failure of the shear plane of the blocks are indicated in Fig.6. The relationship between time and shear/vertical displacement (average) is indicated in Fig.7. The relationship between shear stress and displacement velocity is indicated in Fig.8. The relationship between shear stress and the amount of shear displacement is indicated in Fig.9. And the relationship between shear stress and shear/vertical displacement (average) is indicated in Fig.10.

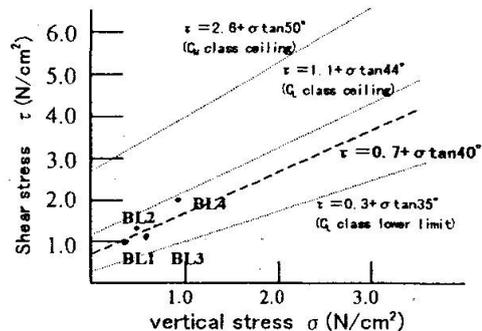
Fig.11 Test results and volcanic rock shear strength properties

In addition, if we plot the values obtained in the tests in the shear strength properties of the volcanic rock shown in Fig. 11, we could see that the test values for BL1-3 would be average values for C_L grade rock and that the test values of BL4 would be at the upper limit for C_L grade rock. Based on this, we can state that appropriate values were obtained in the tests corresponding to the rock type and grade.

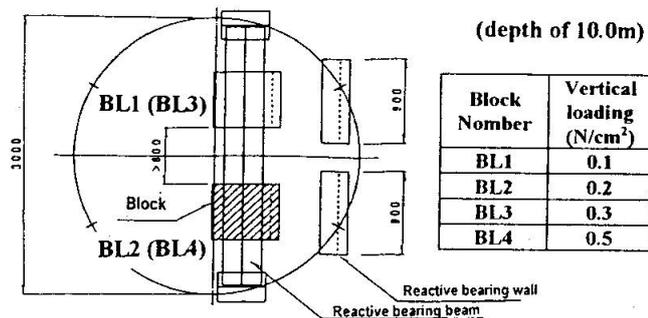
Fig.4 Plane view of the conditions of block shear tests [depth of 8.5m]

Deep foundation holes with a diameter of 3m were excavated in the vicinity of the foundation on side 2A and the tests were conducted using 2 blocks each at a depth of 8.5m (block numbers BL 1 & 2) and a depth of 10.0m (block numbers BL 3 & 4) from G.L. A plane view of the test conditions is shown in Fig.4 and an inclined view is shown in Fig.5.

The shear plane was 60cm × 60cm in size and, since load strength was conjectured to be in the range of 0.4N/cm² under normal loading conditions at the bottom of the foundation, vertical loading was carried out in the stages of 0.1, 0.2, 0.3 and 0.5N/cm². The loading velocity was set at 2.5×10^{-2} N/cm²/min with a stationary period of 5 minutes at each stage. In addition, horizontal shear loading was carried out at a velocity of 5.0×10^{-2} N/cm²/min with a stationary period of 5 minutes after each 0.2N/cm² loading and the load was increased until shear failure occurred. The blocks were set up so that they would shear in the direction of the river.

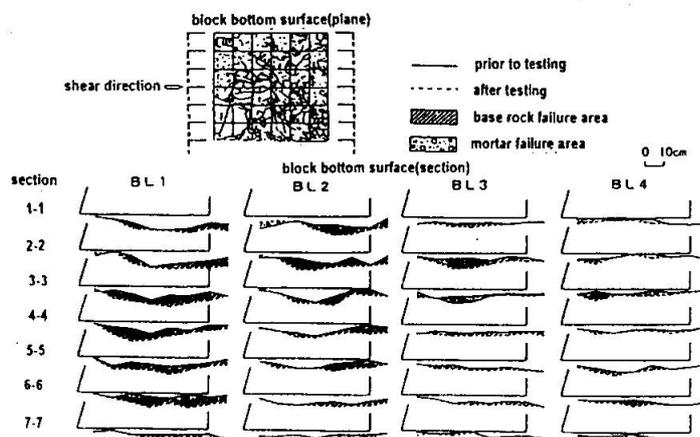
Fig.6 Conditions of failure of the shear plane of the block

Observation of the conditions of the shear plane indicated that the failure of blocks BL1-3 was deeper than in block BL4 and there was also a tendency in all of the blocks to form a slope inclining generally toward the front. In regard to the shear plane conditions, blocks BL1-3 sheared in the direction of the joint of the breccia contained in the auto-brecciated andesite. However, block BL4 sheared with a number of cracks appearing in the base rock itself in the direction of the shear and in the perpendicular direction as shear loading was applied.
