**Artikel:** Evaluation of cracked soft rock on in-situ test results

## Evaluation of Cracked Soft Rock on In-Situ Test Results

The base rock expected to be used for the foundation of a railway arch bridge (180m span) currently in the planning stage is heavily-cracked auto-brecciated andesite (rock grade about  $C_M$ - $C_L$ -Rock classification of dam foundation in Japan). There was a need to accurately evaluate the bearing capacity, since a load amounting to as much as about 2.1kN (normal condition) would be applied to the base rock at each bridge pier. Since being an arch bridge, there was a desire to restrain support point displacement of the foundation to the utmost, and since it was also necessary to take into consideration the reduction in bearing capacity due to the effect of slopes due to the fact that the foundation would be constructed on slopes facing the river. We thus conducted block shear tests as a way of improving the accuracy of the shear constant. We evaluated bearing capacity of the base rock and shear constants ( $c$ ,  $\phi$ ), analyzed the test results as well as the results of prior tests on the same type of base rock and determined the material values to

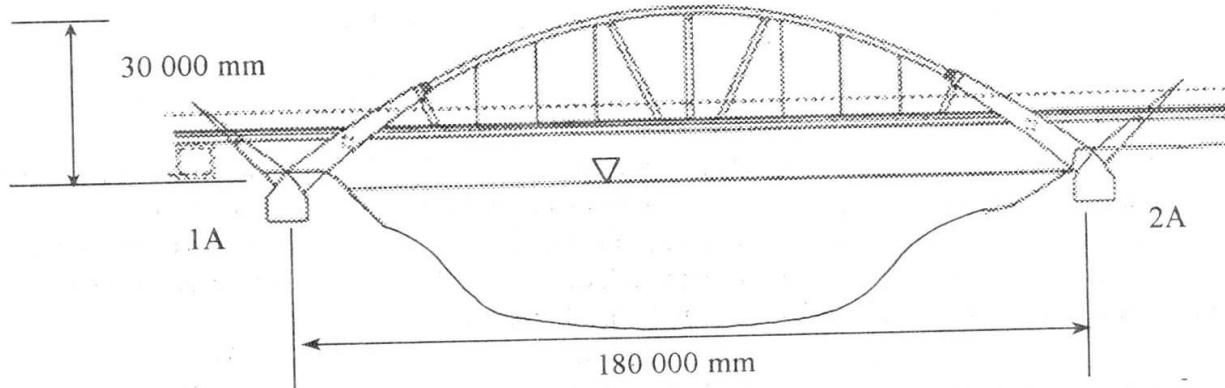
*Fig. 1 Outline view of the bridge*

We will next give an explanation of the strata composition in the vicinity of the foundation. Side 2A is characterized by surface deposits (fill, old surface soil) with an N-value of about 5 to a depth of GL-4m, and terraced deposits (sand and gravel mixed with cobblestone) at a depth of GL-7-9m with soft stone tuff-breccia with heavily-cracked auto-brecciated andesite intrusions) at depths greater than GL-9m (refer to Fig. 1 and Table 1).

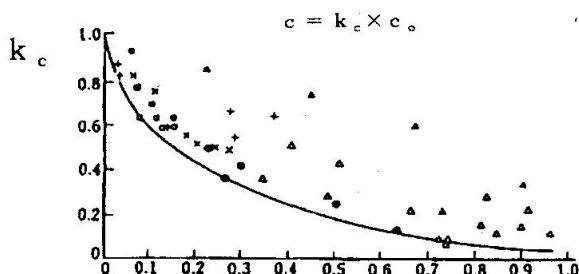
Fig. 2 Relationship of  $Cr$  and  $k_c$

In addition, Figs. 2 & 3 indicate data compiled by the Japan Roadway Public Corporation relating to the relationship between the cracking index and the reduction index of cohesion strength and the angle of internal friction. This data included the test data of the Railway Technical Research Institute of the National Railway. It is possible to estimate the values of  $c$  and  $\phi$  by means of a curve that takes the lower limits of variation indicated in Fig. 2 & 3. In other words:

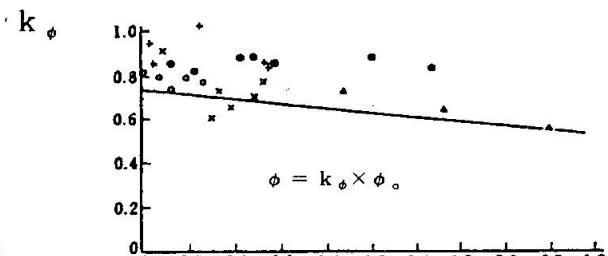
Fig. 3 Relationship of  $Cr$  and  $k_\phi$

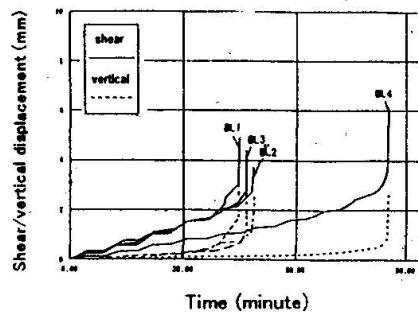
Fig. 7 Relationship between time and shear/vertical displacement (average)

Failure took 2-3 times longer with BL4 than with BL1-3.

The conditions of failure of the shear plane of the blocks are indicated in Fig.6. The relationship between time and shear/vertical displacement (average) is indicated in Fig.7. The relationship between shear stress and displacement velocity is indicated in Fig.8. The relationship between shear stress and the amount of shear displacement is indicated in Fig.9. And the relationship between shear stress and shear/vertical displacement (average) is indicated in Fig.10.

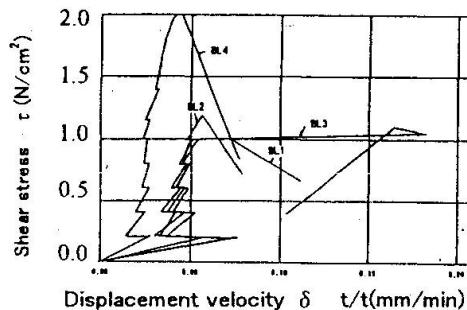
Fig. 8 Relationship between shear stress and displacement velocity

The displacement velocity of BL4 was about 1/2 that of BL1-3 and the progress of the displacement was slow.

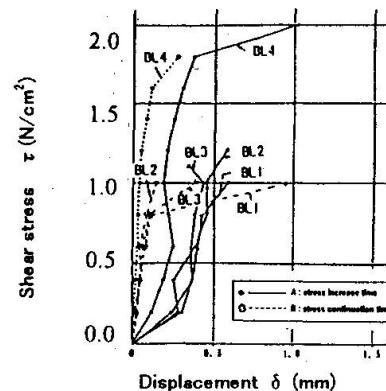
Fig. 9 Relationship between shear stress and the amount of shear displacement

The amount of shear displacement was about 1/2 that of BL1-3 for both stress increase time and continuation time. This would indicate that the base rock of BL4 is hard and that fractures are closed.

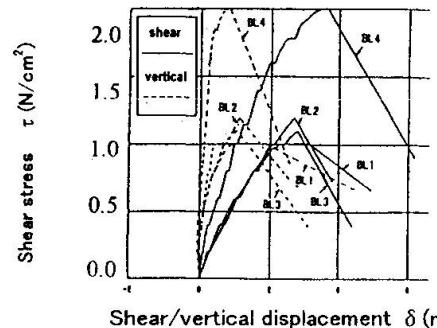
Fig. 10 Relationship between shear stress and shear/vertical displacement (average)

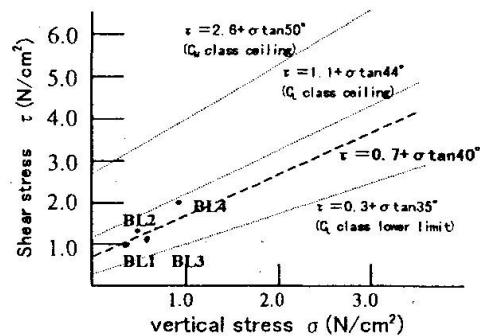
Fig. 11 Test results and volcanic rock shear strength properties

In addition, if we plot the values obtained in the tests in the shear strength properties of the volcanic rock shown in Fig.11, we could see that the test values for BL1-3 would be average values for  $C_L$  grade rock and that the test values of BL4 would be at the upper limit for  $C_L$  grade rock. Based on this, we can state that appropriate values were obtained in the tests corresponding to the rock type and grade.

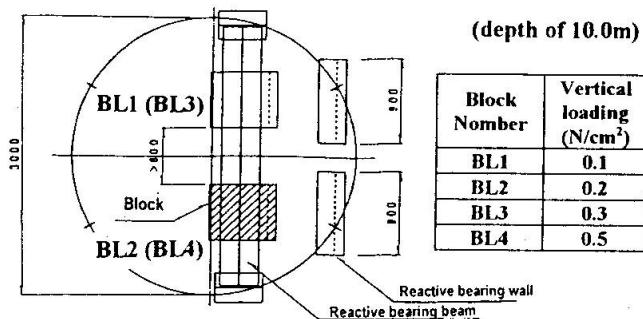
Fig. 4 Plane view of the conditions of block shear tests [depth of 8.5m]

Deep foundation holes with a diameter of 3m were excavated in the vicinity of the foundation on side 2A and the tests were conducted using 2 blocks each at a depth of 8.5m (block numbers BL 1 & 2) and a depth of 10.0m (block numbers BL 3 & 4) from G.L. A plane view of the test conditions is shown in Fig.4 and an inclined view is shown in Fig.5.

The shear plane was 60cm × 60cm in size and, since load strength was conjectured to be in the range of  $0.4\text{N}/\text{cm}^2$  under normal loading conditions at the bottom of the foundation, vertical loading was carried out in the stages of 0.1, 0.2, 0.3 and  $0.5\text{N}/\text{cm}^2$ . The loading velocity was set at  $2.5 \times 10^{-2}$   $\text{N}/\text{cm}^2/\text{min}$  with a stationary period of 5 minutes at each stage. In addition, horizontal shear loading was carried out at a velocity of  $5.0 \times 10^{-2}$   $\text{N}/\text{cm}^2/\text{min}$  with a stationary period of 5 minutes after each  $0.2\text{N}/\text{cm}^2$  loading and the load was increased until shear failure occurred. The blocks were set up so that they would shear in the direction of the river.

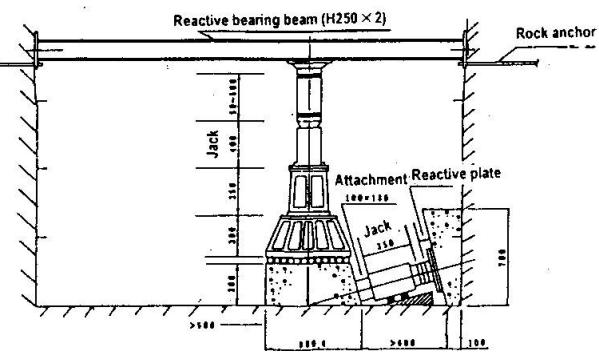
Fig. 5 Side view of the conditions of block shear tests

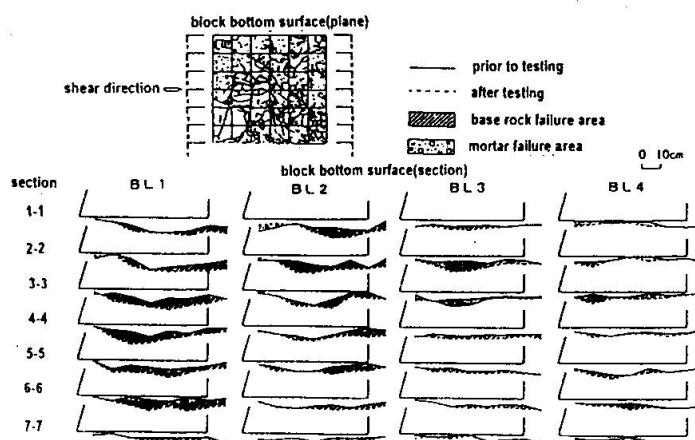
Fig. 6 Conditions of failure of the shear plane of the block

Observation of the conditions of the shear plane indicated that the failure of blocks BL1-3 was deeper than in block BL4 and there was also a tendency in all of the blocks to form a slope inclining generally toward the front. In regard to the shear plane conditions, blocks BL1-3 sheared in the direction of the joint of the breccia contained in the auto-brecciated andesite. However, block BL4 sheared with a number of cracks appearing in the base rock itself in the direction of the shear and in the perpendicular direction as shear loading was applied.
