Evaluation of Cracked Soft Rock on In-Situ Test Results

Civil Engineer
Deputy Manager of
construction supervision sect
East Japan Railway Company
Joshin-etsu Construction
office Takasaki, Japan

The base rock expected to be used for the foundation of a railway arch bridge(180m span) currently in the planning stage is heavily-cracked auto-brecciated andesite (rock grade about C_M - C_L -Rock classification of dam foundation in Japan). There was a need to accurately evaluate the bearing capacity, since a load amounting to as much as about 2.1kN (normal condition) would be applied to the base rock at each bridge pier. Since being an arch bridge, there was a desire to restrain support point displacement of the foundation to the utmost, and since it was also necessary to take into consideration the reduction in bearing capacity due to the effect of slopes due to the fact that the foundation would be constructed on slopes facing the river. We thus conducted block-shear tests as a way of improving the accuracy of the shear constant. We evaluated bearing capacity of the base rock and shear constants (c , ϕ), analyzed the test results as well as the results of prior tests on the same type

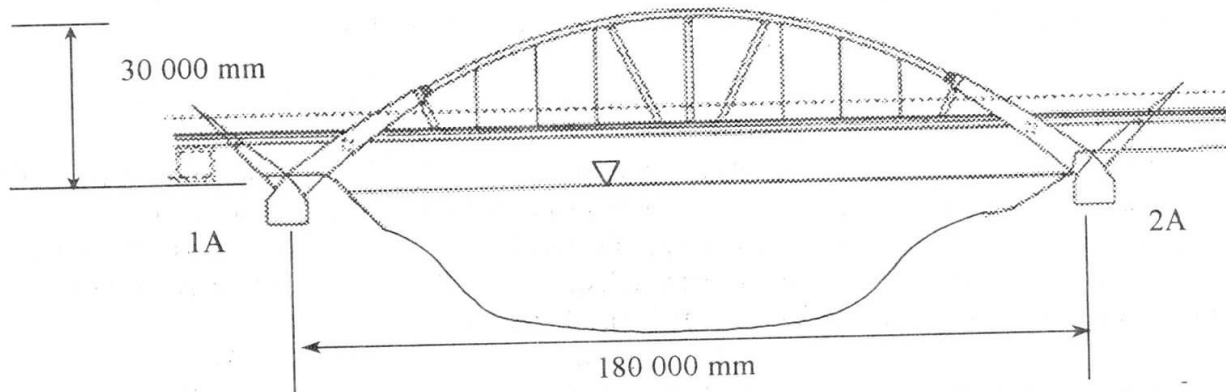
Fig.1 Outline view of the bridge

We will next give an explanation of the strata composition in the vicinity of the foundation. Side 2A is characterized by surface deposits (fill, old surface soil) with an N-value of about 5 to a depth of GL-4m, and terraced deposits (sand and gravel mixed with cobblestone) at a depth of GL-7-9m with soft stone tuff-breccia with heavily-cracked auto-brecciated andesite intrusions) at depths greater than GL-9m (refer to Fig.1 and Table 1).

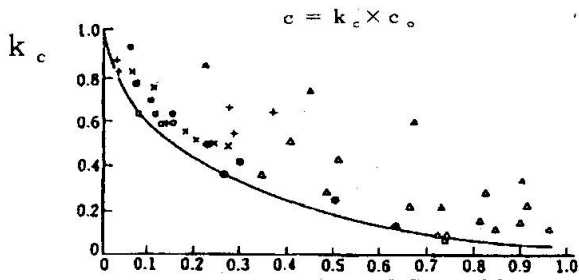
Fig. 2 Relationship of C_r and k_c

In addition, Figs. 2 & 3 indicate data compiled by the Japan Roadway Public Corporation relating to the relationship between the cracking index and the reduction index of cohesion strength and the angle of internal friction. This data included the test data of the Railway Technical Research Institute of the National Railway. It is possible to estimate the values of c and ϕ by means of a curve that takes the lower limits of variation indicated in Fig. 2 & 3. In other words:

Material values for the bedrock of side 2A determined from the above are shown in Table 4. According to this method, it is necessary to carry out a reduction of about 80% for cohesion strength and about 40% for the angle of internal friction relative to the results of triaxial compression tests. However, it is possible that shear constants c and ϕ are underestimated with this method, since there are various reasons, such as the fact that basically the minimum values are used for the reduction index and the impossibility of differentiating quantitatively between open and closed cracks because of the use of elastic waves.

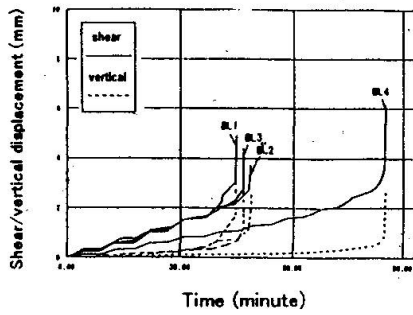
Fig.7 Relationship between time and shear/vertical displacement (average)

Failure took 2-3 times longer with BL4 than with BL1-3.

The conditions of failure of the shear plane of the blocks are indicated in Fig.6. The relationship between time and shear/vertical displacement (average) is indicated in Fig.7. The relationship between shear stress and displacement velocity is indicated in Fig.8. The relationship between shear stress and the amount of shear displacement is indicated in Fig.9. And the relationship between shear stress and shear/vertical displacement (average) is indicated in Fig.10.

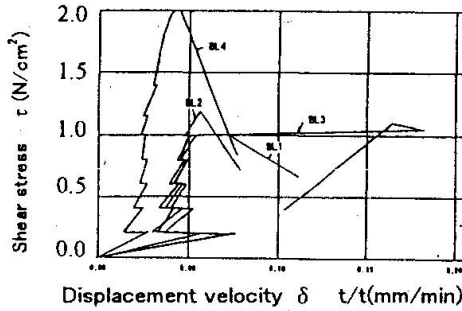
Fig.8 Relationship between shear stress and displacement velocity

The displacement velocity of BL4 was about 1/2 that of BL1-3 and the progress of the displacement was slow.

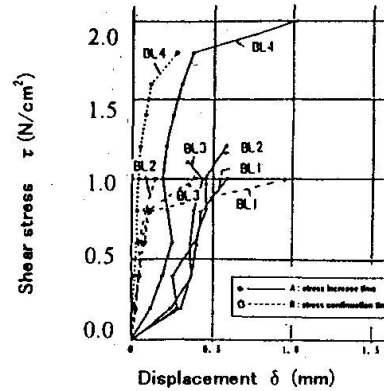
Fig.9 Relationship between shear stress and the amount of shear displacement

The amount of shear displacement was about 1/2 that of BL1-3 for both stress increase time and continuation time. This would indicate that the base rock of BL4 is hard and that fractures are closed.

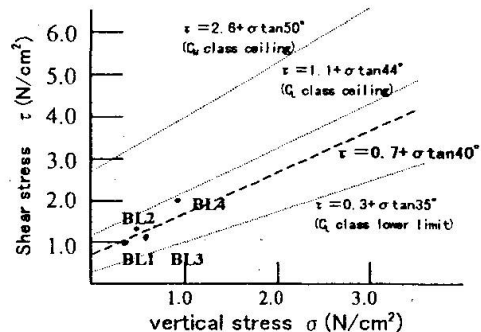
Fig.11 Test results and volcanic rock shear strength properties

In addition, if we plot the values obtained in the tests in the shear strength properties of the volcanic rock shown in Fig. 11, we could see that the test values for BL1-3 would be average values for C_L grade rock and that the test values of BL4 would be at the upper limit for C_L grade rock. Based on this, we can state that appropriate values were obtained in the tests corresponding to the rock type and grade.

If we therefore consider the data for BL1-3 to be typical of the shear strength of the andesite in the tests and use the average angle of internal friction ($\phi = 40^\circ$) for the igneous and volcanic rock of Table 5, it would be possible to formulate the following relational expression:

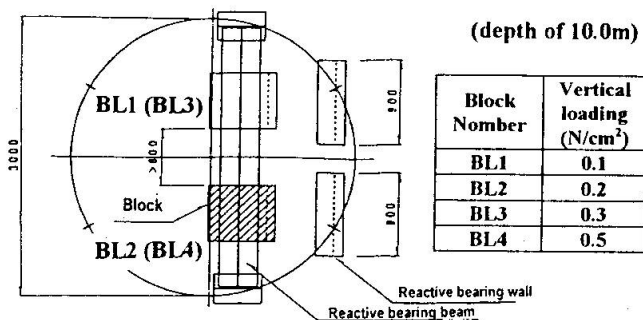
Fig.4 Plane view of the conditions of block shear tests [depth of 8.5m]

Deep foundation holes with a diameter of 3m were excavated in the vicinity of the foundation on side 2A and the tests were conducted using 2 blocks each at a depth of 8.5m (block numbers BL 1 & 2) and a depth of 10.0m (block numbers BL 3 & 4) from G.L. A plane view of the test conditions is shown in Fig.4 and an inclined view is shown in Fig.5.

The shear plane was 60cm × 60cm in size and, since load strength was conjectured to be in the range of 0.4N/cm² under normal loading conditions at the bottom of the foundation, vertical loading was carried out in the stages of 0.1, 0.2, 0.3 and 0.5N/cm². The loading velocity was set at 2.5 × 10⁻² N/cm²/min with a stationary period of 5 minutes at each stage. In addition, horizontal shear loading was carried out at a velocity of 5.0 × 10⁻² N/cm²/min with a stationary period of 5 minutes after each 0.2N/cm² loading and the load was increased until shear failure occurred. The blocks were set up so that they would shear in the direction of the river.

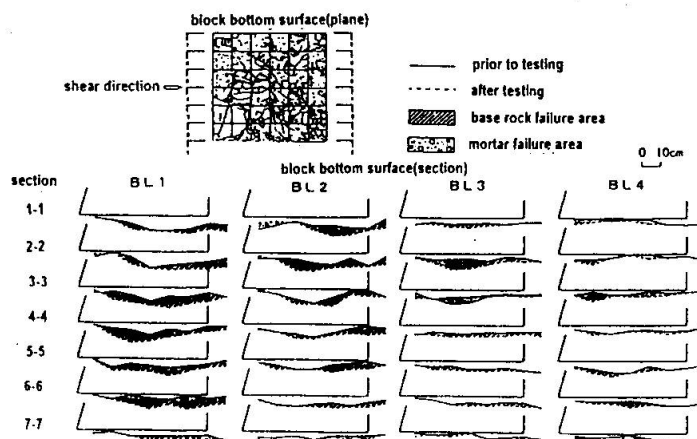
Fig.6 Conditions of failure of the shear plane of the block

Observation of the conditions of the shear plane indicated that the failure of blocks BL1-3 was deeper than in block BL4 and there was also a tendency in all of the blocks to form a slope inclining generally toward the front. In regard to the shear plane conditions, blocks BL1-3 sheared in the direction of the joint of the breccia contained in the auto-brecciated andesite. However, block BL4 sheared with a number of cracks appearing in the base rock itself in the direction of the shear and in the perpendicular direction as shear loading was applied.
