CASE STUDIES AND LESSONS LEARNED FROM RECENT SCOUR-RELATED BRIDGE FAILURES IN THE UNITED STATES

Peter F. LAGASSE

Senior Vice President
Ayres Associates, Inc.
Fort Collins, CO USA

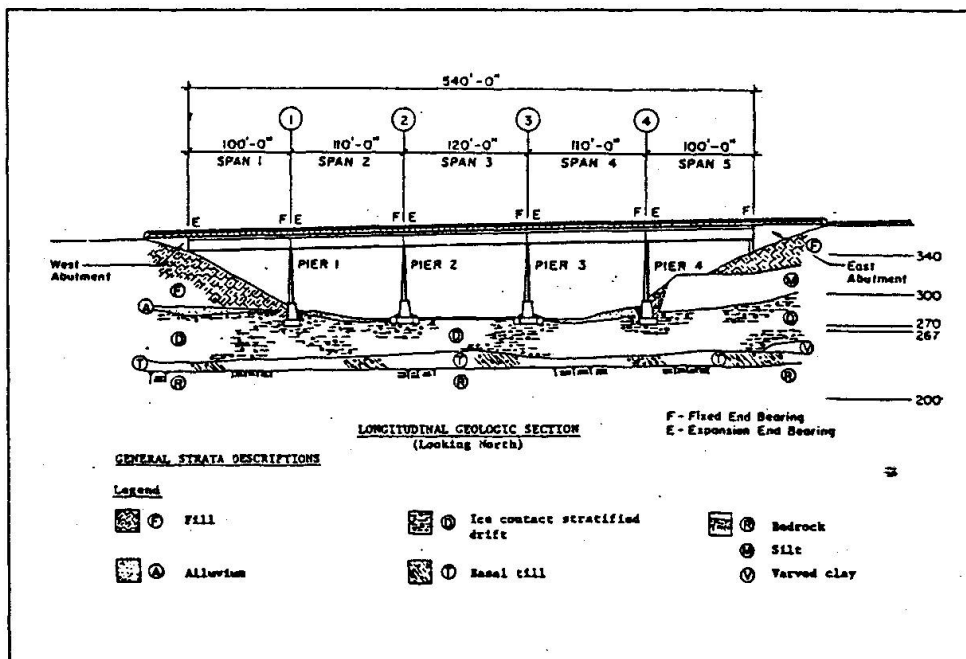
Figure 1. South elevation of Schoharie Creek bridge showing key structural features and schematic geological section.

The substructure consisted of four piers and two abutments. Each pier was a rigid frame (columns and tie beam) supported on a lightly reinforced concrete plinth (pedestal) and spread footing bearing on glacial till just below the streambed. The abutments were founded on piles driven through the embankment fill into the underlying glacial till. The

piers were founded on spread footings 1.5 m deep by 5.5 m wide by 25 m long with no piles. The bridge designers assumed that the glacial till substrate was "nonerodible."

After an extensive investigation and detailed analyses, which included hydraulic computer and physical modeling [1], the U.S. National Transportation Safety Board (NTSB) [2] determined that the probable cause of the collapse of the Schoharie Creek bridge was the failure of the Thruway Authority to maintain adequate riprap around the bridge piers, which led to severe erosion (scour) in the soil beneath the spread footings. It was concluded that the 1987 flood alone probably did not cause failure of the Thruway bridge. Rather, the cumulative effect of local scour around pier 3, particularly in the last 10 years, was the most significant hydraulic factor contributing to the failure.

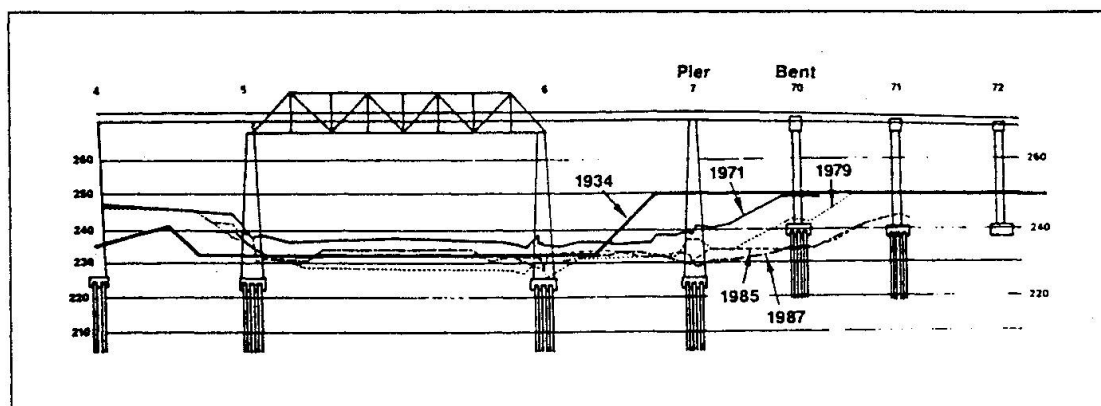
The bridge substructure consisted of main channel piers and floodplain bents supported on piles about 6.1 m long (Figure 2). There was about a 4-meter difference in elevation between the pile cap for the main channel piers and the pile cap of the shallower floodplain bents. A post-failure investigation revealed the following rates of channel migration into the north bank of the river at the bridge: 1931 to 1975 - 0.24 m/yr; 1975 to 1989 - 1.37 m/yr; and 1981 to 1989 - 0.58 m/yr [4].

Figure 2. Channel cross section change at the Hatchie River bridge, Tennessee.

The NTSB determined that the probable cause of the collapse of the northbound U.S. Route 51 bridge spans was the northward migration of the main river channel, which the Tennessee Department of Transportation failed to evaluate and correct. As with the Schoharie Creek failure, the lack of structural redundancy in the design of the bridge spans contributed to the severity of the accident [4].
