Artikel: Case studies and lessons learned from recent scour-related bridge failures in the United States
Autor: Lagasse, Peter F.
DOI: <https://doi.org/10.5169/seals-60752>

CASE STUDIES AND LESSONS LEARNED FROM RECENT SCOUR-RELATED BRIDGE FAILURES IN THE UNITED STATES

2. SCHOHARIE CREEK, NEW YORK (1987) BRIDGE FAILURE

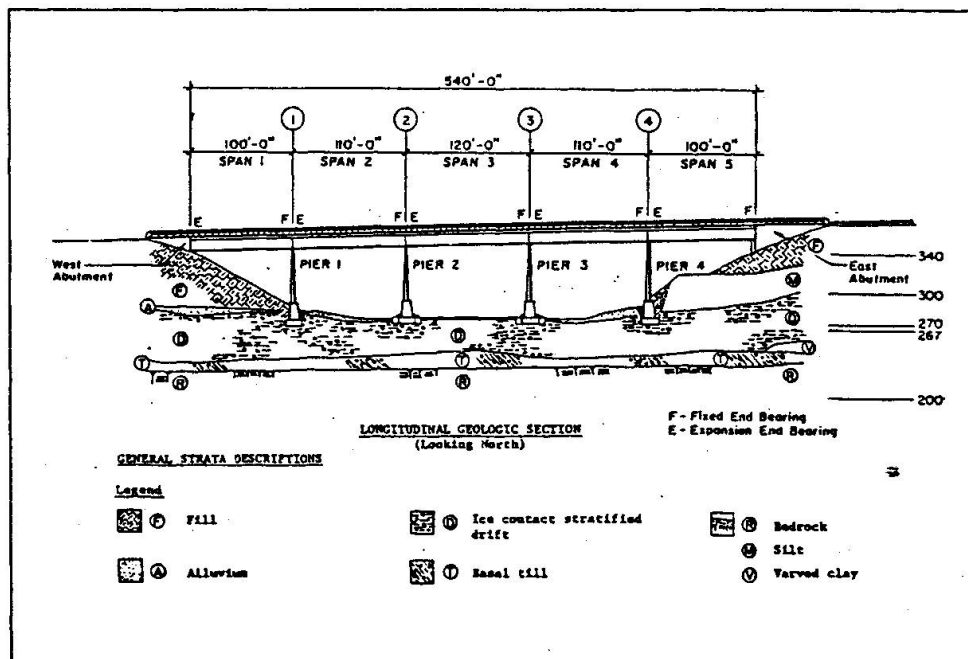
Figure 1. South elevation of Schoharie Creek bridge showing key structural features and schematic geological section.

The substructure consisted of four piers and two abutments. Each pier was a rigid frame (columns and tie beam) supported on a lightly reinforced concrete plinth (pedestal) and spread footing bearing on glacial till just below the streambed. The abutments were founded on piles driven through the embankment fill into the underlying glacial till. The

piers were founded on spread footings 1.5 m deep by 5.5 m wide by 25 m long with no piles. The bridge designers assumed that the glacial till substrate was "nonerodible."

After an extensive investigation and detailed analyses, which included hydraulic computer and physical modeling [1], the U.S. National Transportation Safety Board (NTSB) [2] determined that the probable cause of the collapse of the Schoharie Creek bridge was the failure of the Thruway Authority to maintain adequate riprap around the bridge piers, which led to severe erosion (scour) in the soil beneath the spread footings. It was concluded that the 1987 flood alone probably did not cause failure of the Thruway bridge. Rather, the cumulative effect of local scour around pier 3, particularly in the last 10 years, was the most significant hydraulic factor contributing to the failure.
