**Zeitschrift:** IABSE reports = Rapports AIPC = IVBH Berichte  
**Band:** 80 (1999)

**Artikel:** Construction of anchored caissons for a motorway viaduct  
**Autor:** Halimeh, Nader  
**DOI:** <https://doi.org/10.5169/seals-60773>

## CONSTRUCTION OF ANCHORED CAISSONS FOR A MOTORWAY VIADUCT

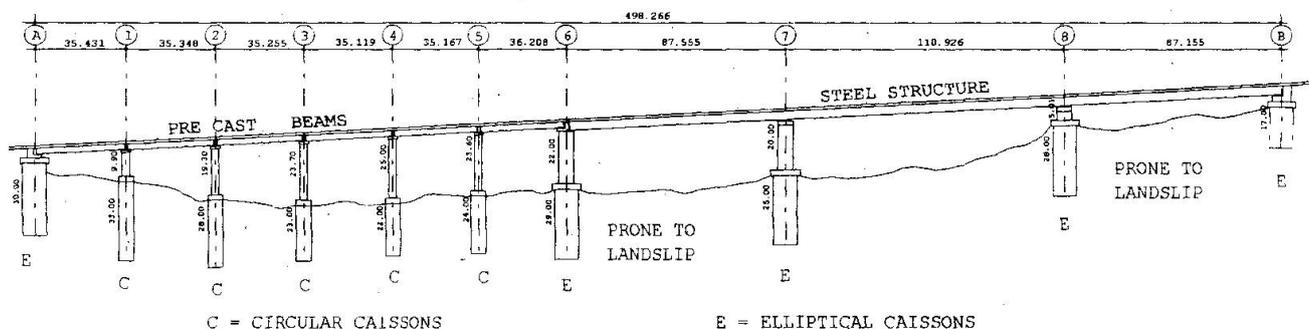
Figure 1: Longitudinal section of Viaduct V5.

Viaduct V5 is 500 m long, comprising nine spans, with a maximum span of 110 m in each carriageway, see Figure 1 below. The entire design and concept is governed by geological factors, as described below, which necessitated the use of caisson structures to form the deep foundations for all piers and abutments. Part of the viaduct super-structure is constructed of pre-cast beams, the remainder of structural steel box girders; accordingly, two different types of pier columns and foundations were required. Two types of caissons were designed, one circular, 6 m in diameter, and the other elliptical, 12 m by 8.5 m; the elliptical shape was chosen to reduce the obstructing effect that might occur in the event of a landslide. The caisson depth varies between 10 m and 31 m.

In general, tie-back walls are constructed in soft ground such as clay, sand, gravel and shales. The caissons for the piers adjacent to Abutment A of Viaduct No. 5 were six metre diameter circular caissons, as shown in Figure 1. When the Contractor came to create Abutment A itself, for each carriageway it have been logical to have two similar caissons, but he elected instead to have one larger 12 x 8.5m elliptical caisson with anchor-supported walls because the excavation of the smaller circular caissons at the adjacent piers had proved to be slow. Hanna points out that for any specific problem, and the above is a good example, a large number of possible solutions is often available, and selection is usually controlled by factors other than technical.

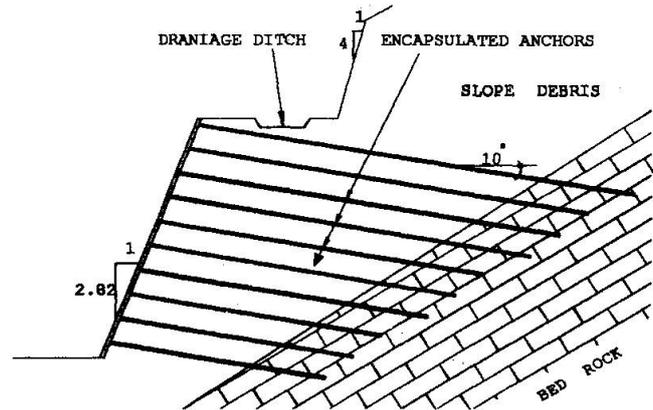
Figure 2: Slope formation.

Preparatory excavations were made in the slope debris in order to obtain a level working platform for construction of the caisson proper. These excavations were carried down step by step, each step being supported by shotcrete reinforced with wire mesh and retained by encapsulated (passive) anchors comprising 26.5 mm diameter bars of 835/1030 U.T.S. steel inserted into a 130 mm diameter hole. The anchors were embedded three metres into the bed rock, as shown in Figure 2. Two inclinometers were installed to monitor any movement during excavation.

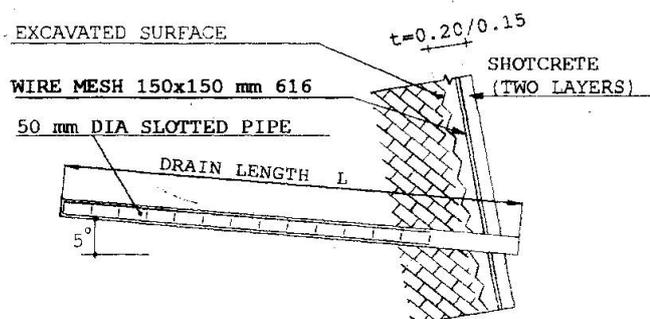
Figure 4: Drainage behind shotcrete lining.

Excavation was carried out, using a hydraulic excavator, the use of explosives was rejected both from fear of precipitating further landslips, and to prevent loosening of anchors already installed for previous stages. The ground was removed down to the level of the next support stage; wire mesh was applied to the exposed ground that formed the wall of the excavation, and then shotcrete was applied as shown in Figure 3 on the next page. In the circular caissons, shotcrete 150 mm thick was sprayed onto the exposed ground, increased to 200 mm thick when more than 10 m below the top of the caisson. In the elliptical caissons, in addition to 200mm of shotcrete, a reinforced concrete ring beam was cast at the bottom of each excavation stage, through which pre-stressed cable anchors (active) were installed as described in Paragraph 3.3 below. These beams and anchors were only required through the slope debris; in rock, ring beams were formed in shotcrete. Drainage pipes, as shown in Figure 4, were installed through the shotcrete of alternate vertical panels, of each caisson, to prevent accumulation of ground water pressure behind the shotcrete.

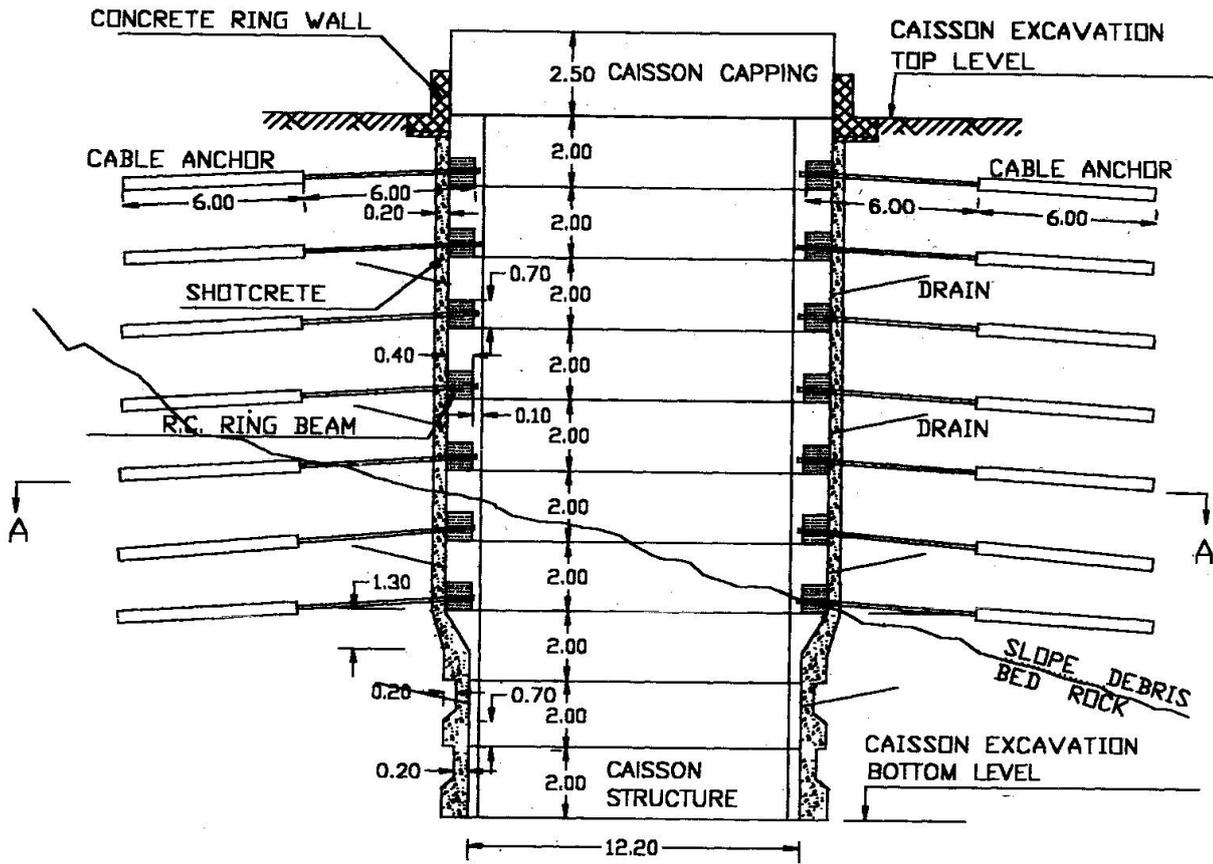
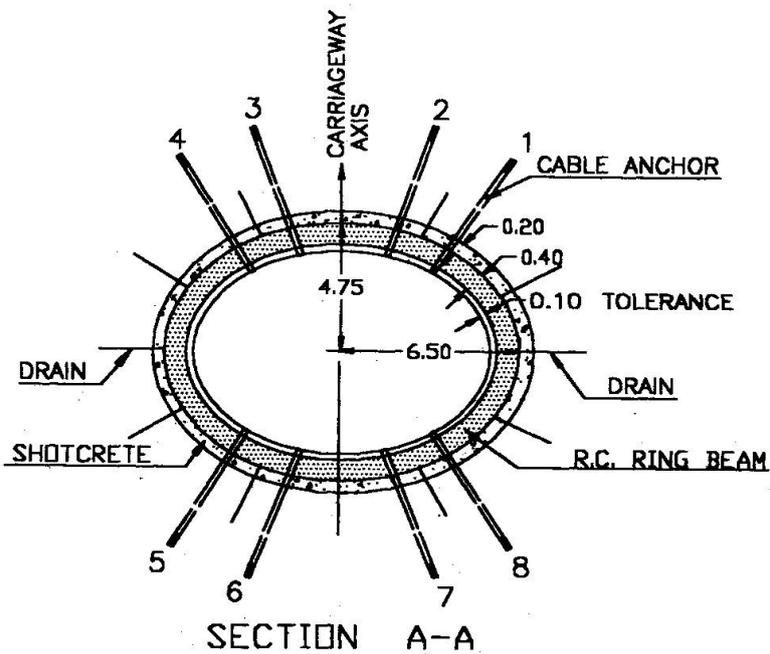
Fig. 3. Plan and section of an elliptical caisson showing excavation stages and the peripheral supporting system.

Eight cable anchors were used at each stage of excavation of the elliptical caissons, as shown in Figure 3, each anchor had two strands 15.24 mm in diameter as shown in Figure 5. The drilling of

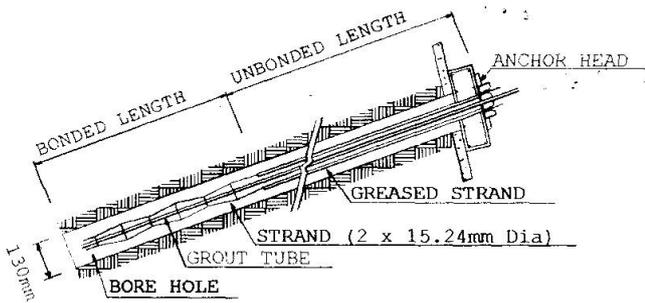
Figure 5: Pre-stressed cable anchor details.

the 130 mm diameter holes was performed by a SoilMech SM 305 drilling rig, lowered down to the current floor of the excavation. The cable anchors were assembled on site, and inserted into the holes, after which grout was pumped in to form an anchorage, from a grouting plant located on the surface nearby. After the ring beam had gained sufficient strength, the anchors were stressed. The imposed stressing force was 150 kN for the top row, and 250 kN for the remainder; however, for some anchors at the second level this could not be achieved, even after the bond length was increased from six to ten metres, probably due to excessive ground water. This was overcome by accepting 150 kN for these anchors as well, and post-grouting them. One anchor at each level was tested in accordance with the relevant AASHTO specification.
