**Zeitschrift:** IABSE reports = Rapports AIPC = IVBH Berichte  
**Band:** 80 (1999)

**Artikel:** Construction of anchored caissons for a motorway viaduct  
**Autor:** Halimeh, Nader  
**DOI:** <https://doi.org/10.5169/seals-60773>

## CONSTRUCTION OF ANCHORED CAISSENS FOR A MOTORWAY VIADUCT

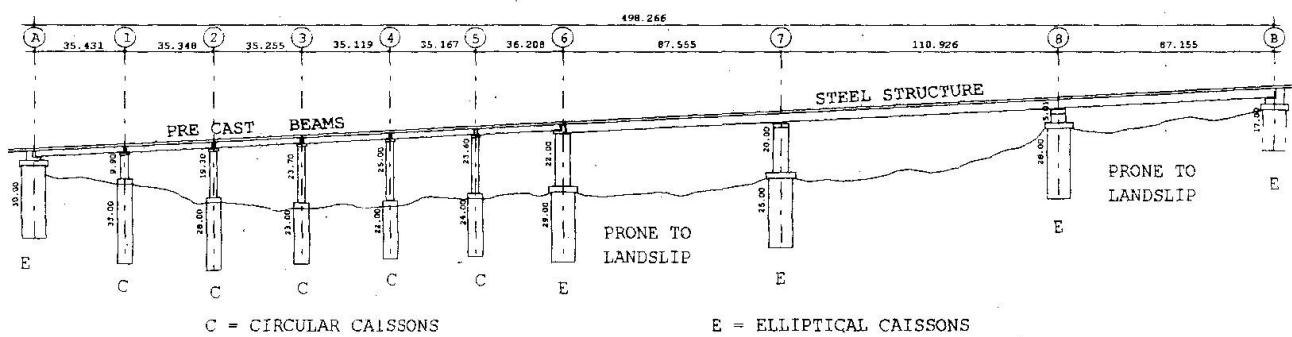
Figure 1: Longitudinal section of Viaduct V5.

Viaduct V5 is 500 m long, comprising nine spans, with a maximum span of 110 m in each carriageway, see Figure 1 below. The entire design and concept is governed by geological factors, as described below, which necessitated the use of caisson structures to form the deep foundations for all piers and abutments. Part of the viaduct super-structure is constructed of pre-cast beams, the remainder of structural steel box girders; accordingly, two different types of pier columns and foundations were required. Two types of caissons were designed, one circular, 6 m in diameter, and the other elliptical, 12 m by 8.5 m; the elliptical shape was chosen to reduce the obstructing effect that might occur in the event of a landslide. The caisson depth varies between 10 m and 31 m.

In general, tie-back walls are constructed in soft ground such as clay, sand, gravel and shales. The caissons for the piers adjacent to Abutment A of Viaduct No. 5 were six metre diameter circular caissons, as shown in Figure 1. When the Contractor came to create Abutment A itself, for each carriageway it have been logical to have two similar caissons, but he elected instead to have one larger 12 x 8.5m elliptical caisson with anchor-supported walls because the excavation of the smaller circular caissons at the adjacent piers had proved to be slow. Hanna points out that for any specific problem, and the above is a good example, a large number of possible solutions is often available, and selection is usually controlled by factors other than technical.

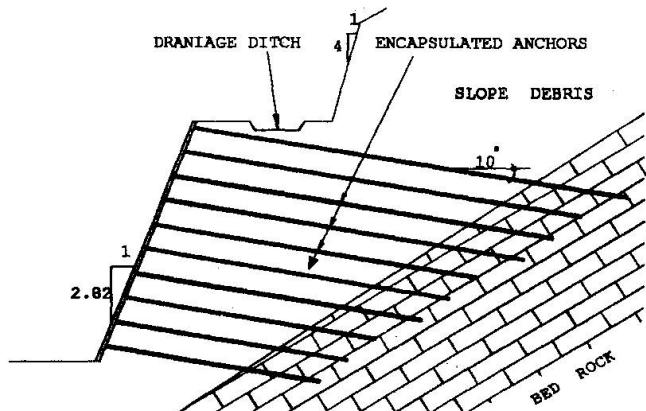
Figure 2: Slope formation.

Preparatory excavations were made in the slope debris in order to obtain a level working platform for construction of the caisson proper. These excavations were carried down step by step, each step being supported by shotcrete reinforced with wire mesh and retained by encapsulated (passive) anchors comprising 26.5 mm diameter bars of 835/1030 U.T.S. steel inserted into a 130 mm diameter hole. The anchors were embedded three metres into the bed rock, as shown in Figure 2. Two inclinometers were installed to monitor any movement during excavation.

The anchors were embedded three metres into the bed rock, as shown in Figure 2. Two inclinometers were installed to monitor any movement during excavation.

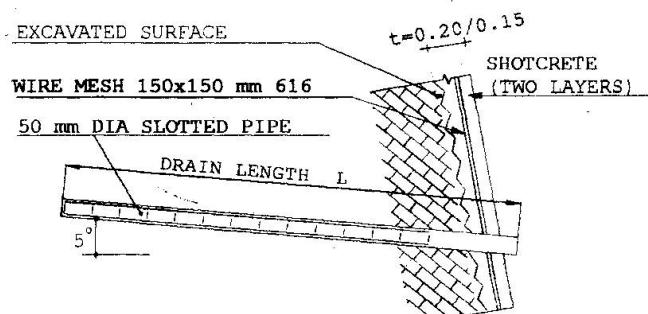
Figure 4: Drainage behind shotcrete lining.

Excavation was carried out, using a hydraulic excavator, the use of explosives was rejected both from fear of precipitating further landslips, and to prevent loosening of anchors already installed for previous stages. The ground was removed down to the level of the next support stage; wire mesh was applied to the exposed ground that formed the wall of the excavation, and then shotcrete was applied as shown in Figure 3 on the next page. In the circular caissons, shotcrete 150 mm thick was sprayed onto the exposed ground, increased to 200 mm thick when more than 10 m below the top of the caisson. In the elliptical caissons, in addition to 200mm of shotcrete, a reinforced concrete ring beam was cast at the bottom of each excavation stage, through which pre-stressed cable anchors (active) were installed as described in Paragraph 3.3 below. These beams and anchors were only required through the slope debris; in rock, ring beams were formed in shotcrete. Drainage pipes, as shown in Figure 4, were installed through the shotcrete of alternate vertical panels, of each caisson, to prevent accumulation of ground water pressure behind the shotcrete.

The accumulation of ground water draining into the excavation was a cause of delay in construction of the deepest caissons; a system of four well-points outside and on the axes each caisson had been intended at the design stage, using 150 - 200 mm diameter pipes with submersible pumps, but this could not be adopted, because such pumps were not available. Although the Contractor used a sump at each level of the excavation, this proved to be

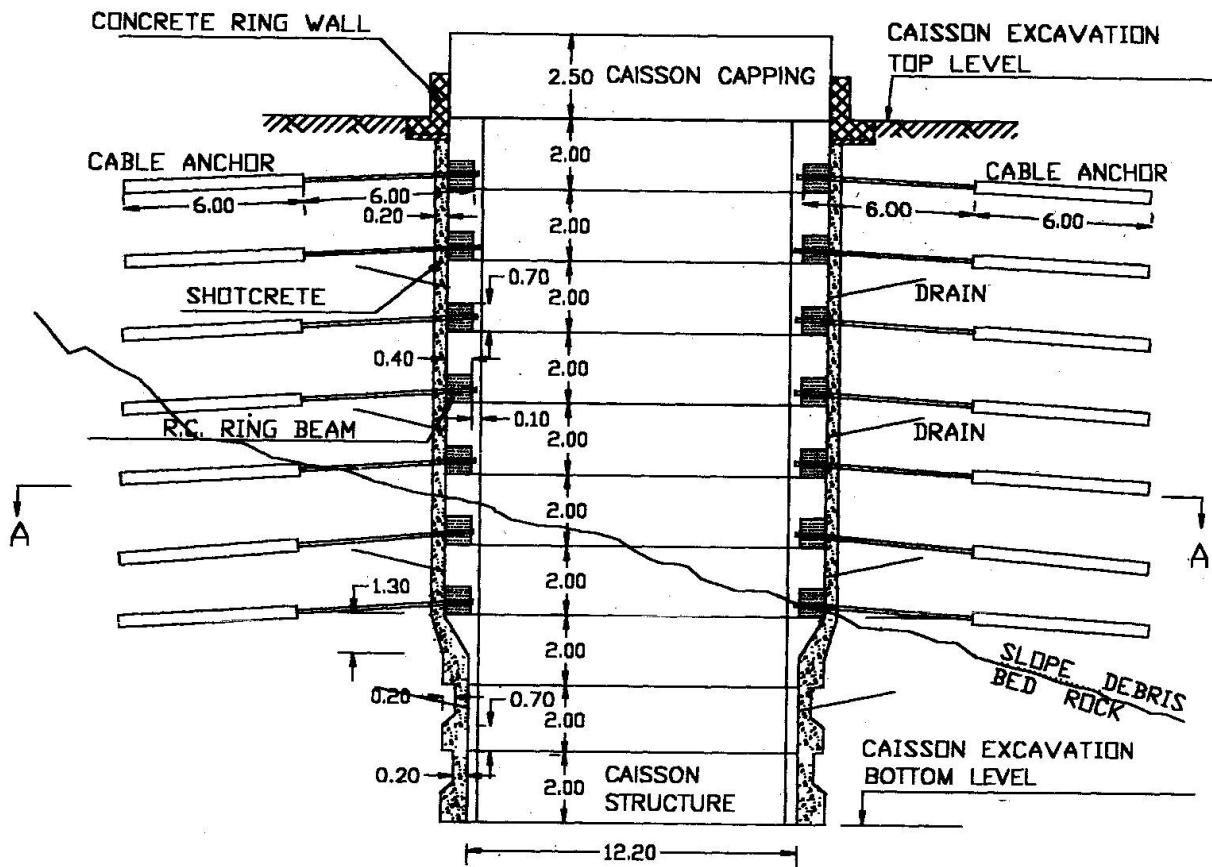
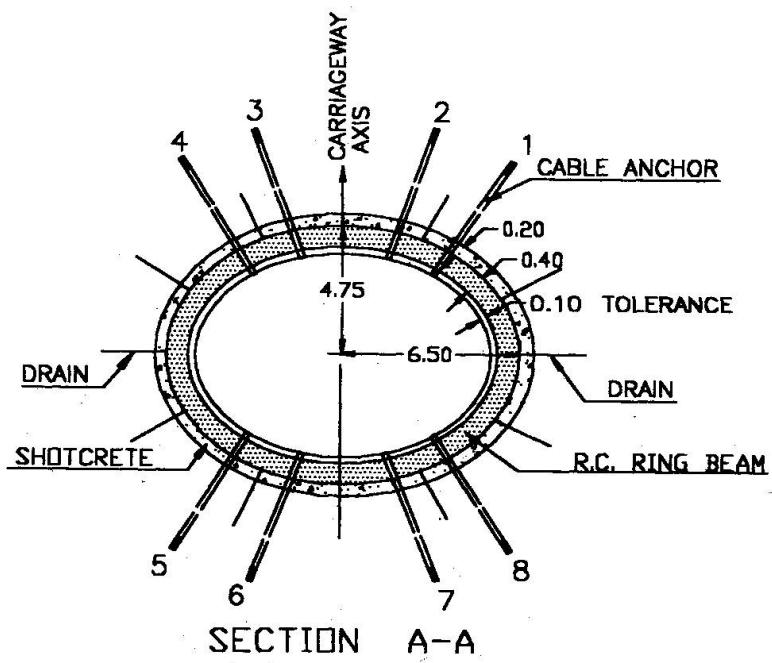
Fig. 3. Plan and section of an elliptical caisson showing excavation stages and the peripheral supporting system.

Eight cable anchors were used at each stage of excavation of the elliptical caissons, as shown in Figure 3, each anchor had two strands 15.24 mm in diameter as shown in Figure 5. The drilling of

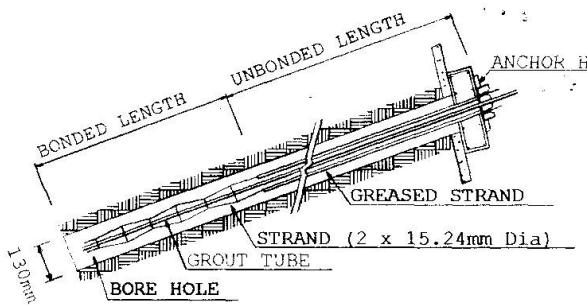
Figure 5: Pre-stressed cable anchor details.

the 130 mm diameter holes was performed by a SoilMech SM 305 drilling rig, lowered down to the current floor of the excavation. The cable anchors were assembled on site, and inserted into the holes, after which grout was pumped in to form an anchorage, from a grouting plant located on the surface nearby. After the ring beam had gained sufficient strength, the anchors were stressed. The imposed stressing force was 150 kN for the top row, and 250 kN for the remainder; however, for some anchors at the second level this could not be achieved, even after the bond length was increased from six to ten metres, probably due to excessive ground water. This was overcome by accepting 150 kN for these anchors as well, and post-grouting them. One anchor at each level was tested in accordance with the relevant AASHTO specification.
