Artikel: Construction of anchored caissons for a motorway viaduct
Autor: Halimeh, Nader
DOI: <https://doi.org/10.5169/seals-60773>

CONSTRUCTION OF ANCHORED CAISSONS FOR A MOTORWAY VIADUCT

Viaduct V5 is one of the major viaducts presently under construction for a motorway in the Middle East. This section of the motorway is 258 km long with three lanes in each direction, and involves a number of large structures including fourteen viaducts.

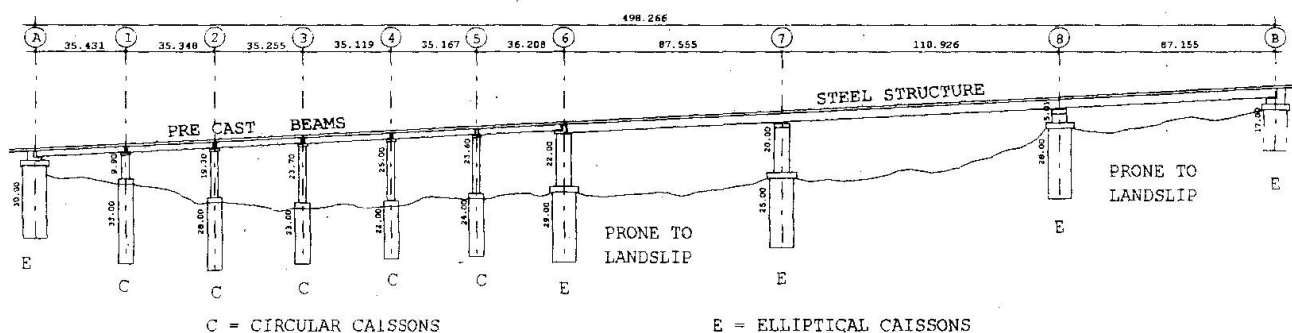
Figure 1: Longitudinal section of Viaduct V5.

Viaduct V5 is 500 m long, comprising nine spans, with a maximum span of 110 m in each carriageway, see Figure 1 below. The entire design and concept is governed by geological factors, as described below, which necessitated the use of caisson structures to form the deep foundations for all piers and abutments. Part of the viaduct super-structure is constructed of pre-cast beams, the remainder of structural steel box girders; accordingly, two different types of pier columns and foundations were required. Two types of caissons were designed, one circular, 6 m in diameter, and the other elliptical, 12 m by 8.5 m; the elliptical shape was chosen to reduce the obstructing effect that might occur in the event of a landslide. The caisson depth varies between 10 m and 31 m.

In general, tie-back walls are constructed in soft ground such as clay, sand, gravel and shales. The caissons for the piers adjacent to Abutment A of Viaduct No. 5 were six metre diameter circular caissons, as shown in Figure 1. When the Contractor came to create Abutment A itself, for each carriageway it have been logical to have two similar caissons, but he elected instead to have one larger 12 x 8.5m elliptical caisson with anchor-supported walls because the excavation of the smaller circular caissons at the adjacent piers had proved to be slow. Hanna points out that for any specific problem, and the above is a good example, a large number of possible solutions is often available, and selection is usually controlled by factors other than technical.

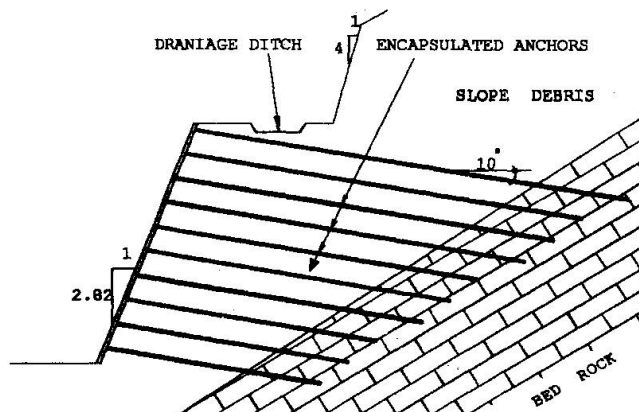
Figure 2: Slope formation.

Preparatory excavations were made in the slope debris in order to obtain a level working platform for construction of the caisson proper. These excavations were carried down step by step, each step being supported by shotcrete reinforced with wire mesh and retained by encapsulated (passive) anchors comprising 26.5 mm diameter bars of 835/1030 U.T.S. steel inserted into a 130 mm diameter hole. The anchors were embedded three metres into the bed rock, as shown in Figure 2. Two inclinometers were installed to monitor any movement during excavation.

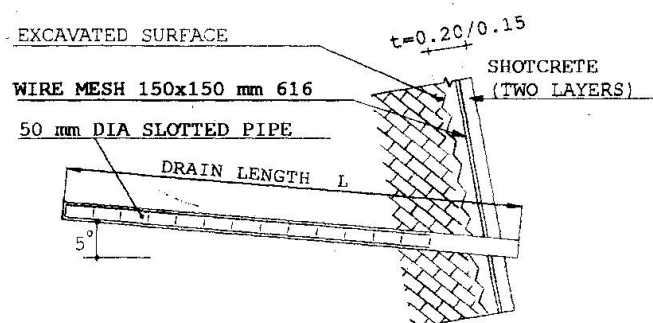
Figure 4: Drainage behind shotcrete lining.

Excavation was carried out, using a hydraulic excavator, the use of explosives was rejected both from fear of precipitating further landslips, and to prevent loosening of anchors already installed for previous stages. The ground was removed down to the level of the next support stage; wire mesh was applied to the exposed ground that formed the wall of the excavation, and then shotcrete was applied as shown in Figure 3 on the next page. In the circular caissons, shotcrete 150 mm thick was sprayed onto the exposed ground, increased to 200 mm thick when more than 10 m below the top of the caisson. In the elliptical caissons, in addition to 200mm of shotcrete, a reinforced concrete ring beam was cast at the bottom of each excavation stage, through which pre-stressed cable anchors (active) were installed as described in Paragraph 3.3 below. These beams and anchors were only required through the slope debris; in rock, ring beams were formed in shotcrete. Drainage pipes, as shown in Figure 4, were installed through the shotcrete of alternate vertical panels, of each caisson, to prevent accumulation of ground water pressure behind the shotcrete.

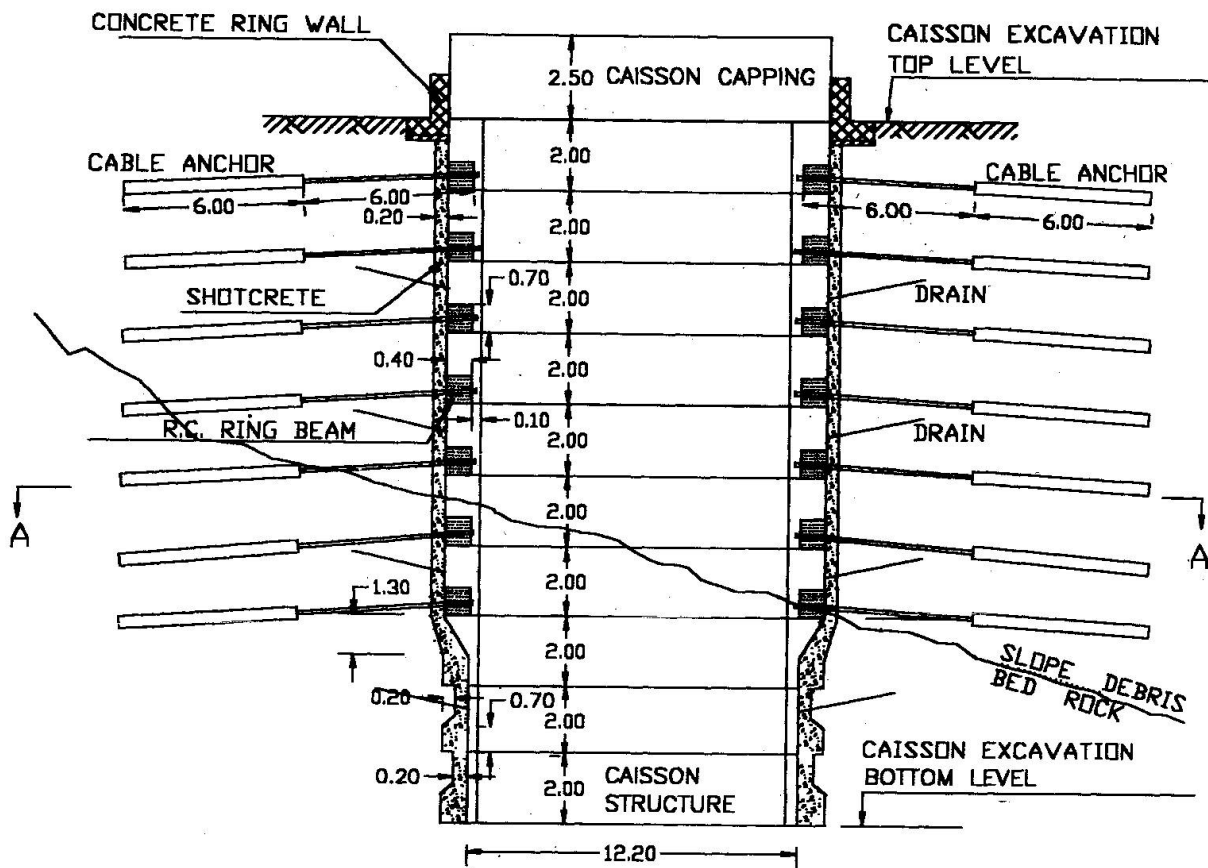
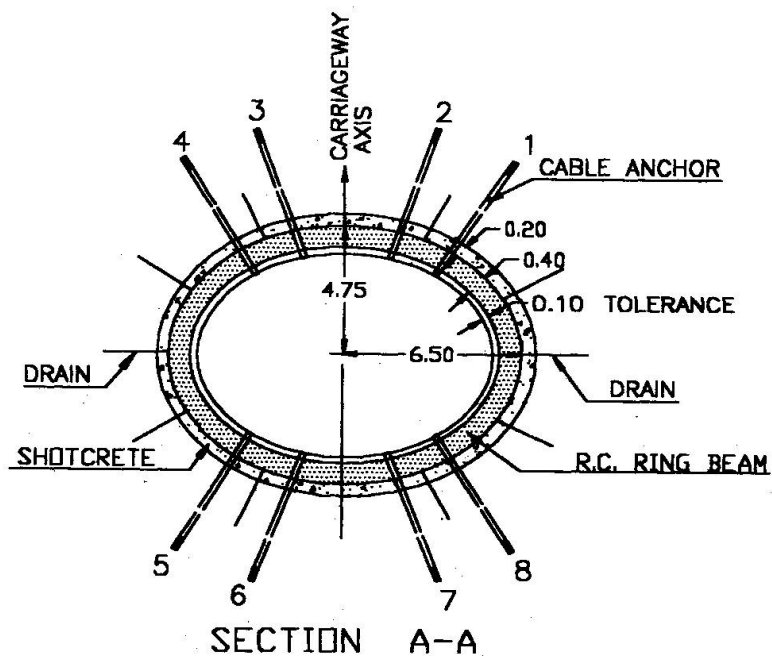
Fig. 3. Plan and section of an elliptical caisson showing excavation stages and the peripheral supporting system.

Eight cable anchors were used at each stage of excavation of the elliptical caissons, as shown in Figure 3, each anchor had two strands 15.24 mm

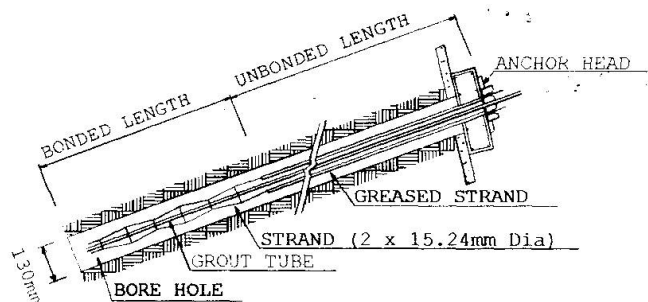
Figure 5: Pre-stressed cable anchor details.

the 130 mm diameter holes was performed by a SoilMech SM 305 drilling rig, lowered down to the current floor of the excavation. The cable anchors were assembled on site, and inserted into the holes, after which grout was pumped in to form an anchorage, from a grouting plant located on the surface nearby. After the ring beam had gained sufficient strength, the anchors were stressed. The imposed stressing force was 150 kN for the top row, and 250 kN for the remainder; however, for some anchors at the second level this could not be achieved, even after the bond length was increased from six to ten metres, probably due to excessive ground water. This was overcome by accepting 150 kN for these anchors as well, and post-grouting them. One anchor at each level was tested in accordance with the relevant AASHTO specification.

in diameter as shown in Figure 5. The drilling of
