Zeitschrift: IABSE reports = Rapports AIPC = IVBH Berichte
Band: 80 (1999)

Rubrik: Session 6: Construction. Part 2

Session - 6
Construction (Part - 2)

Verifying Computer Models of Bridge Foundations

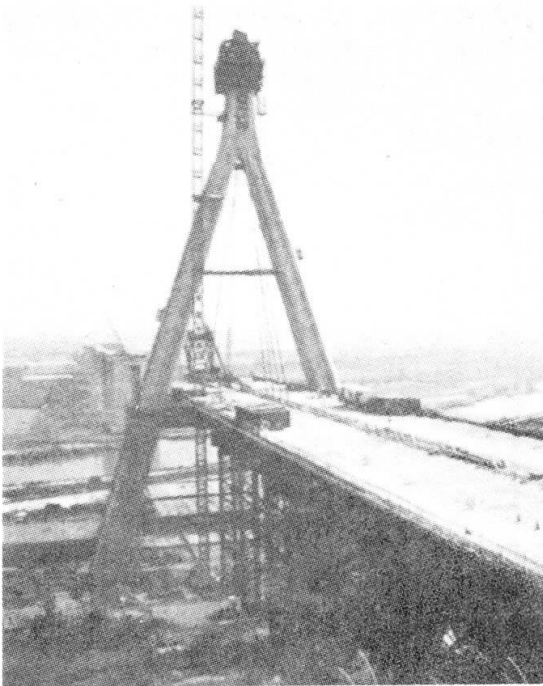
Fig.3 Kao Ping Hsi Pylon

In the course of the preliminary design, two variations were considered for the pylon foundation; one foundation with slurry walls and the other with piles of \varnothing 1.50 m. Under the observance of the dispersing forces, as well as the scouring, an efficient comparison of both variations was executed, whereby it was shown that a slurry wall foundation is the more favorable solution from the economic point of view. Additionally, this system results in a substantially greater security of the foundation elements.
