Zeitschrift: IABSE reports = Rapports AIPC = IVBH Berichte
Band: 80 (1999)

Rubrik: Session 6: Construction. Part 2

Session - 6
Construction (Part - 2)

Verifying Computer Models of Bridge Foundations

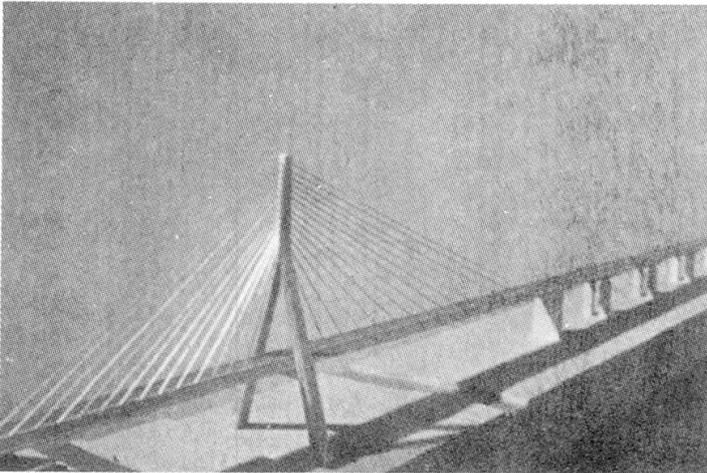
Fig.1 Kao Ping Hsi Bridge

The proposed structure is a cable stayed bridge with an unequal span arrangement. The best location for the pylon was determined with respect to geometry and the relation of the structure to the natural environment. This produces a final side span length of 186 meters. For a perfect geometrical balance the main span was chosen to be 330 m. This is also appropriate relative to the height of the structure, which is an average of 45 meters above the ground.

The height of the pylon was fixed at 180 meters. For aesthetic and balancing reasons, it was decided not to use anchor piers in the side spans. This makes the structure unique and one of the largest asymmetrical cable stayed bridge in the world.

To help balance the span, it was decided to use a concrete deck for the side span and the steel deck for the main span. Fourteen pairs of cable support the structure in a semi-fan arrangement. The cables are anchored on both ends and the distance between cables was chosen to maximize utilization of the deck's bending capacity and optimum stabilization of the pylon.

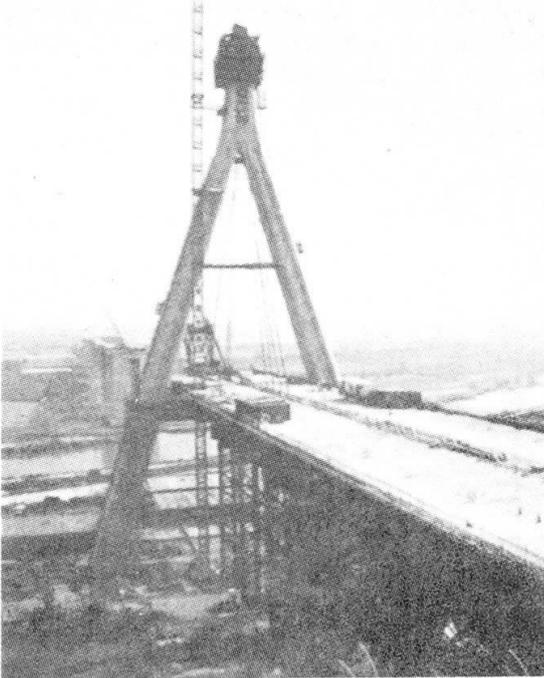
Fig.3 Kao Ping Hsi Pylon

In the course of the preliminary design, two variations were considered for the pylon foundation; one foundation with slurry walls and the other with piles of \varnothing 1.50 m. Under the observance of the dispersing forces, as well as the scouring, an efficient comparison of both variations was executed, whereby it was shown that a slurry wall foundation is the more favorable solution from the economic point of view. Additionally, this system results in a substantially greater security of the foundation elements.

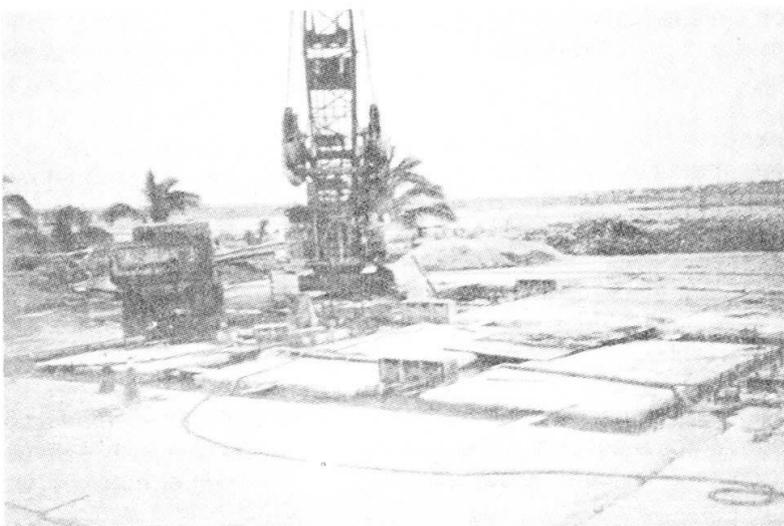
Fig.4 Foundation

The dispersal of the normal forces results during lateral friction, whereby the lateral friction begins at a level of +11.0 m. This measure takes under consideration complete scouring in the event of a catastrophe. The lateral friction itself is applied internally and externally, whereby the spacing of the individual elements amounts to a minimum of three times the width of the element's cross section. The value of the lateral friction amounts to 65 kN/m². This value follows from accumulated values based on borehole samples and results of the Standard Penetration Tests.

The basic principle of the foundation in the presence of the soil types as determined by the borehole samples, is that: The soil within the foundation elements is enclosed through the slurry wall, the normal forces are dispersed correspondingly during lateral friction, and, through the corresponding stiffening of the slurry wall elements, as also through structural design of the individual elements, an optimal dispersal of the horizontal forces in a normal loading condition, as well as in an earthquake loading condition, is secured.

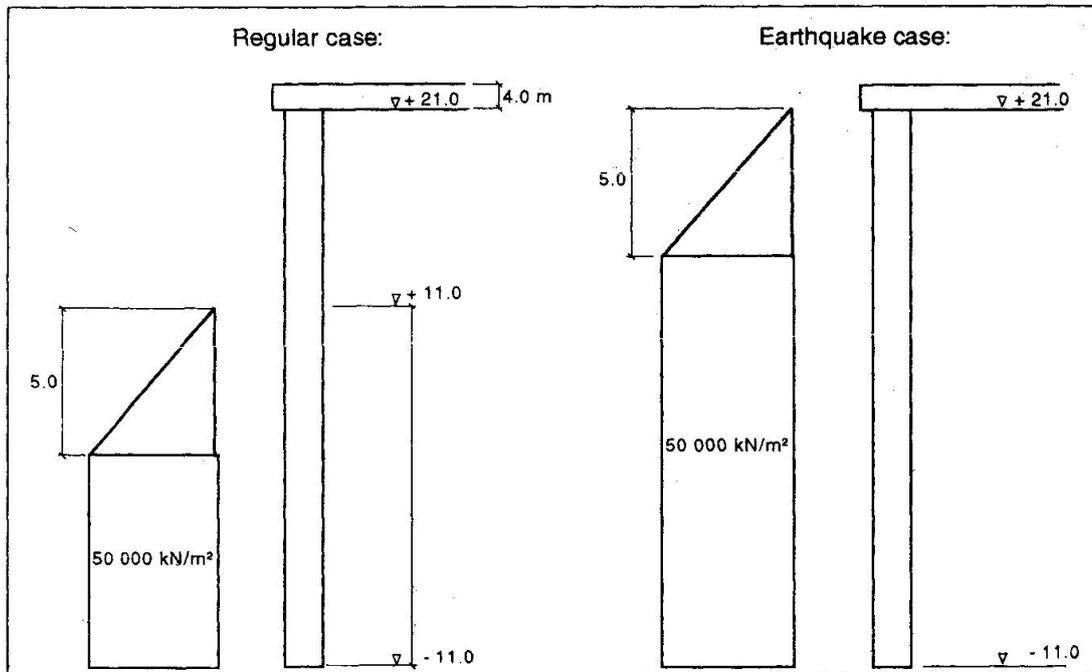
Fig.5 Horizontal bedding – pylon

Shear forces in the longitudinal direction of the bridge are dispersed over an elastic bedding at the base. For the normal loading condition, a bedding according to the figure below is considered. Additionally it is important that above all a corresponding safety factor is given for the earthquake loading condition in relation to the possible passive soil pressure. For the earthquake loading condition itself, a full scouring must not be considered alone. Moreover, the possible passive soil pressure at total scouring plus earthquake loading was also analyzed, thereby showing that nevertheless the second degree safety factor is still present.

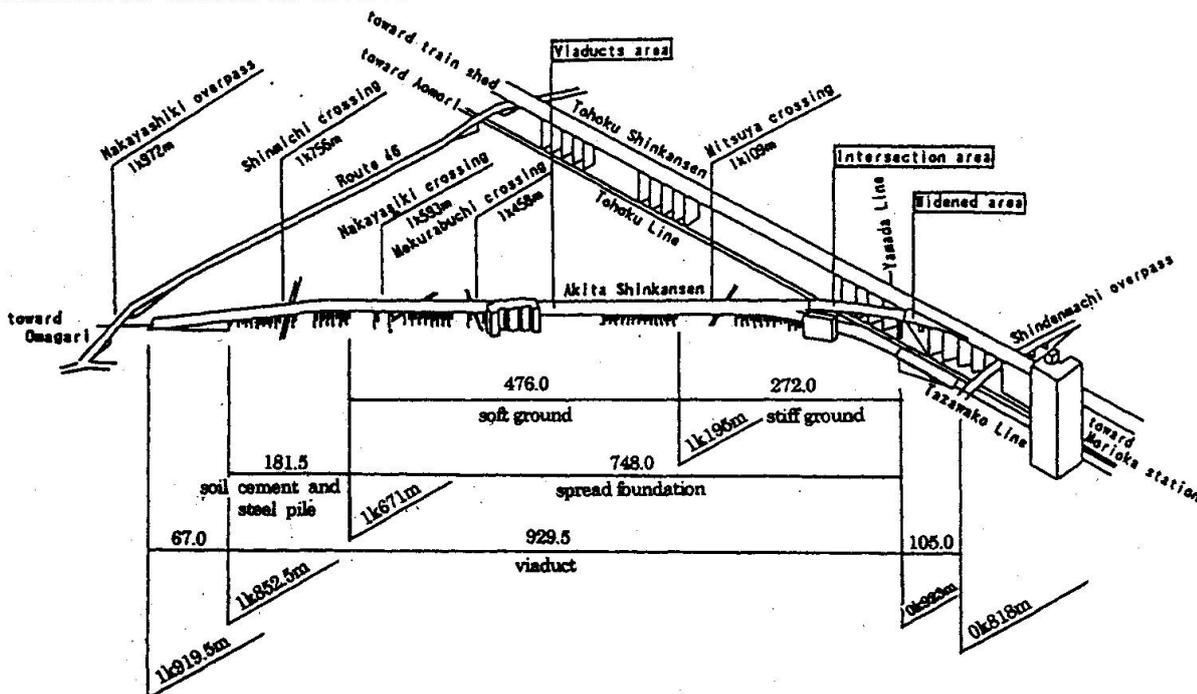
Fig.1 The Morioka approach near Morioka Sta.

The extension of the Morioka approach is 1.2km (Fig.1). The extension of the viaducts is 1.0km. The houses stand close together around that. In the area, we had to construct the Akita Shinkansen Line over the Tazawako Local Line. We devised to construct foundations and pillars on both sides of the railroad, connect that two pillars, and erect a beam. But in that method, the construction expenses was high. It was difficult to secure the road for construction, the construction period was long. So, we have suspended train service in the Tazawako Local line for an year, constructed the viaducts for six months.

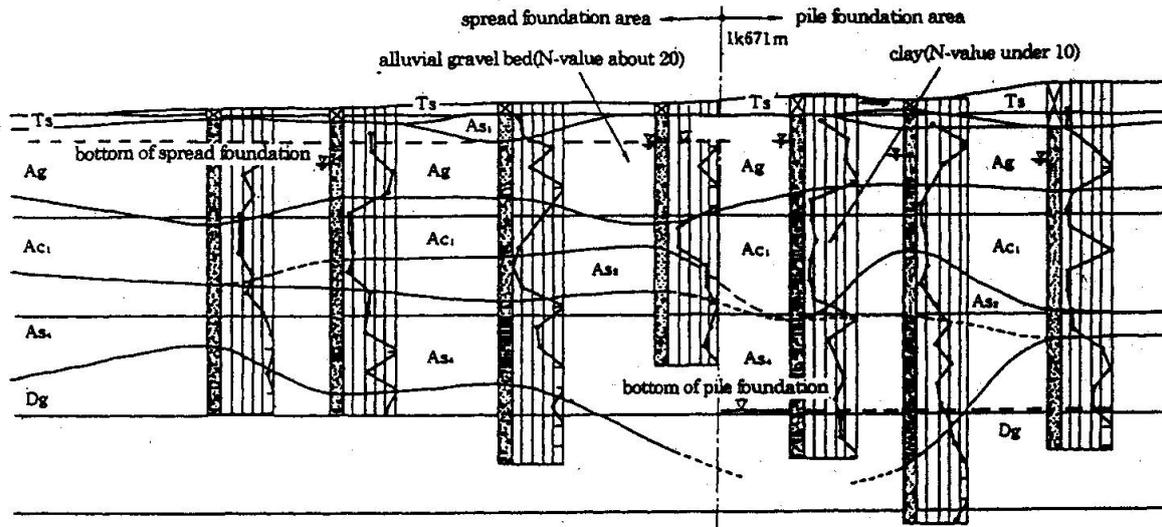
Fig.2 Geological longitudinal profile

In the viaducts area, geological survey and plate loading test were enforced. We planed to construct spread foundation from starting point to 1k671m. But except that area, sandy clay including gravel (N-value : under 10), the thickness was 3 or 6m, accumulated under the gravel bed (N-value : about 20) which we supposed as bearing stratum of spread foundation, so we adopted pile foundation in fear of consolidation settlement (Fig.2).

And, diluvial gravel bed that was bearing stratum was inclined, uneven. Medium alluvial gravel bed included boulder, the maximum size of that was 150mm.

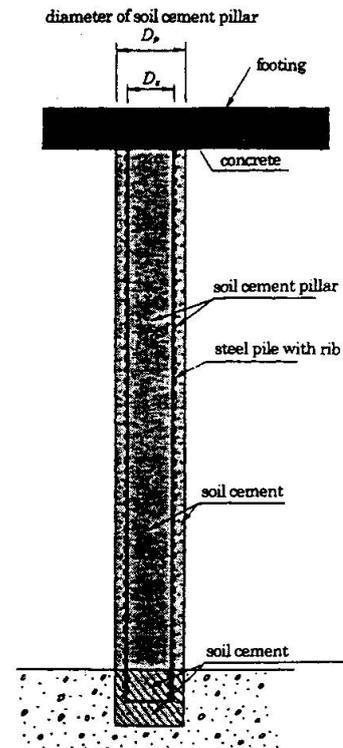
Fig.4 The general drawing

This test was done by multi-cycle form, based on the rule of Japanese Society of Soil Mechanics and Foundation Engineering. Planning ultimate load was 930t, four-thirds the ultimate bearing capacity of cast-in-place pile that was based on the design rule of railway structure. Table.2 shows the calculation result of ultimate vertical loading capacity.

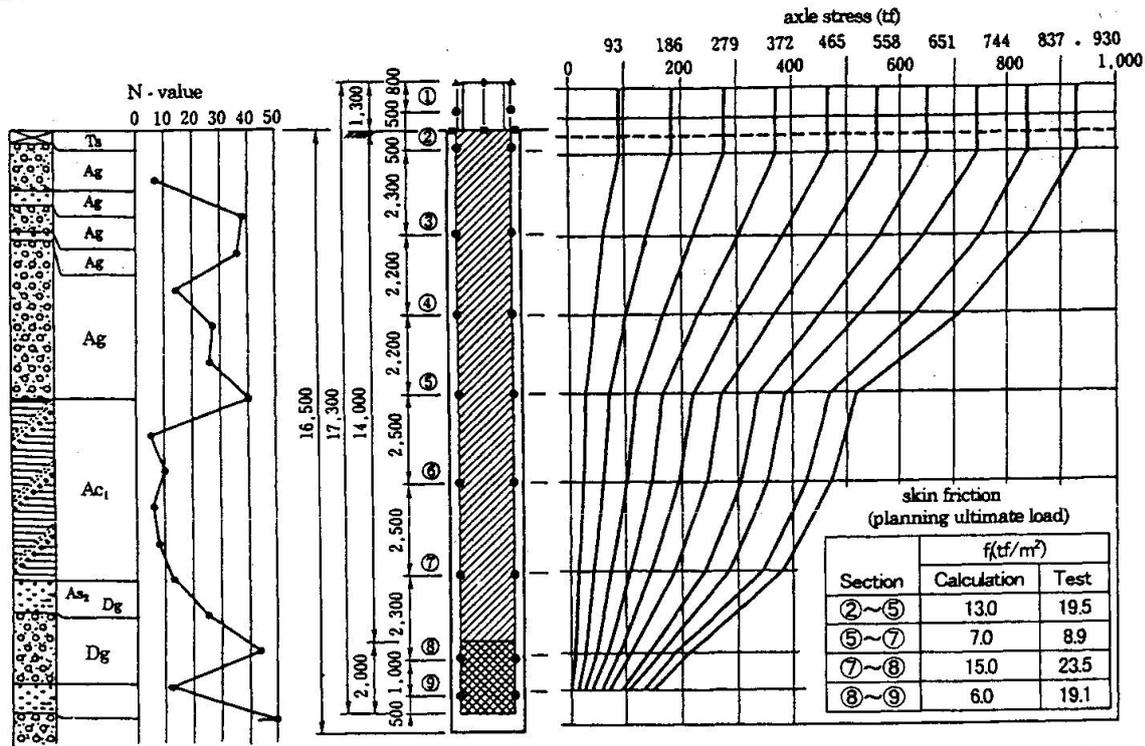
Fig.7 The distribution of linear stress

Fig.7 shows the distribution of linear stress. When we loaded ultimate load, 10 percent of that, about 90t, was transmitted to the end of pile. We grasped that skin friction worked well, and that skin friction corresponded to the ground strength of stratum. The skin friction calculated from this distribution of linear stress was larger than assumed that in all stratum. In clay stratum that we feared the decline of skin friction by excavation and agitating stir with casing, the skin friction satisfied expectation value.

As mentioned, we realized that we could design the pile constructed by this method as skin friction pile, could apply the estimation formula of cast-in-place pile of the design rule of railway structure to estimate this ultimate bearing capacity.

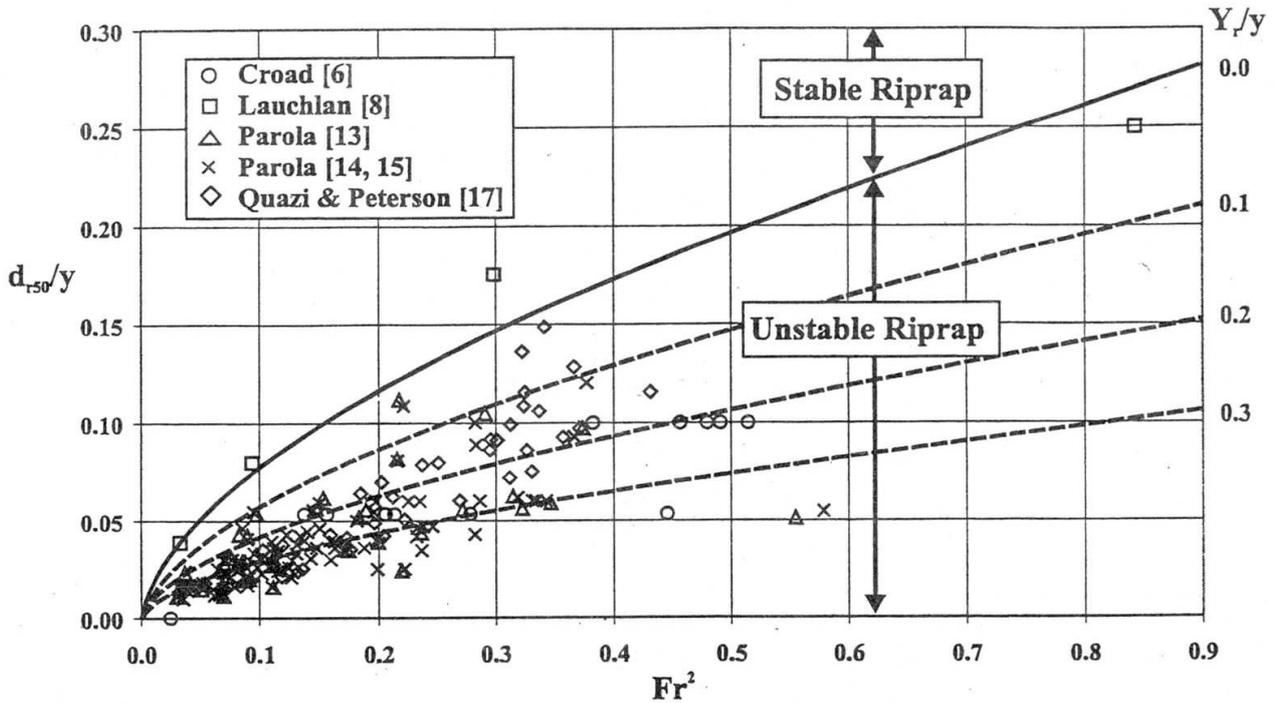
Figure 2 Design Curves for Riprap Size by Lauchlan [8]

Riprap was selected based on the Lauchlan [8] equation (2) with $Y_r = 0$. For $V = 3.6$ m/s and $y = 5.96$ m, $d_{r50p} = 724$ mm, equivalent to a model size of 36.2 mm. Two sizes of riprap were used in the model, having median sizes, $d_{r50m} = 35$ mm and 28 mm, and grading satisfying the criteria of equation (3). Note that subscripts 'p' and 'm' refer to prototype and model, respectively. The riprap was placed according to the recommendations in Figure 3 (end radii = 1.5b, width = 3b), with the top surface flush with the undisturbed bed. Tests were conducted with the pier both aligned with the flow and also skewed at angle $\theta = 10^\circ$ to the flow. Two thickness arrangements were tested. One arrangement featured $t_r = 2d_{r50}$ throughout the layer. For the other arrangement, the thickness of the riprap layer was increased to $3d_{r50}$ for the section of riprap upstream of the pier where it was observed that the worst scour occurred.

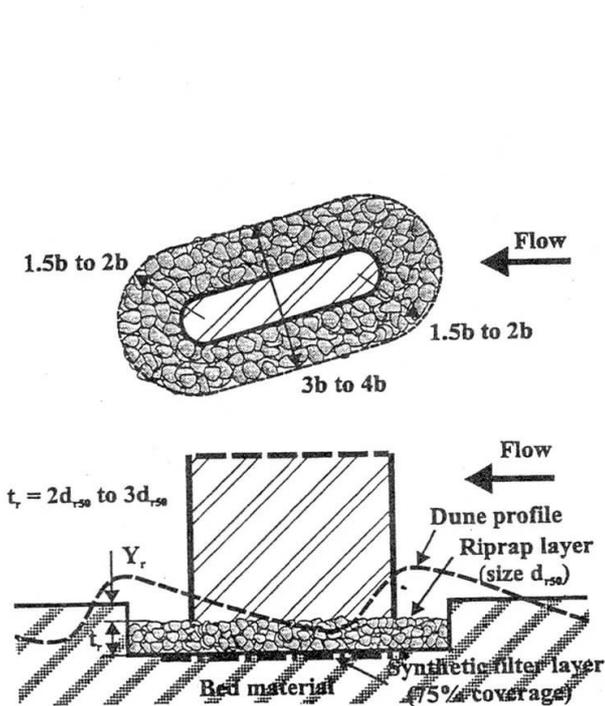
Figure 3 Riprap Placement Recommendations

Other important factors relating to riprap design are the thickness (t_r), horizontal extent, and placement level (Y_r) of the riprap layer. Figure 3 shows recommendations for these factors, based principally on recent studies by Lim and Chiew [9] and Lauchlan [8]. Parker, Toro-Escobar and Voigt [12] have shown that the use of a synthetic filter (or geotextile), placed below the riprap, is advantageous because the effects of winnowing failure are minimised. Their experiments demonstrate, however, that the synthetic filter should have lateral extent limited to about 75% of that of the riprap. With a full-coverage geotextile, edge failure of the riprap stones can result in roll-up of the edges of the geotextile leading to subsequent failure of the riprap layer. Typical recommendations for riprap grading, e.g. Croad [6], are as follows:

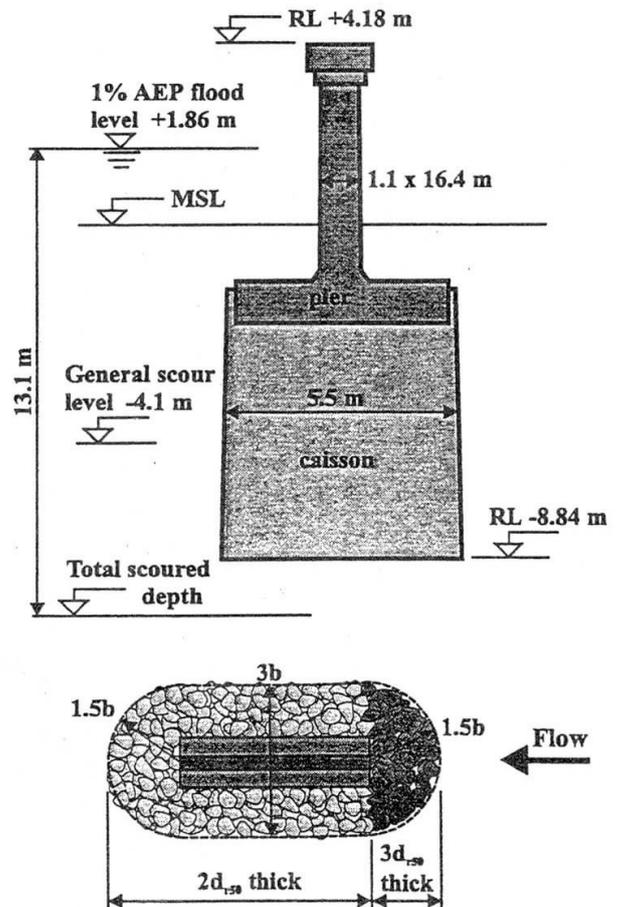
Figure 4 Riprap Design for Hutt Estuary Bridge

For all tests, the scour reduction was significant. The riprap configuration for Test 4 was recommended. The riprap comprises a 1400 mm thick layer of 700 mm riprap thickened to 2100 mm upstream of the pier. The local scour depth is reduced 88% when the flow is skewed 10° to the axis of the pier. The recommended riprap configuration is illustrated in Figure 4.

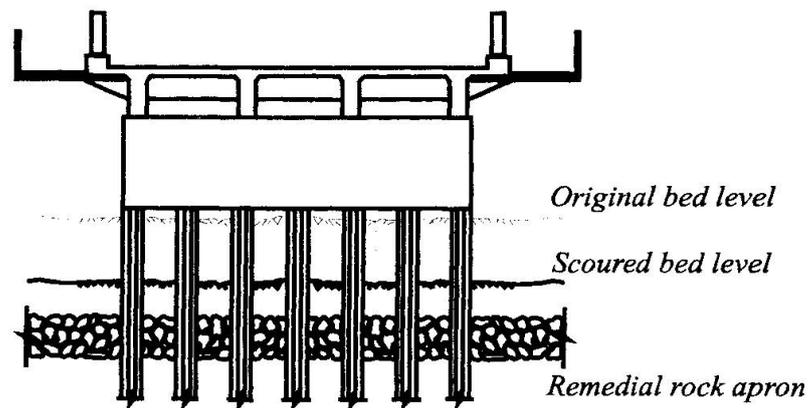
Figure 1 Typical Side Elevation of a Foundation and Remedial Works for the Ashburton River Road Bridge

of the pile cap, these additional piles extending to 13 m below the design bed level. The riprap utilised consisted of rocks of $d_{50} = 750$ mm. Each pier remaining in the revised stream channel was underpinned with two cylinders of 1.5 m diameter at 11 m centres, each cylinder connected to the existing pier via a 1.0 m octagonal column above the design bed level. The cylinder foundations were driven to 13 m below the bed. The existing piled foundations and mass concrete skirt for each of these piers in the revised stream channel were removed along with the base of the slab pier to 2 m above the design flood levels, this level allowing some clearance to minimise any debris accumulations at the piers.

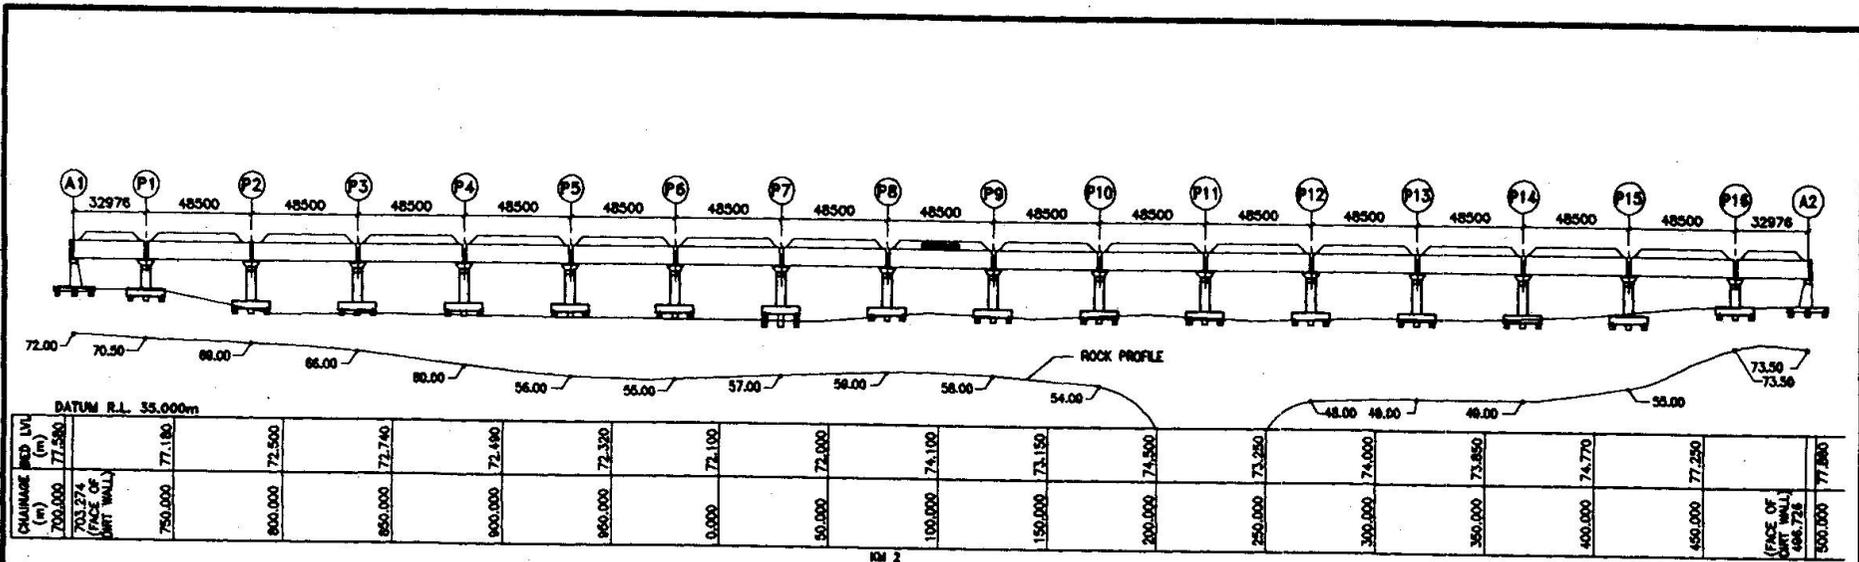
FIGURE : 1

**GENERAL ARRANGEMENT AND GEOTECHNICAL PROFILE OF
RAIL-CUM-ROAD BRIDGE ACROSS RIVER DAMODAR**

PLAN AT PILECAP LEVEL

Large-diameter piles of 1,200 mm dia have been used after examining the relative economy with possible alternative sizes. Considering the generalized soil profile of the river as reflected in figure-1, the pile groups are divided under two heads.

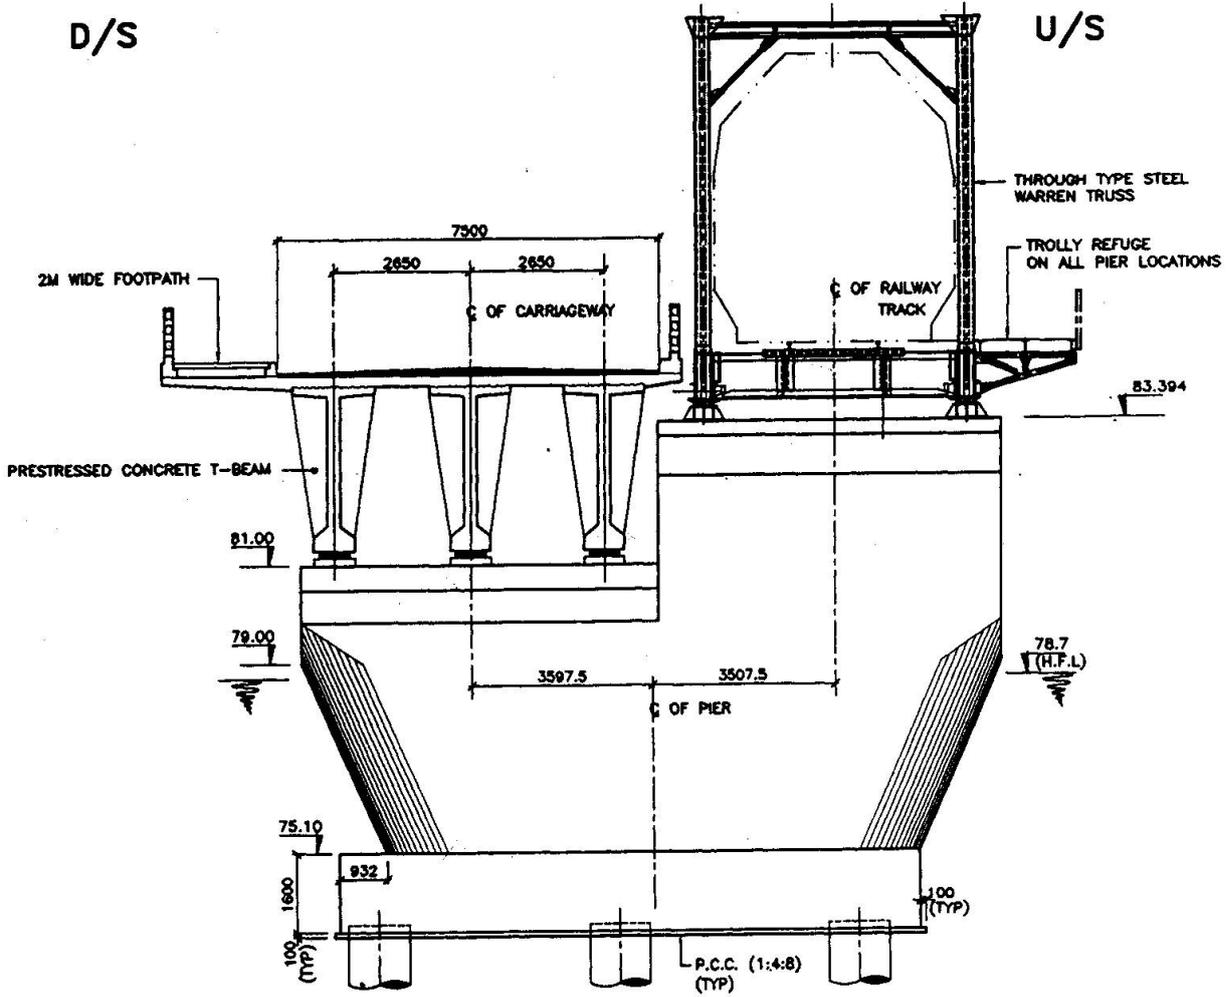
**TYPICAL CROSS SECTION OF RAIL-CUM-ROAD BRIDGE
OVER RIVER DAMODAR NEAR MEJIA**

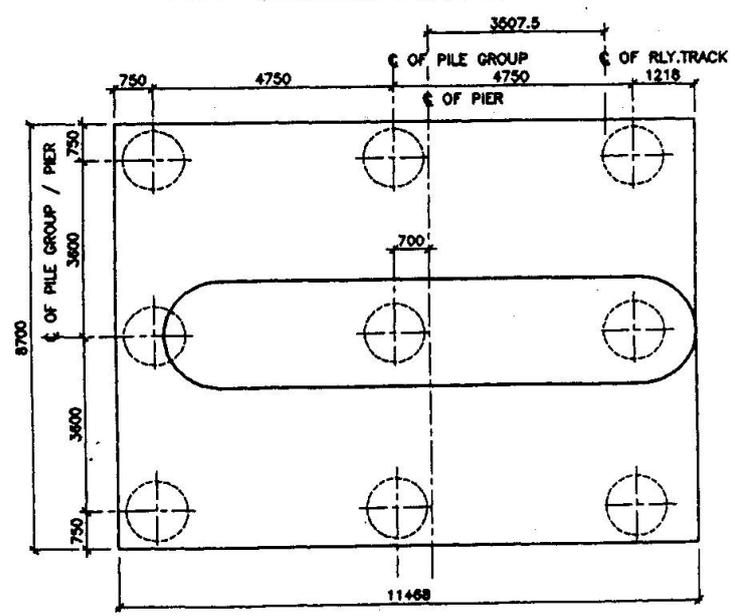
FIGURE:2

PLAN OF PILECAP

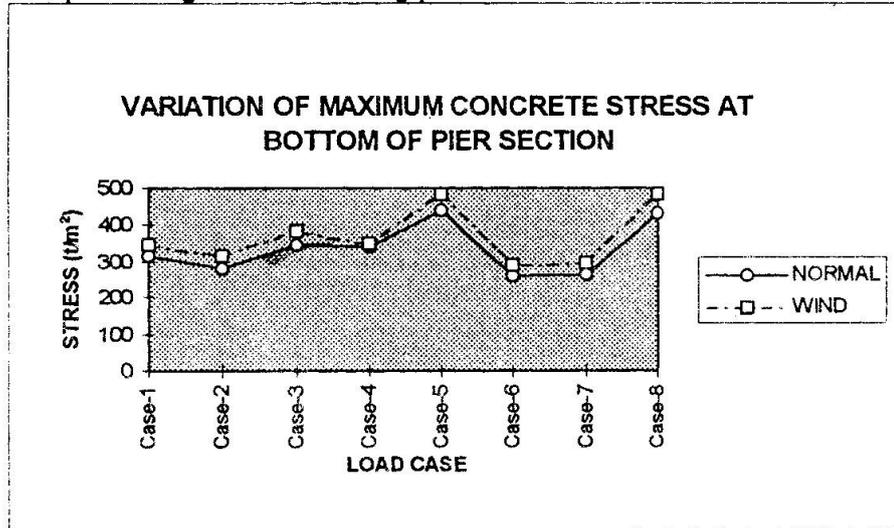
figure-3

greater than that of the roadway live load. The combined effect of these loads results in wide variations of stresses on the foundation elements as can be seen from the figure-3. The pier configuration was made eccentric with respect to the geometrical centre of the two superstructures and the pile groups for partially compensating for this loading pattern

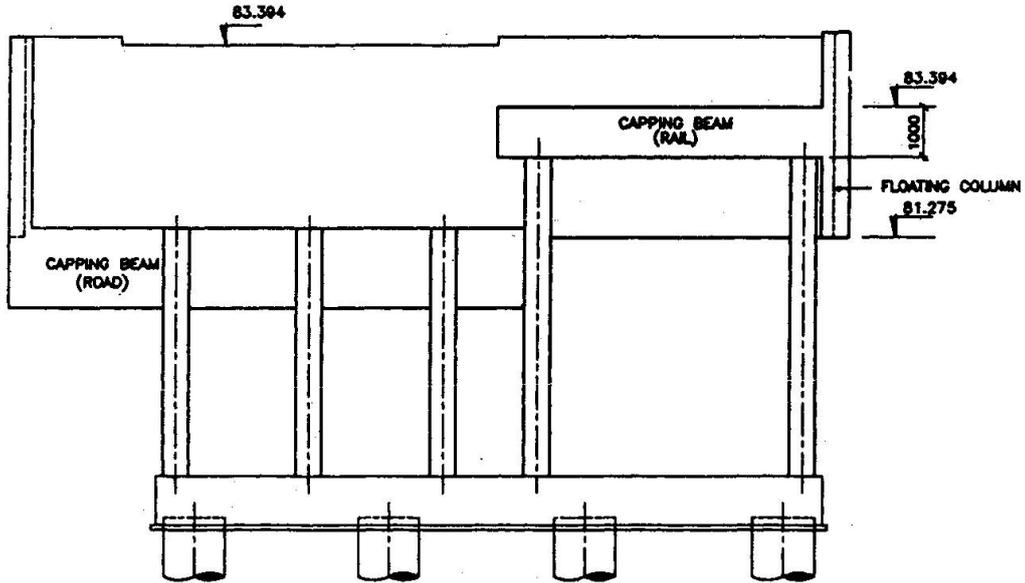
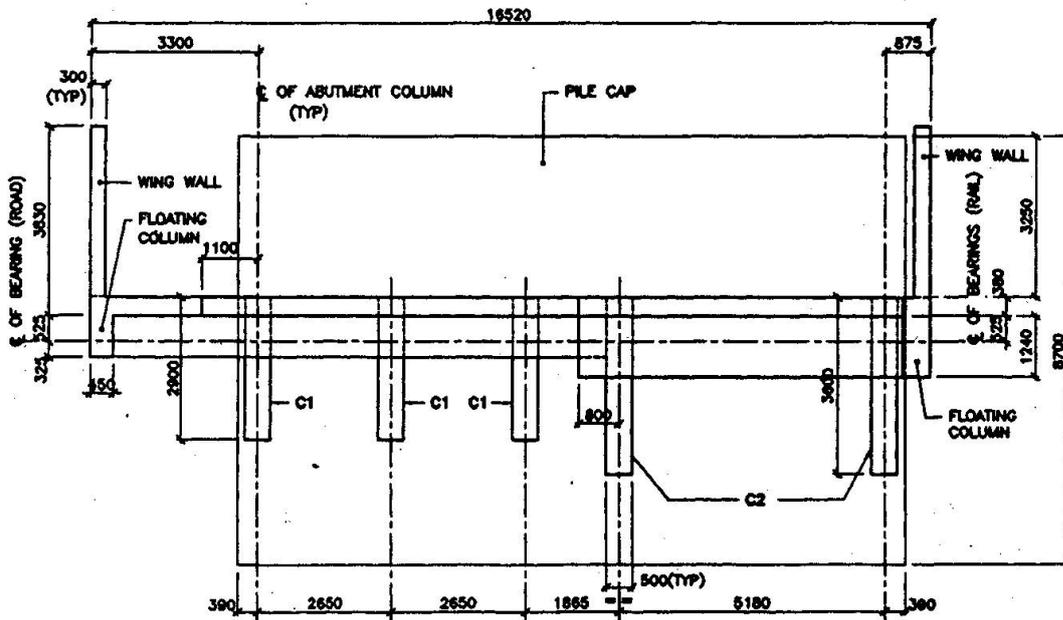
FIGURE:4

ELEVATION OF ABUTMENT

PLAN OF ABUTMENT

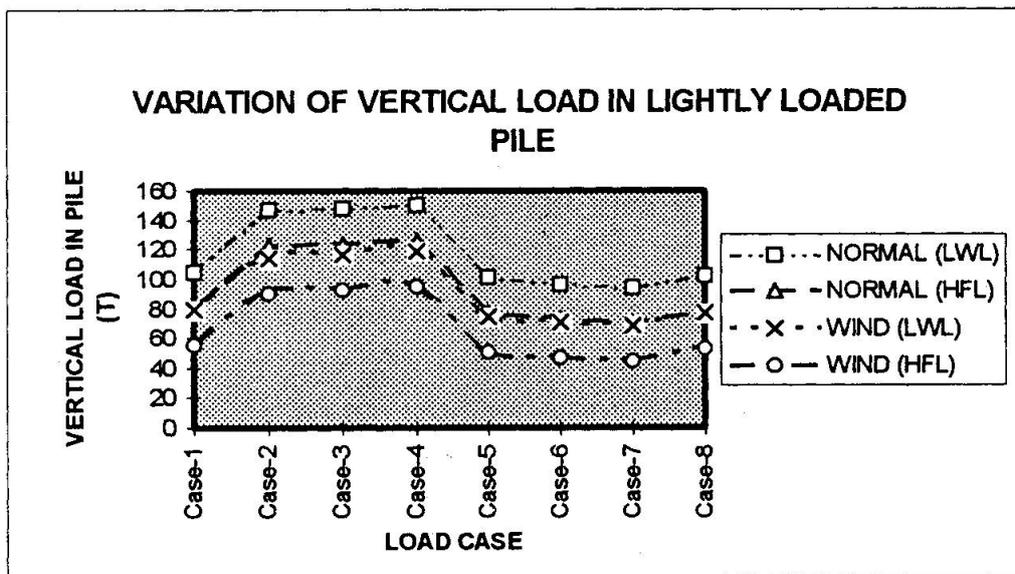
figure-5

The variations of vertical load in the most lightly loaded and heavily loaded piles are reflected in figures-5 & 6

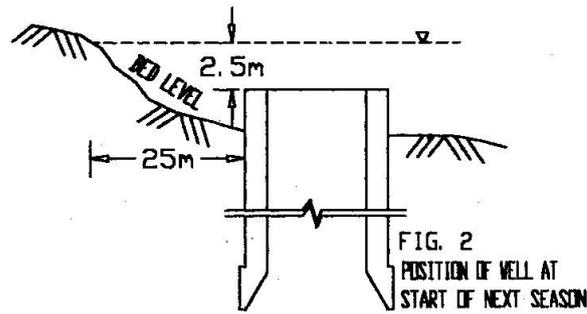
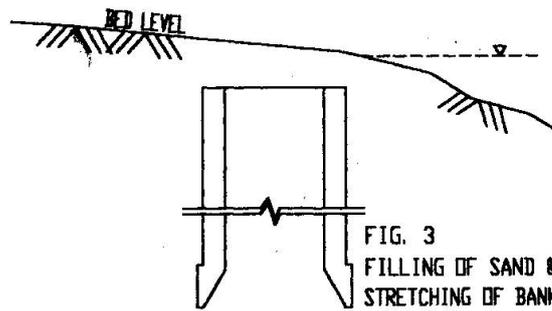
SKETCH 3

CASE STUDY 3 - REVIVAL OF OVERSUNK WELL

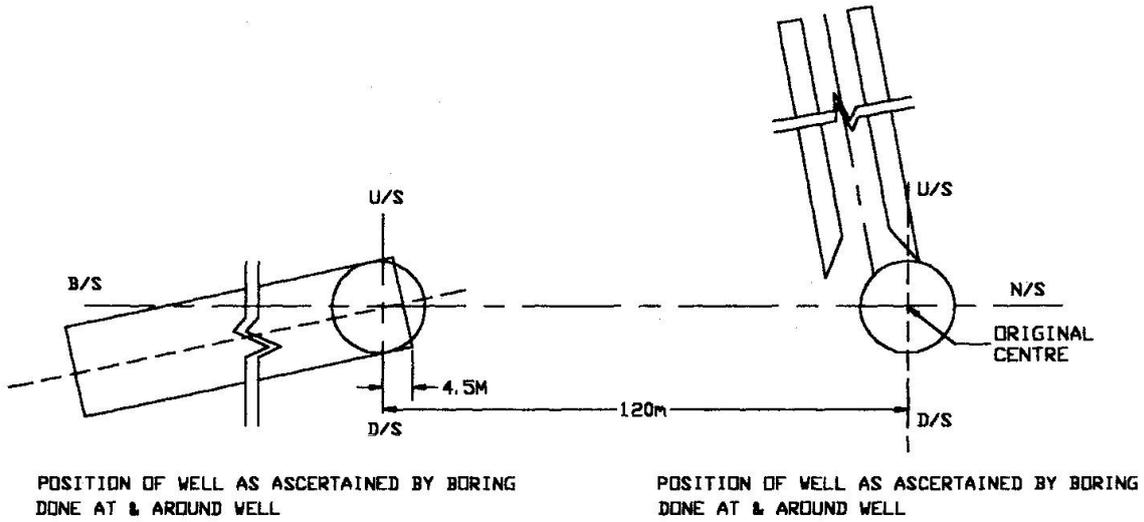
CASE STUDY 4 - SCOURING OF FOUNDATIONS DURING CONSTRUCTION

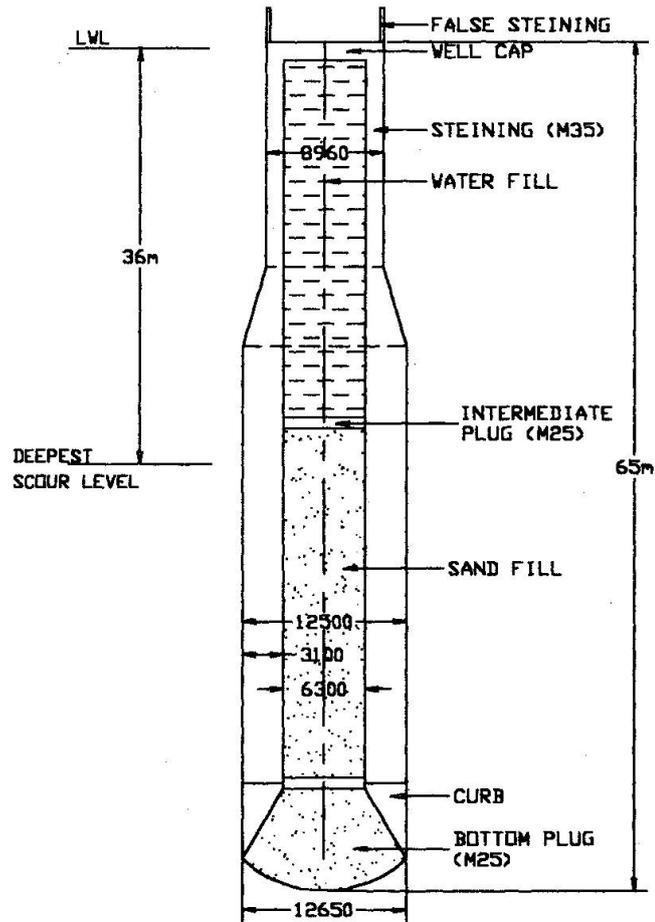
SKETCH 4

CASE STUDY 4 - TYPICAL CROSS SECTION OF PIER WELL

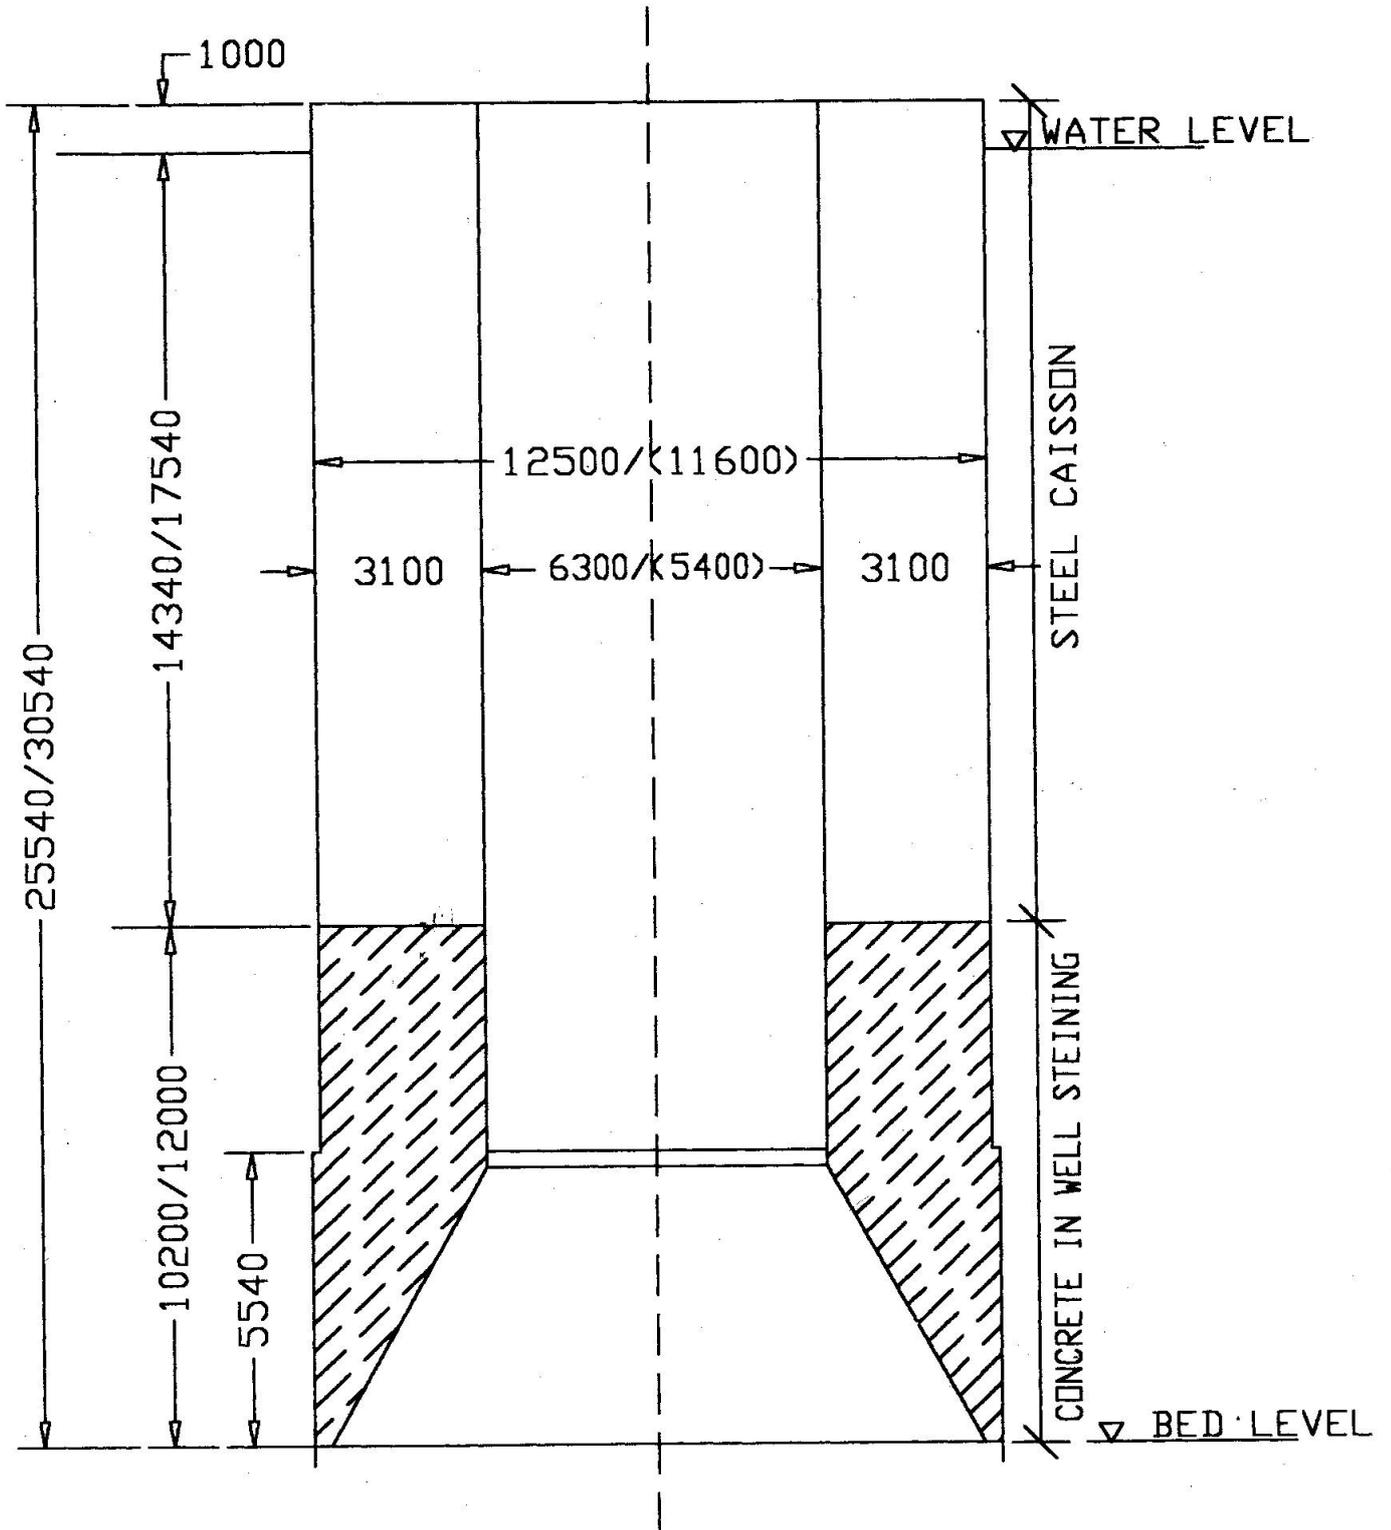
SKETCH 5

CASE STUDY 4 - LAST STAGE DURING GROUNDING OF CAISSON
