Zeitschrift: IABSE reports = Rapports AIPC = IVBH Berichte
Band: 80 (1999)

Rubrik: Session 7: Case studies

Design of Foundations for the Storebælt East Bridge

Present situations and problems in design and construction of caisson foundations in Japan

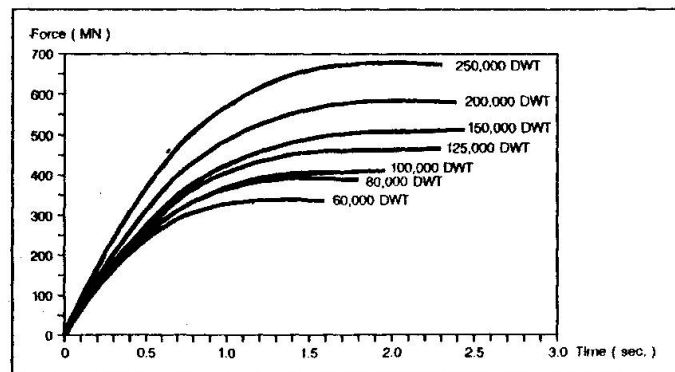
Fig. 3: Idealised load-time curves for ship impacts

The load-time curve for the impact against the non-moving pier was established based on theoretical considerations of the energy dissipated by adding up the contributions during plastic deformation of all basic structural elements of the ships hull. The procedure developed for bow crushing analysis is based on an upper-bound plasticity theory which can also handle rigid body motions of crushed and non-crushed parts of the structure. Validation of the numerically predicted crushing loads has been done by comparison with experimental crushing results of small scale bow models.

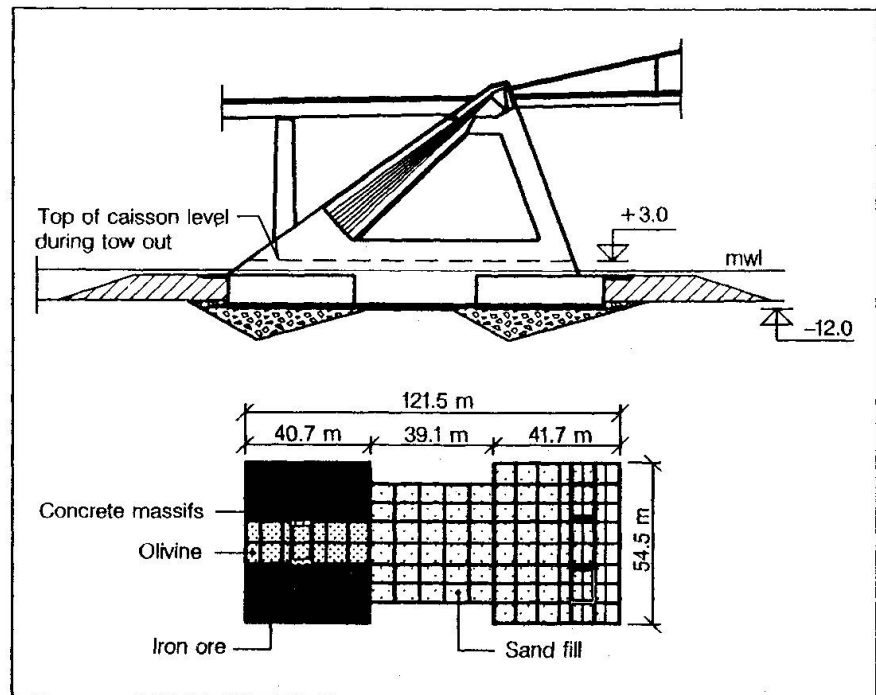
Fig. 4: Elevation and Plan of Anchor Block Caisson. and

The foundation caissons, each covering an area of 6,100 m², are 121.5 m long and 54.5 m wide and divided in three parts. Only the front and rear parts are in contact with the supporting stone wedges as explained above. The height of the pre-fabricated part of the caissons is 15 m having a weight of 50,000 tonnes when towed to the bridge site whereas the remaining parts of the anchor blocks above level +3.0 m were cast in-situ.

The rear part of the caissons contains the anchorage massifs comprising 18,000 m³ of concrete which was cast in-situ partly inside some of the cells in the pre-fabricated caisson. Other cells in the rear part were ballasted with olivine (heavy sand) iron ore.

The middle part of the caisson, which has no contact with the underlying ground, is partly sand-filled; the longitudinal walls are post-tensioned with vertical bars; and the bottom slab is heavily post-tensioned

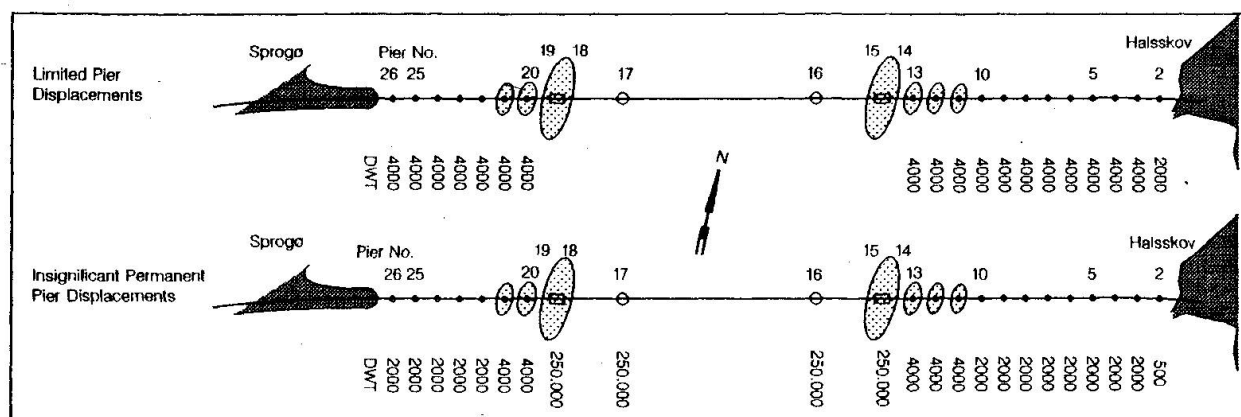
Fig. 5: Design vessels (in DWT) for Head on Bow Collisions with Approach Bridge Piers

Based on the collision risk model the design basis for the ship impact loads was established, see Fig. 5.

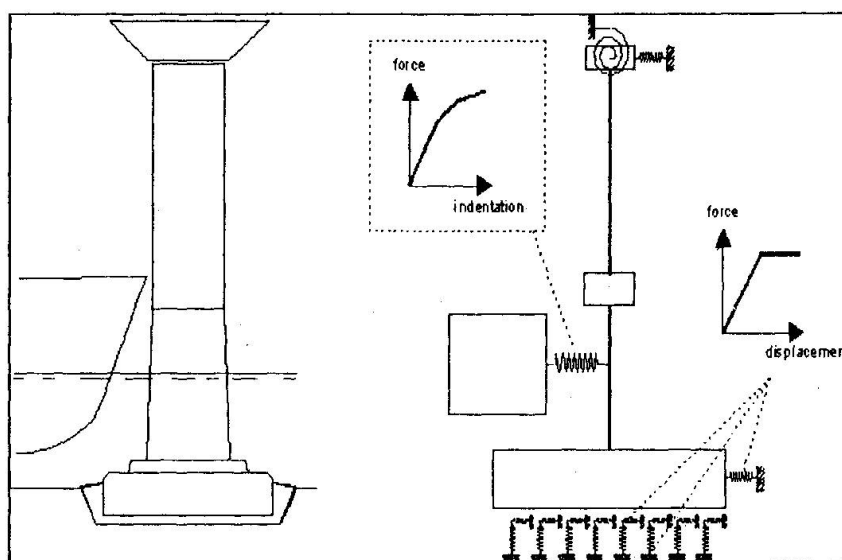
Fig. 6: Idealised model of the Ship Collision.

A simplified but still advanced computer model was developed for the ship impact analyses, see Fig. 6. The model comprises: a non-linear elasto-plastic model of the soil-structure interaction, a stiff foundation caisson, elastic beam elements for the pier shaft and a concentrated mass and spring at the pier top representing the bridge girder. To verify the simplified model, independent 2D finite element analyses were carried out using two different programs ABAQUS and FENRIS. In addition the effects of eccentric impacts were studied by 3D models with a more refined modelling of the soil, including local weak areas etc. in FENRIS.

The comparison of results from the simplified model and the finite element analyses showed a good agreement with differences in ultimate bearing capacity being some 10% only. However, the finite element models give a better description of the behaviour of the soil especially when failure is dominated by overturning and twisting moments. For further information, see Feld and Gravgaard, [4].

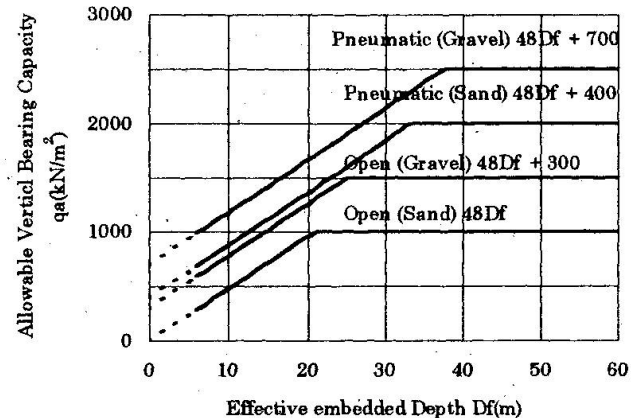
Figure. 3 Maximum Value (Normal Conditions) of the Allowed Vertical Bearing Capacity of the Ground at the Bottom Surface of a Caisson Foundation

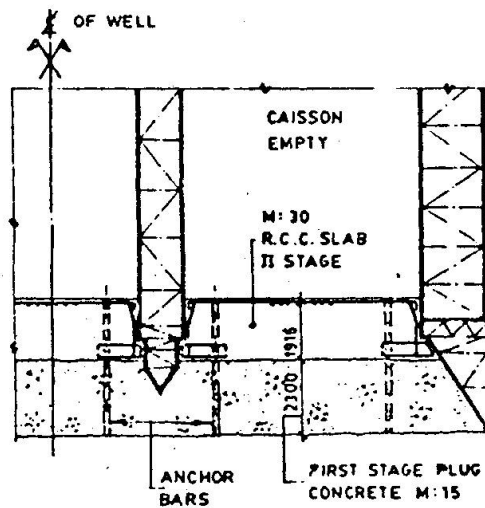
PART CROSS SECTION SHOWING
BOTTOM SLAB REINFORCEMENT.
BOTTOM PLUG FOR CAISSON OF F-3
FIG. 4

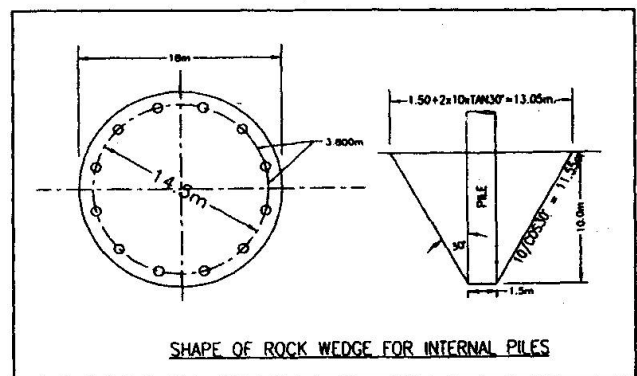
Fig:5

The piles have been provided essentially for resisting the tension developed at the base of the well caused due to overturning moments and resultant uplift under seismic conditions. The base of the well is treated as the solid circular section with each pile acting as steel reinforcement resisting the tension. The socket length inside the rock and the bond length of pile within the well steining have to provide adequate safety against the uplift. The brief computations are given below.

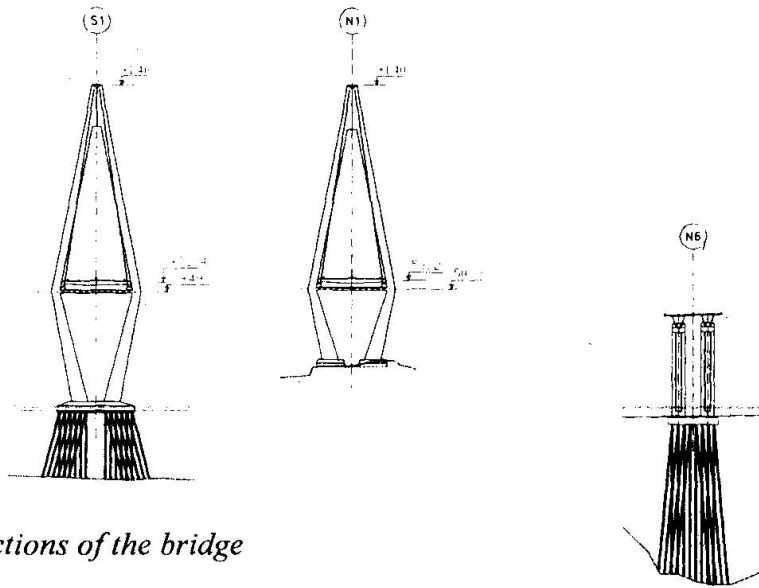
Figure 1b Sections of the bridge

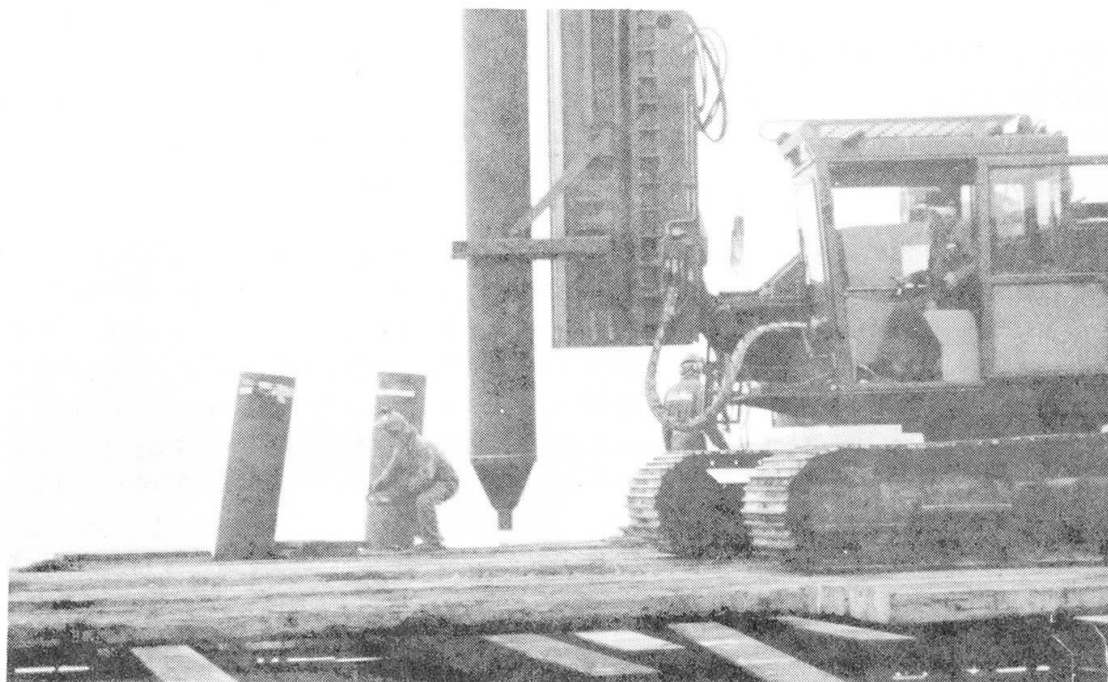
Figure 3. Pile driving equipment used for foundation at support N6 and N7.

To increase the capacity of the pile driving it was necessary to take alternative measures to decrease the amount of blows for the installation with the originally selected equipment or change the equipment to a more efficient one. However the allowed noise level was reached (and in some cases exceeded) with the initially selected pile driving equipment. To avoid exceeding the stated noise level the first alternative was to reduce the amount of blows during the installation through drilling beside the pile during the driving. High water pressures had been observed during the pile driving. The drilling reduced the pore pressure and had a good effect on the capacity of the pile driving, but not good enough. Hence it was decided to add an equipment with a more efficient hammer to make the final driving of the piles. That implied that it was also necessary to take additional measures to increase the noise damping. These were performed in two ways. The first was a tube of concrete with a length of 5 m placed around the pile and the hammer during the final pile driving. The second way was a wall of normal transport containers with a height of about 10 m placed on three sides of the foundation area. Together these measures were efficient to reduce the noise level so it was possible to perform the piled foundation without exceeding the stated maximum noise level in any apparent way.

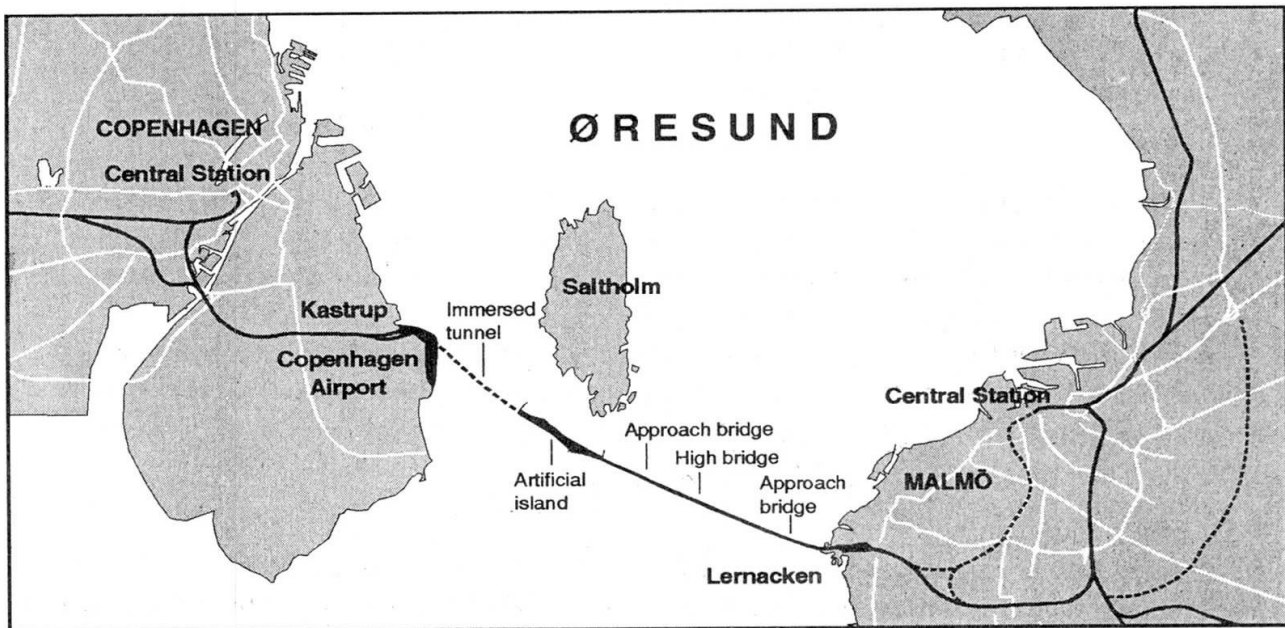
Fig.1. Plan of the Øresund Link

The 15.8km Link comprises, from Copenhagen Airport in Denmark to Lernacken in Sweden, the following main parts (Fig.1):

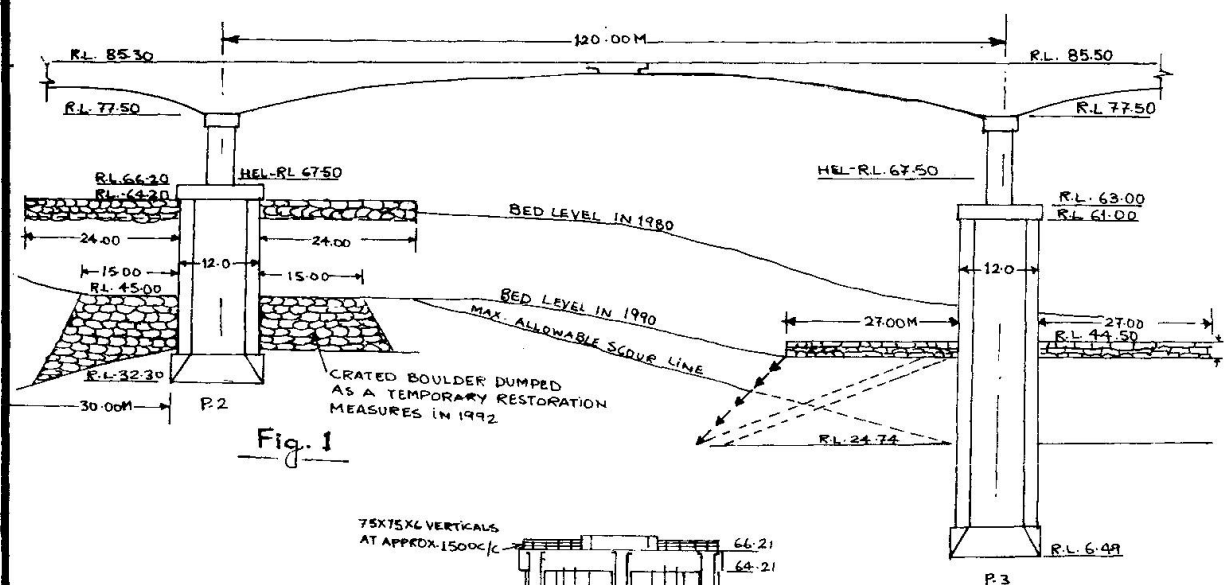
Fig. 1

SKETCH SHOWING FOUNDATION LEVEL SCOUR LEVELS AND TENTATIVE PROTECTIVE MEASURES TO PIER WELLS P-2 AND P-3 OF KALIA BHOMORA BRIDGE ON NH-37-A

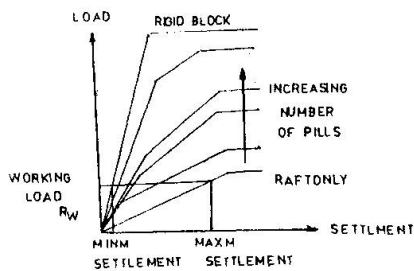
FIG-5 LOAD SETTLEMENT CHARACTERISTICS OF PILE COMBINED WITH CAP AFTER POLOUS AND DEVISAT (1972)

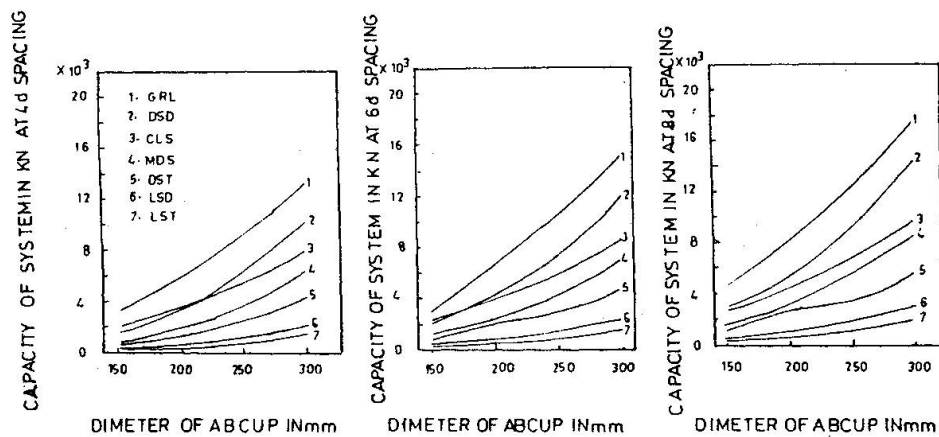
FIG.7 DIAMETER OF ABCUP VS CAPACITY OF CIDF SYSTEM AT VARIOUS SPACINGS OF ABCUP

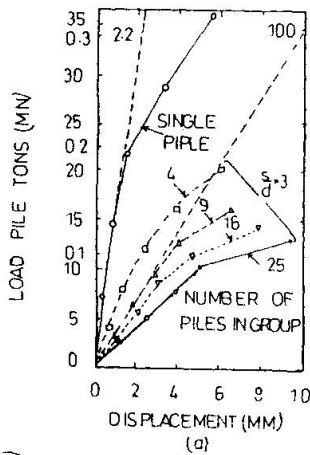
FIG-3. DISPLACEMENT VERSUS PILE LOAD (a) SINGLE PILE & VARIOUS GROUP AT 3d SPACING IN SILTY SAND, (b) NINE PILE GROUP AT VARIOUS SPACING

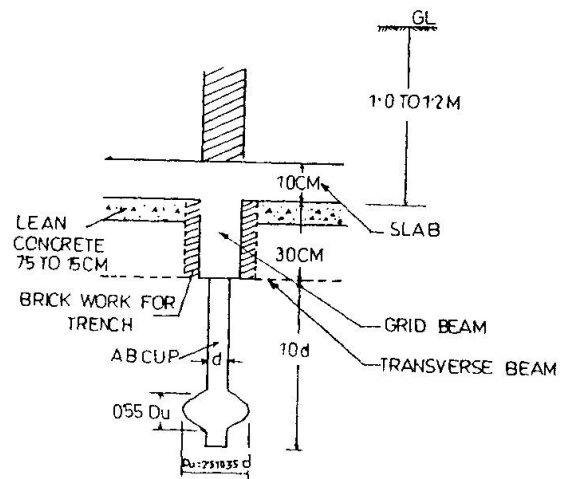
FIG4-A VIEW OF JUNCTION OF BEAM SLAB & ABCUP

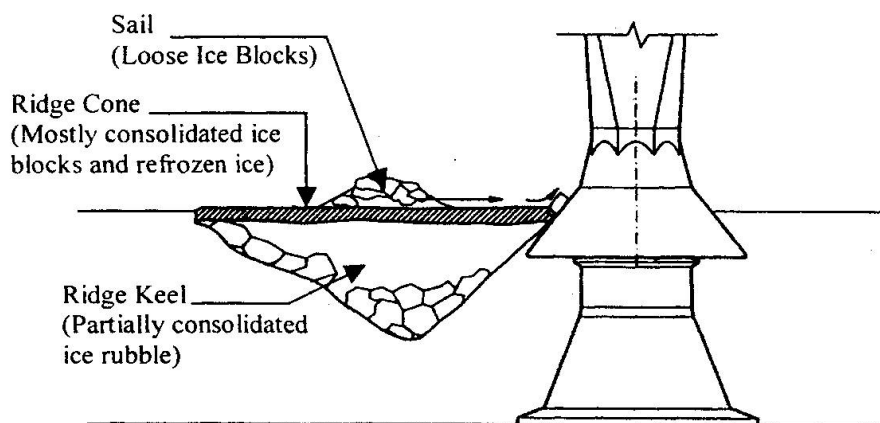
Figure 1: Ice Formations

Generally, the ice season in the Northumberland Strait begins in December or early January, and conditions worsen until late March. The maximum thickness of ice floes, i.e. floating pressure ridges formed from large sheets at the surface of the sea, is about 0.30 m. Floes may occasionally extend over 500 m with a mean of 118 m.
