# Session 7: Case studies

Zeitschrift: **IABSE reports = Rapports AIPC = IVBH Berichte**

Band (Jahr): **80 (1999)**

## Design of Foundations for the Storebælt East Bridge

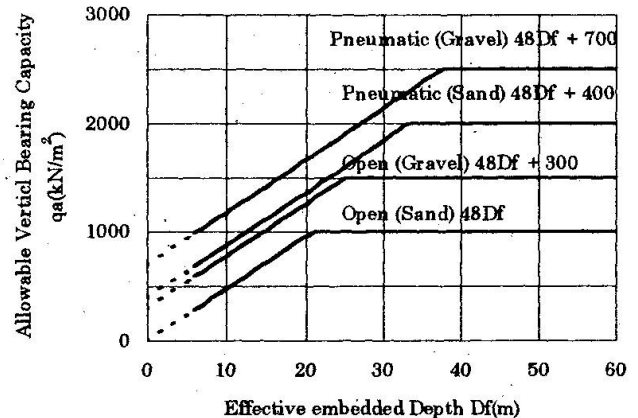
Figure. 3 Maximum Value (Normal Conditions) of the Allowed Vertical Bearing Capacity of the Ground at the Bottom Surface of a Caisson Foundation
