Zeitschrift: IABSE reports = Rapports AIPC = IVBH Berichte
Band: 80 (1999)

Rubrik: Session 7: Case studies

Case Studies

Design of Foundations for the Storebælt East Bridge

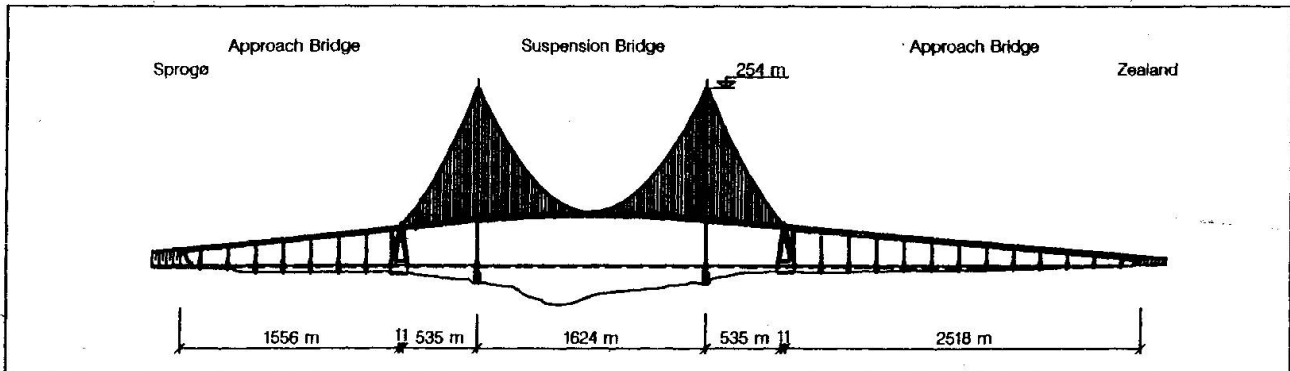
Fig. 1: Longitudinal section of the Storebælt East Bridge (exaggerated vertical scale)

The water depth in the deep part of the channel reaches more than 50 m, but at the positions of the pylons it is reduced considerably to about 21 m. At the anchor blocks and the approach span piers the maximum water depth is less than 12 m.

Generally, the geology in the bridge alignment consists of clay till on top of a marl layer and below that limestone. The clay till has a thickness of 20 to 30 m except at the pylons, where it is reduced to 8-10m. In the deep channel the till formation is missing.

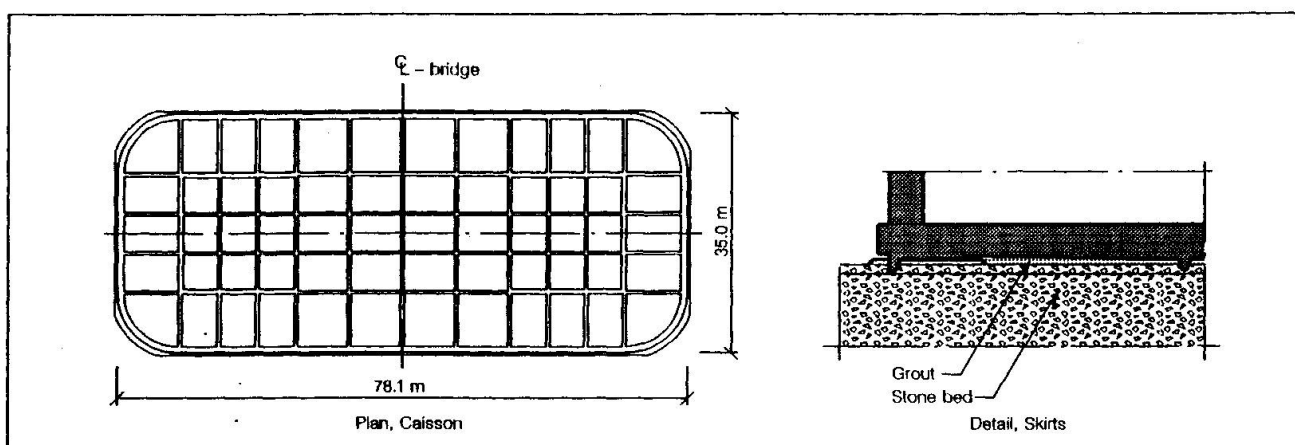
Fig. 2: Plan and Detail of Foundation Caisson

The foundation caissons, each covering an area of $2,770 \text{ m}^2$, are 78 m long and 35 m wide, see Fig. 2. However, the corners and the edges are rounded in order to reduce the water blocking effect and to limit damage to possible colliding ships by avoiding sharp corners and edges. They are divided into 60 cells by internal walls and are 20 m high, including a 3 m thick plinth cast in situ on top of the cellular caissons within a temporary steel cofferdam. This was required because the top of the caisson is kept 3.5 m below water level in order to avoid the undesirable visual effect of the slender pylon legs and the voluminous caisson standing one on top of the other.

The bottom slab of the caissons has a variable thickness between 0.95 m and 1.1 m, creating a roof-shaped underside to the slab. Around the periphery of the slab and below some of the internal walls 0.5 m deep skirts are provided, designed to penetrate about 0.3 m into the uncompacted screeded top layer of the stone beds, see Figure 2. The voids thus formed between the roof-shaped underside of the slab and the stone bed were subsequently filled with sand/cement grout through pre-installed pipes, the skirts serving to confine the grout. For each of the caissons the quantity of grout was some 725 m^3 , placed in about 40 hours

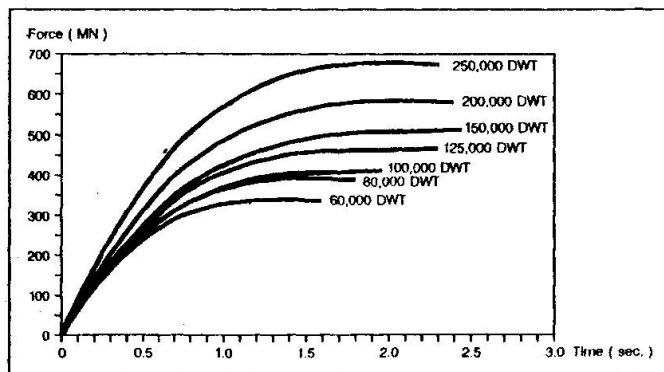
Fig. 3: Idealised load-time curves for ship impacts

The load-time curve for the impact against the non-moving pier was established based on theoretical considerations of the energy dissipated by adding up the contributions during plastic deformation of all basic structural elements of the ships hull. The procedure developed for bow crushing analysis is based on an upper-bound plasticity theory which can also handle rigid body motions of crushed and non-crushed parts of the structure. Validation of the numerically predicted crushing loads has been done by comparison with experimental crushing results of small scale bow models.

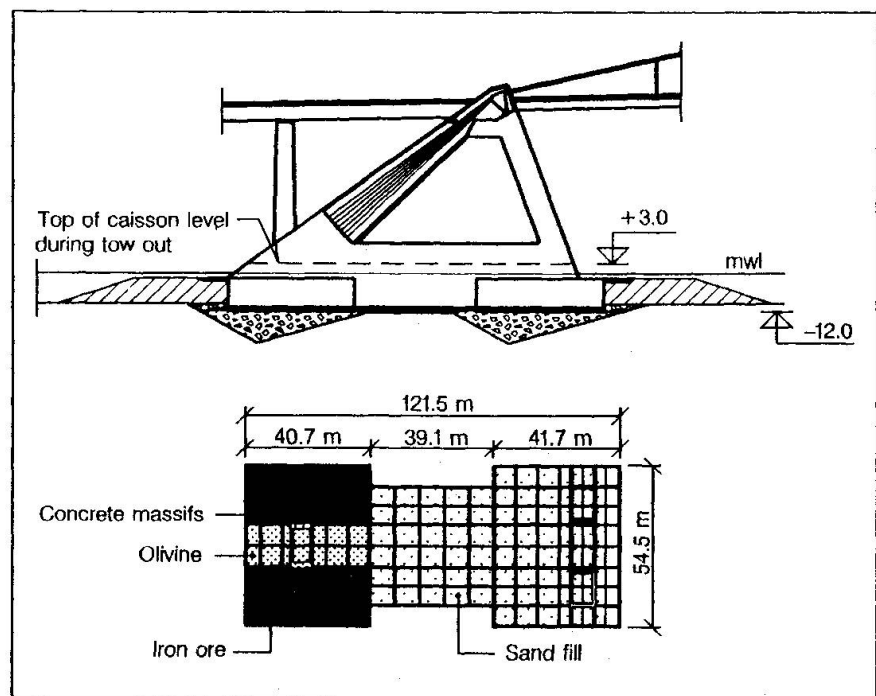
Fig. 4: Elevation and Plan of Anchor Block Caisson.

The foundation caissons, each covering an area of 6,100 m², are 121.5 m long and 54.5 m wide and divided in three parts. Only the front and rear parts are in contact with the supporting stone wedges as explained above. The height of the pre-fabricated part of the caissons is 15 m having a weight of 50,000 tonnes when towed to the bridge site whereas the remaining parts of the anchor blocks above level +3.0 m were cast in-situ.

The rear part of the caissons contains the anchorage massifs comprising 18,000 m³ of concrete which was cast in-situ partly inside some of the cells in the pre-fabricated caisson. Other cells in the rear part were ballasted with olivine (heavy sand) iron ore.

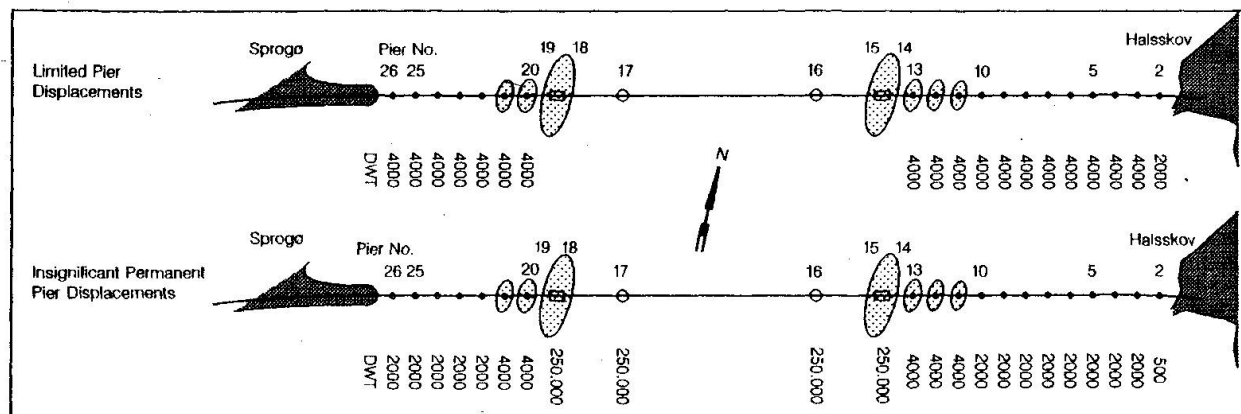
Fig. 5: Design vessels (in DWT) for Head on Bow Collisions with Approach Bridge Piers

Based on the collision risk model the design basis for the ship impact loads was established, see Fig. 5.

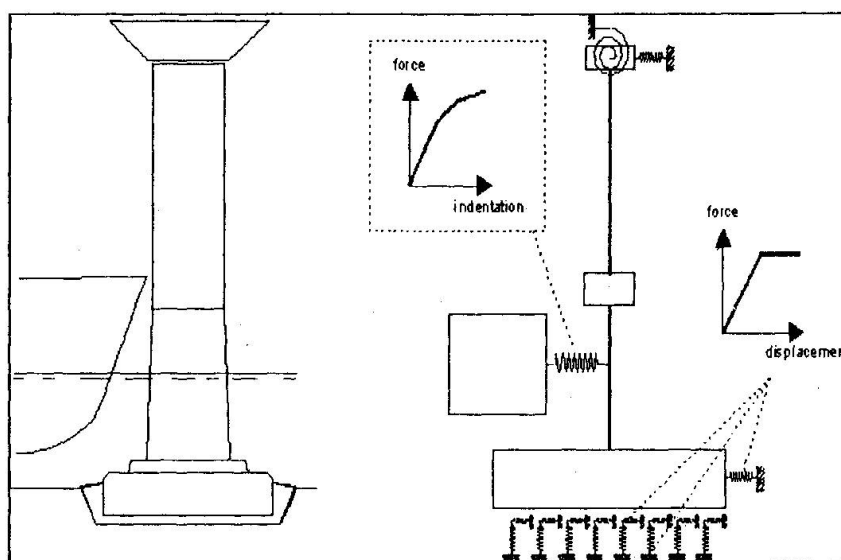
Fig. 6: Idealised model of the Ship Collision.

A simplified but still advanced computer model was developed for the ship impact analyses, see Fig. 6. The model comprises: a non-linear elasto-plastic model of the soil-structure interaction, a stiff foundation caisson, elastic beam elements for the pier shaft and a concentrated mass and spring at the pier top representing the bridge girder. To verify the simplified model, independent 2D finite element analyses were carried out using two different programs ABAQUS and FENRIS. In addition the effects of eccentric impacts were studied by 3D models with a more refined modelling of the soil, including local weak areas etc. in FENRIS.

The comparison of results from the simplified model and the finite element analyses showed a good agreement with differences in ultimate bearing capacity being some 10% only. However, the finite element models give a better description of the behaviour of the soil especially when failure is dominated by overturning and twisting moments. For further information, see Feld and Gravgaard, [4].

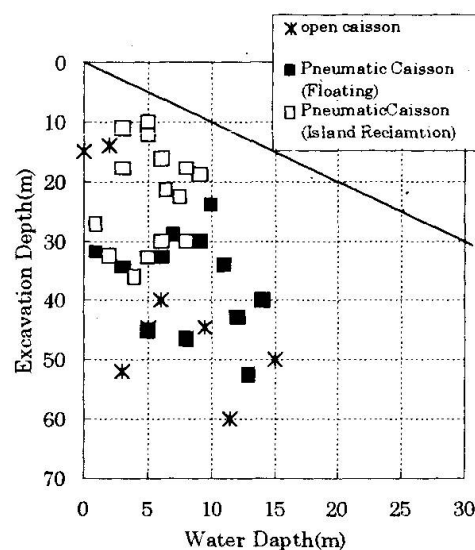
Figure.1 Underwater caisson Foundation Executions in Japan

Fig. 1 shows that many of those caisson foundations, which support long span bridges, have been constructed at locations with very deep water. The reason of this situation is that they are appropriate for deep foundations thanks to the benefits cited above and the large bearing capacity of a caisson foundation.

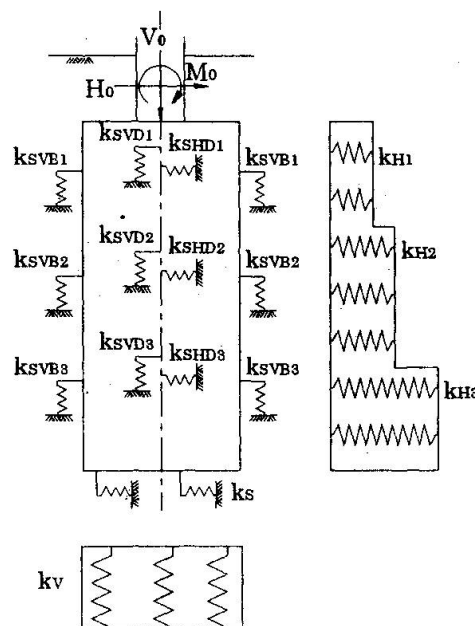
Figure. 2 Ground Resistance

To use the ductility design method, an elasto-plastic spring model with the ultimate bearing capacity of the bottom surface ground obtained from formula (1) as the maximum value is established.

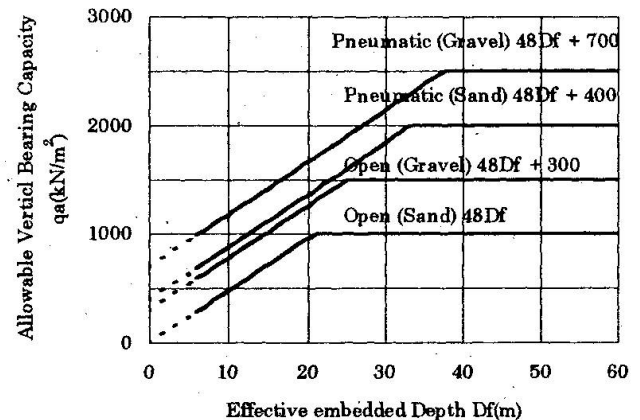
Figure. 3 Maximum Value (Normal Conditions) of the Allowed Vertical Bearing Capacity of the Ground at the Bottom Surface of a Caisson Foundation

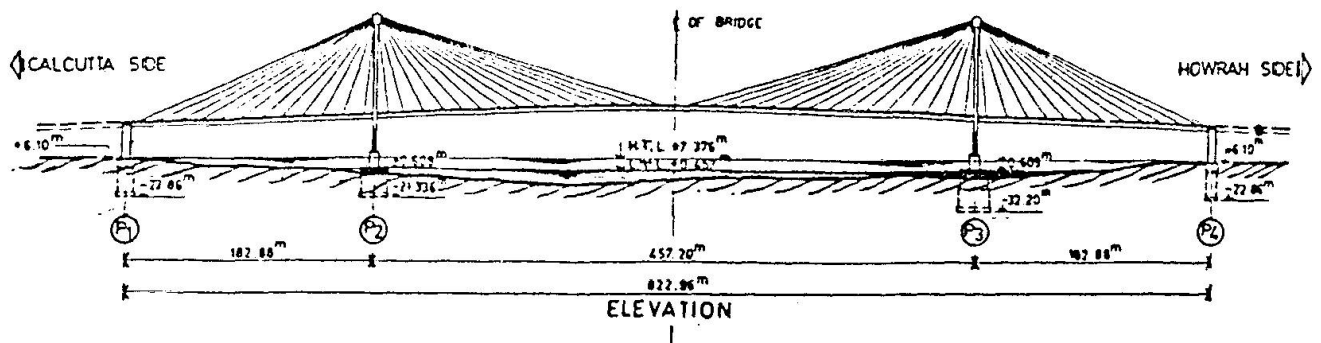
FIG. 1

SECOND HOOGHLY BRIDGE

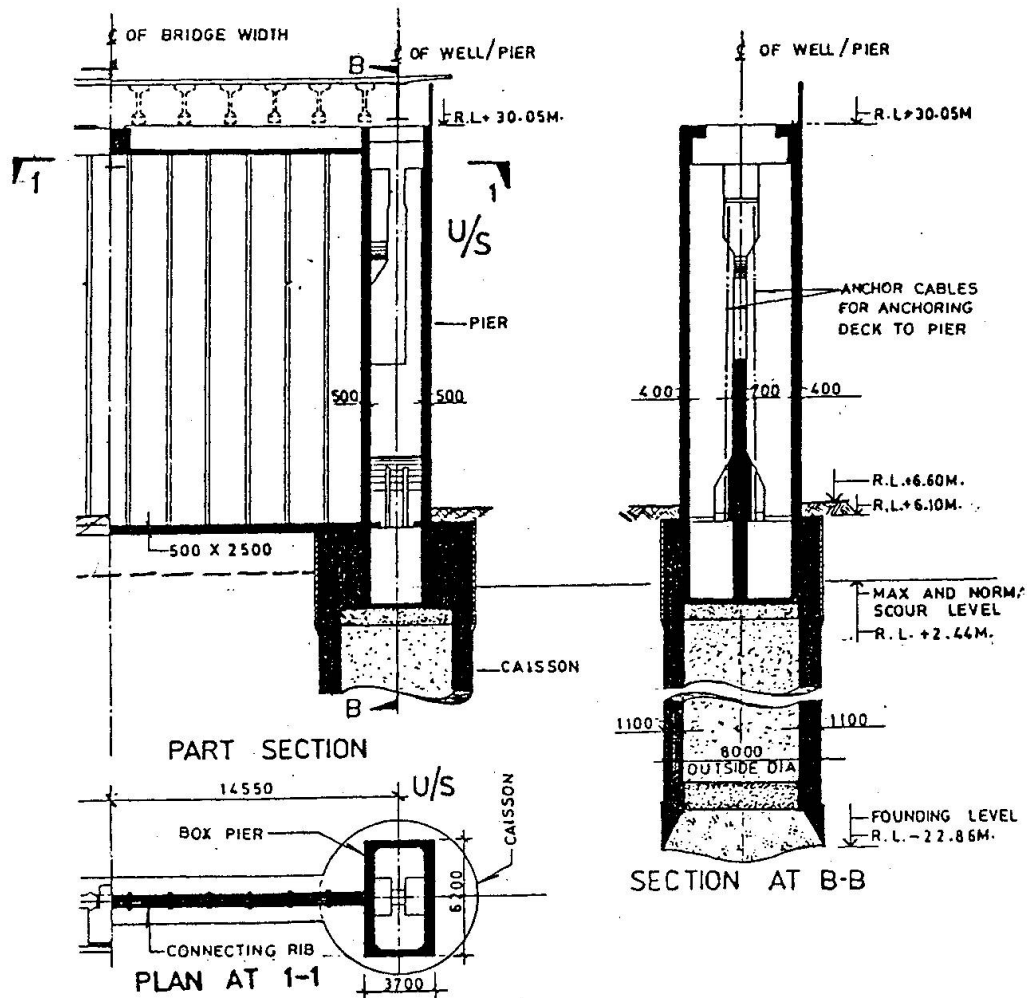
PART PIER P4 AND ONE CAISSON OF F-4
FIG. 3

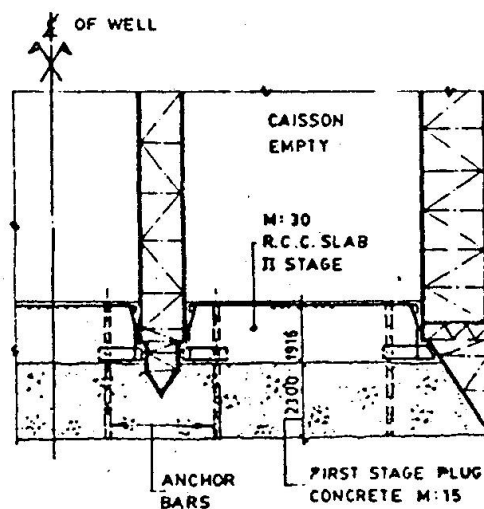
PART CROSS SECTION SHOWING
BOTTOM SLAB REINFORCEMENT.
BOTTOM PLUG FOR CAISSON OF F-3
FIG. 4

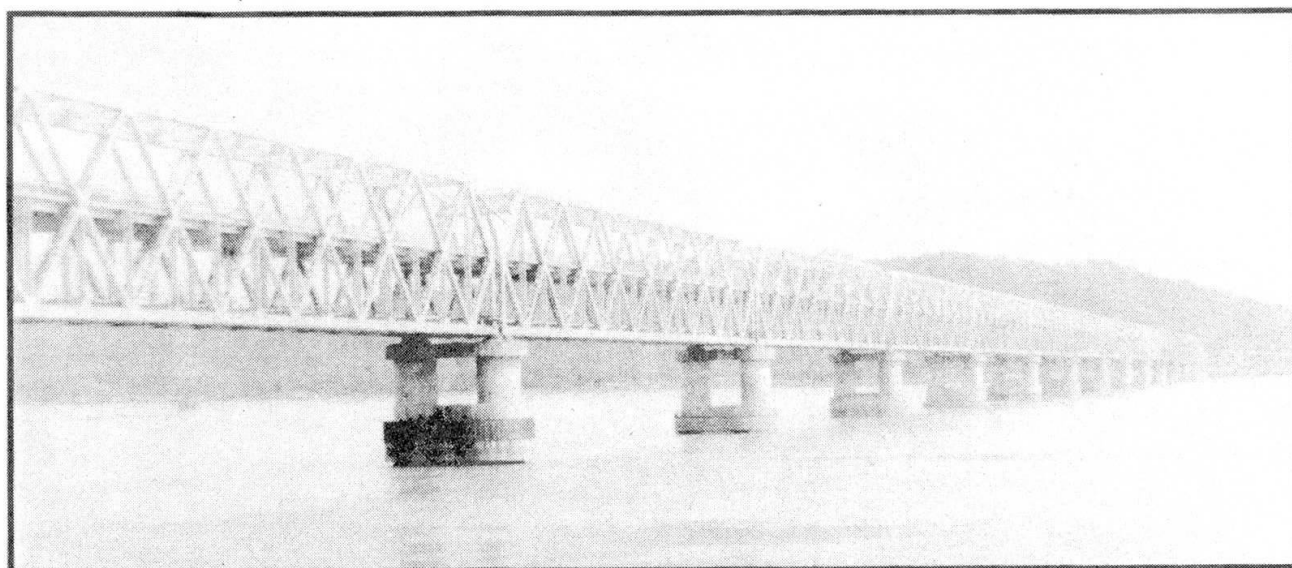
Fig:3

Design Loads at the Base of Pier No. 17

The experts at the University of Roorkee carried out the dynamic analysis of the structure for determining the seismic forces induced by the weight of the structure during earthquake vibrations. For the purpose of mathematical modeling, the entire pier structure was divided into 26 masses, which were lumped at appropriate levels. The pier structure has been modeled as a vertical cantilever structure free to vibrate laterally. The response spectrum for the site was developed on the basis of typical earthquakes having epicenters at different fault zones. Based on dynamic analysis, the longitudinal and transverse seismic moments and seismic shears at different levels were worked out. The vertical seismic coefficient was taken as $g/16$. The moments and shears at the base of the well under seismic conditions are tabulated below.

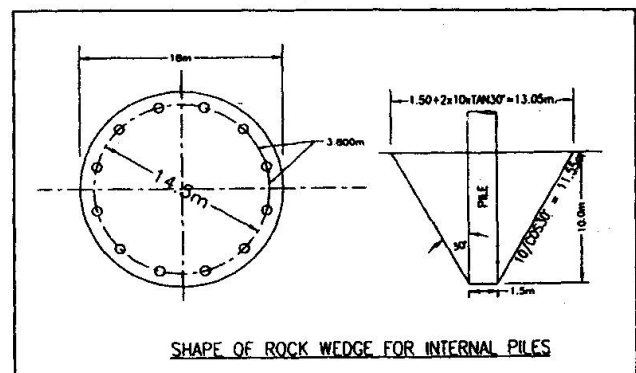
Fig:5

The piles have been provided essentially for resisting the tension developed at the base of the well caused due to overturning moments and resultant uplift under seismic conditions. The base of the well is treated as the solid circular section with each pile acting as steel reinforcement resisting the tension. The socket length inside the rock and the bond length of pile within the well steining have to provide adequate safety against the uplift. The brief computations are given below.

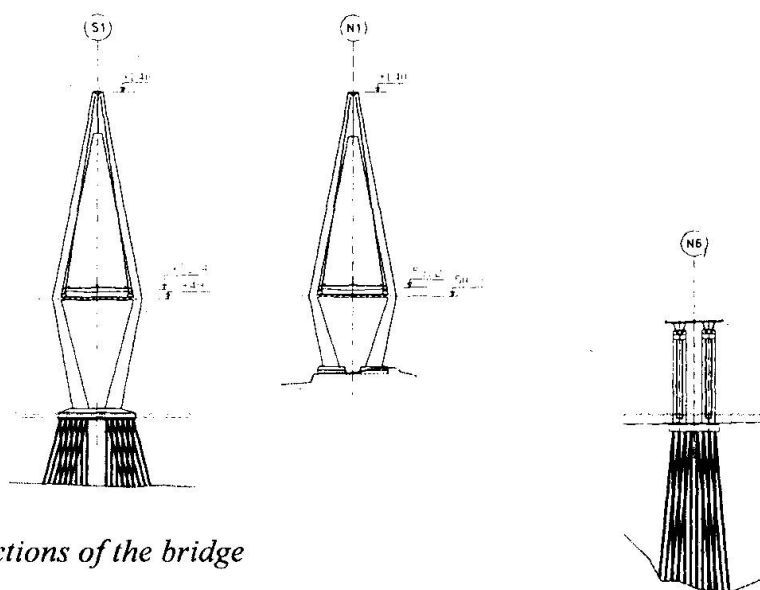
Figure 1b Sections of the bridge

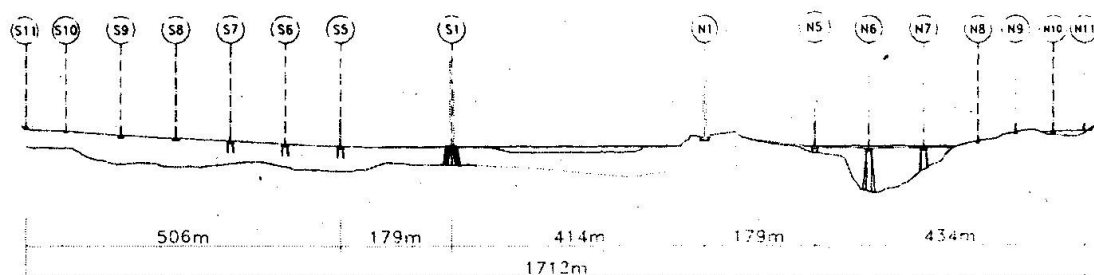
Figure 1a Elevation of the bridge

The main bridge is a cable stayed bridge having a main span of 414 m and two side spans of 179 m each. The superstructure is a steel grid with a composite slab of precast concrete. The two towers have a height of 140 m above the sea level. The towers are built in concrete using self climbing formwork. The southern tower is founded on piles and the northern tower is founded on solid rock.

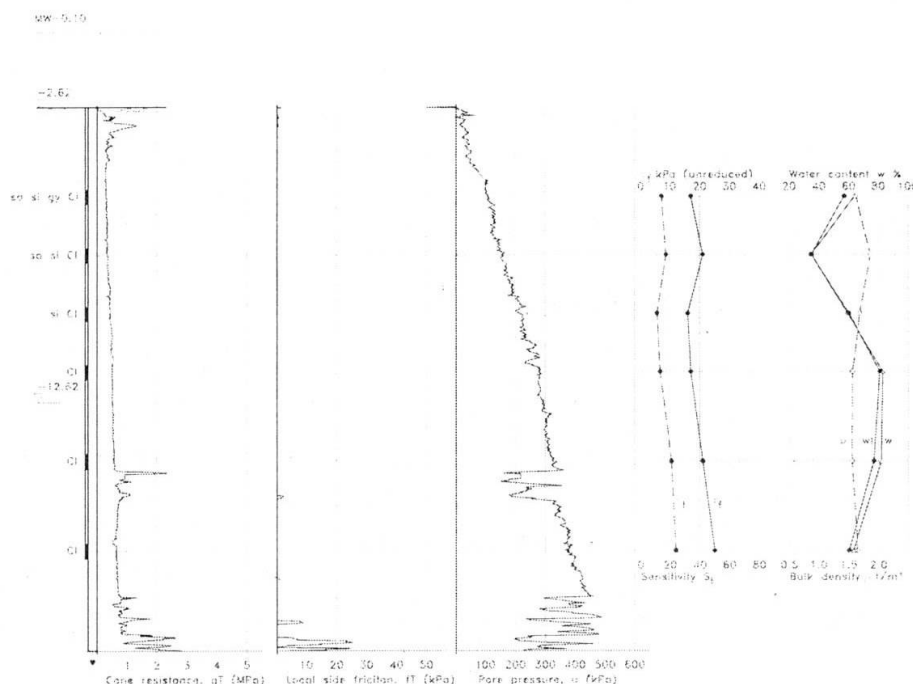
Figure 2 CPT-results and results from laboratory investigations at support N6

underneath follows glacial sediments. The postglacial soils are in the surface layers sand with gyttja, clay and silt. The dominating postglacial soil is however loose clay. This clay is described in figure 2. The glacial sediments are sand and clay with sand layers.

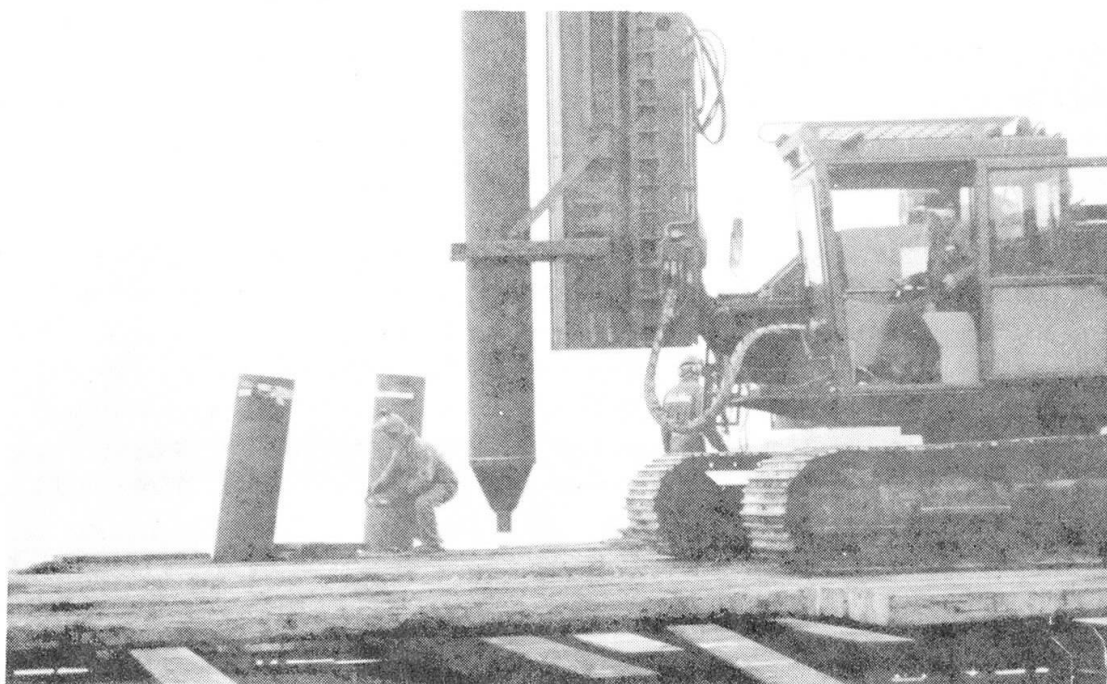
Figure 3. Pile driving equipment used for foundation at support N6 and N7.

To increase the capacity of the pile driving it was necessary to take alternative measures to decrease the amount of blows for the installation with the originally selected equipment or change the equipment to a more efficient one. However the allowed noise level was reached (and in some cases exceeded) with the initially selected pile driving equipment. To avoid exceeding the stated noise level the first alternative was to reduce the amount of blows during the installation through drilling beside the pile during the driving. High water pressures had been observed during the pile driving. The drilling reduced the pore pressure and had a good effect on the capacity of the pile driving, but not good enough. Hence it was decided to add an equipment with a more efficient hammer to make the final driving of the piles. That implied that it was also necessary to take additional measures to increase the noise damping. These were performed in two ways. The first was a tube of concrete with a length of 5 m placed around the pile and the hammer during the final pile driving. The second way was a wall of normal transport containers with a height of about 10 m placed on three sides of the foundation area. Together these measures were efficient to reduce the noise level so it was possible to perform the piled foundation without exceeding the stated maximum noise level in any apparent way.

The northern approach bridge is founded with footings on solid rock, in soil and on piles driven to rock. The additional geotechnical investigations for the piled foundations (support N5, N6 and N7) indicated that the rock surface locally has steeper slopes than originally assumed. Hence some of the pile toes were redesigned with a steel dowel as mentioned above. The foundation works were performed in principal in accordance to the original design. Compare photo in figure 3 showing the equipment for pile driving of the steel pipe piles at support N6 and N7.

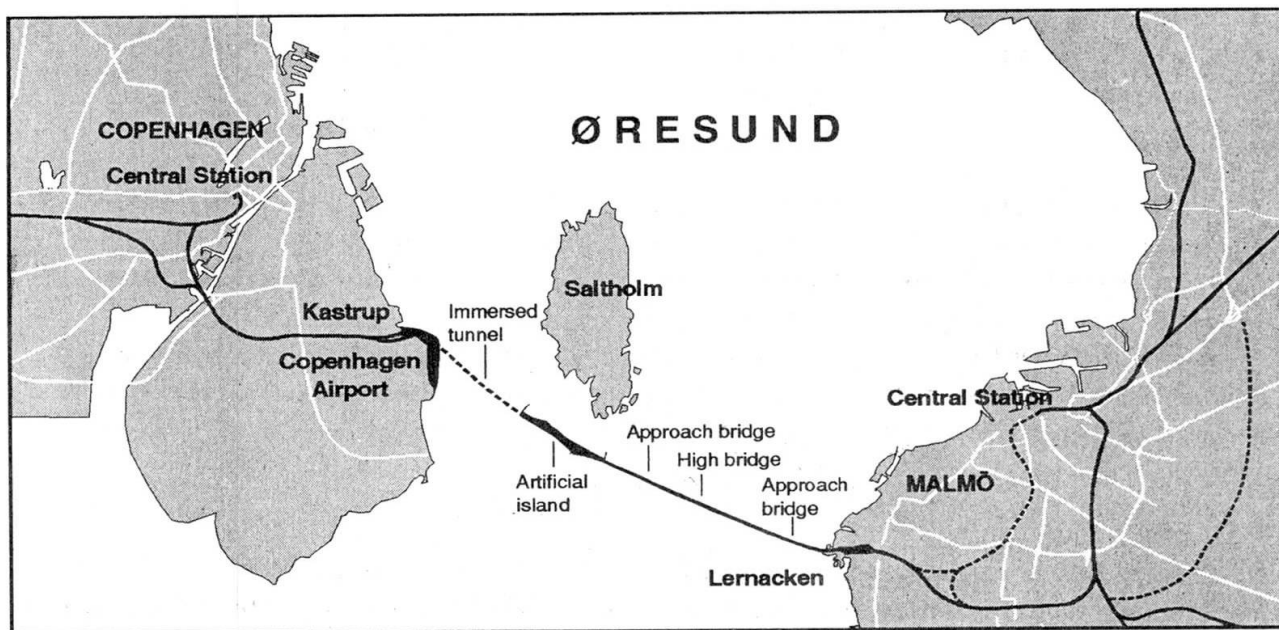
Fig.1. Plan of the Øresund Link

The 15.8km Link comprises, from Copenhagen Airport in Denmark to Lernacken in Sweden, the following main parts (Fig.1):

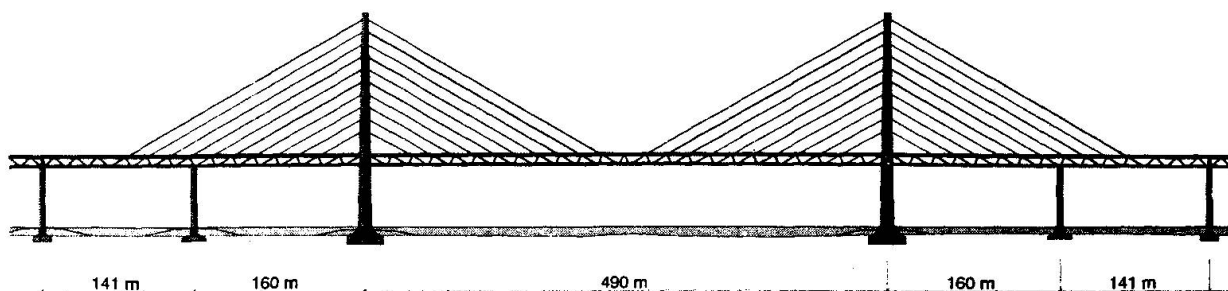
Fig.2 The 490m Main Span crosses an international Shipping Lane

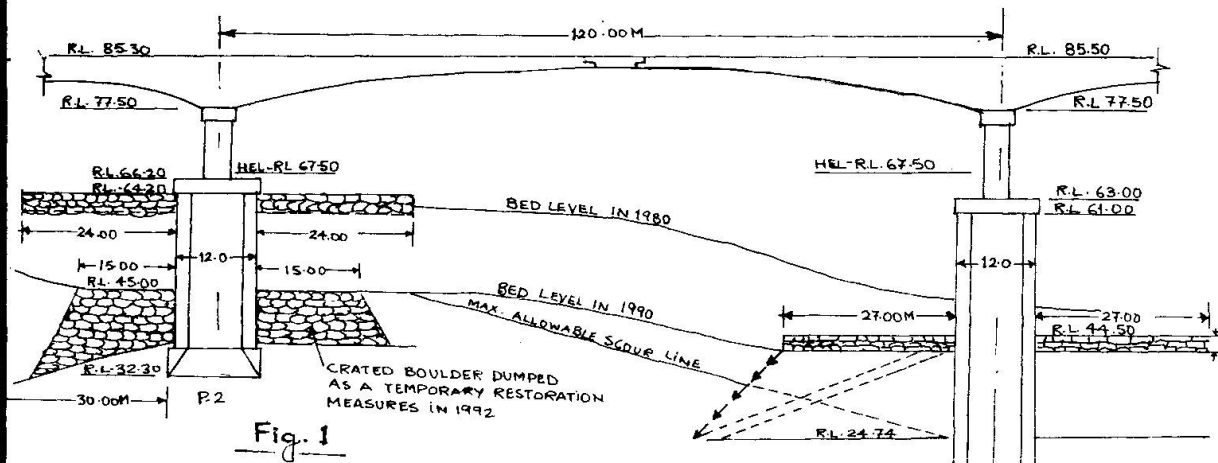
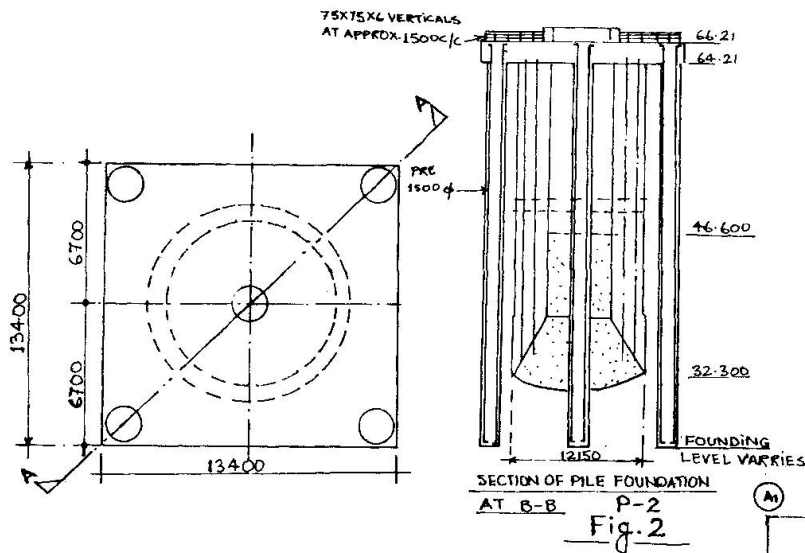
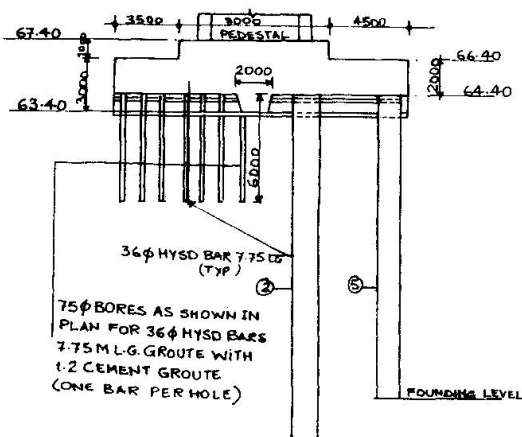
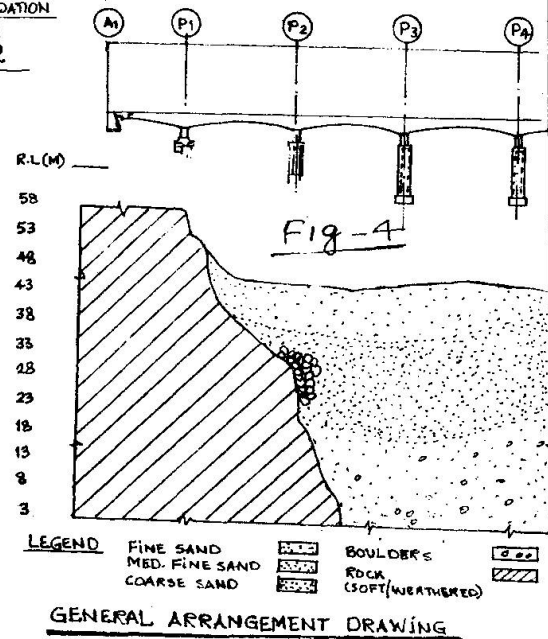
SKETCH SHOWING FOUNDATION LEVEL SCOUR LEVELS AND TENTATIVE PROTECTIVE MEASURES TO PIER WELLS P-2 AND P-3 OF KALIA BHOMARA BRIDGE ON NH-37-A

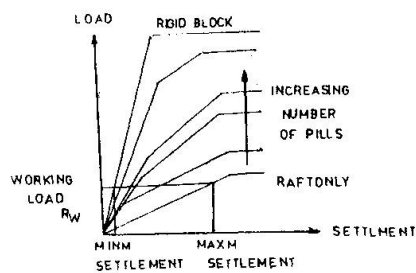
FIG-5 LOAD SETTLEMENT CHARACTERISTICS OF PILE COMBINED WITH CAP AFTER POLOUS AND DEVISAT (1972)

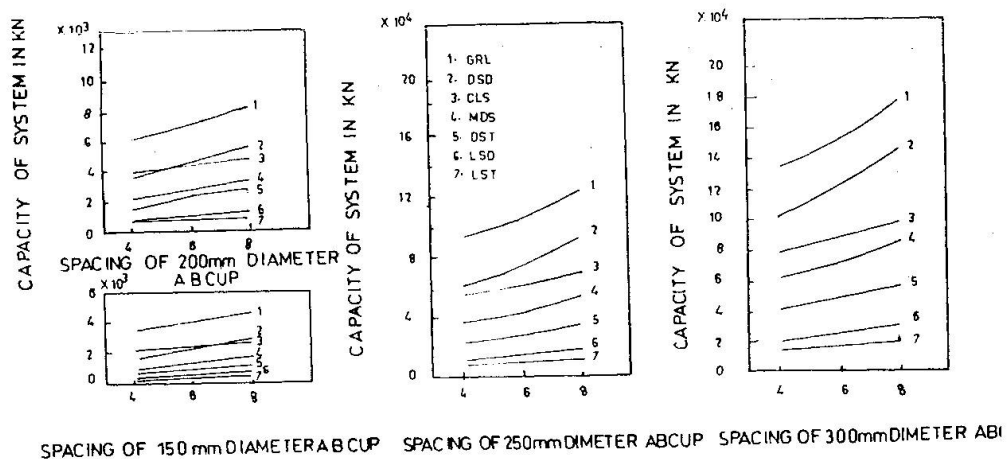
FIG.6 SPACING VS CAPACITY OF CIDF SYSTEM

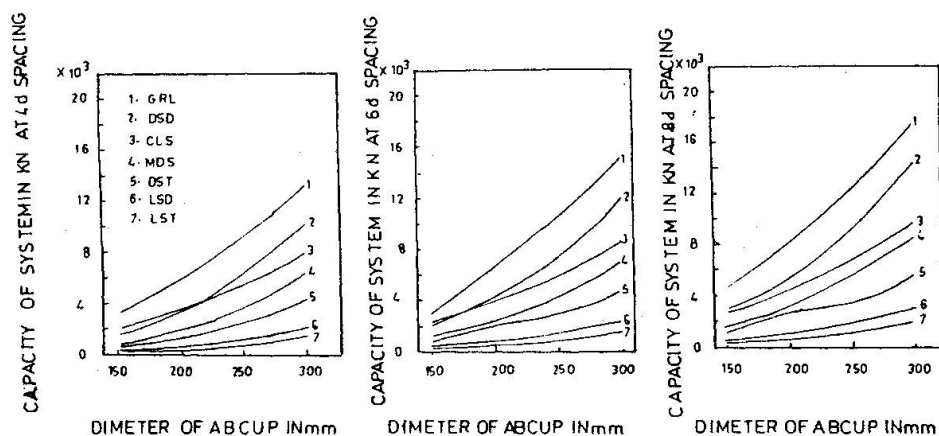
FIG.7 DIAMETER OF ABCUP VS CAPACITY OF CIDF SYSTEM AT VARIOUS SPACINGS OF ABCUP

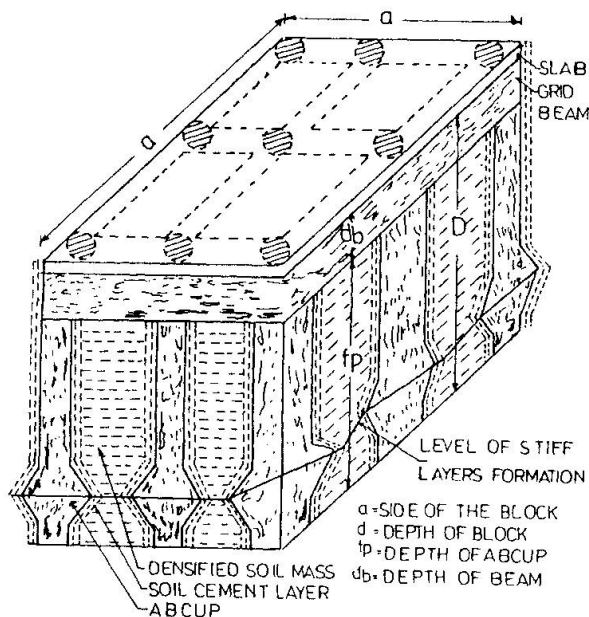
FIG1 CIDF SYSTEM AS BLOCK FOUNDATION

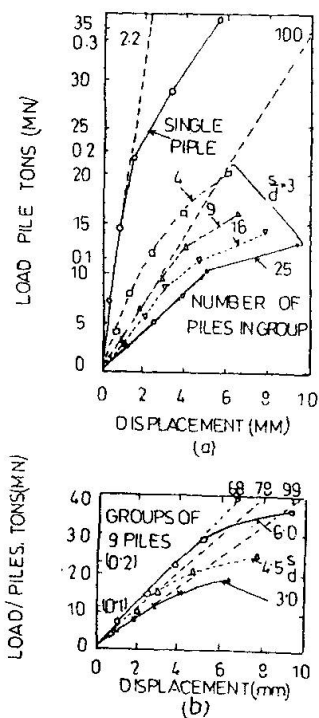
FIG-3 DISPLACEMENT VERSUS PILE LOAD
(a) SINGLE PILE VARIOUS GROUP AT 3d
SPACING IN SILTY SAND, (b) NINE PILE
GROUP AT VARIOUS SPACING

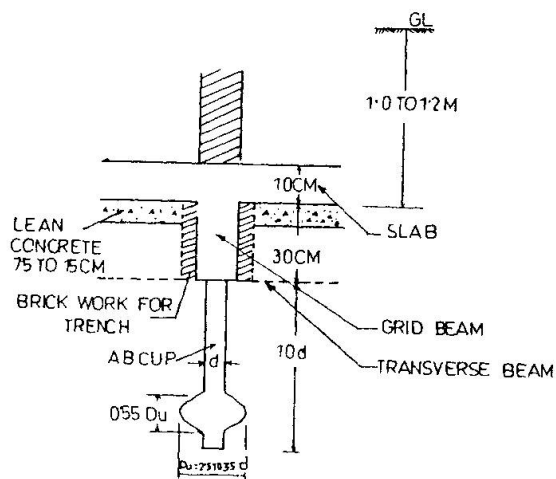
FIG4-A VIEW OF JUNCTION OF
BEAM SLAB & ABCUP

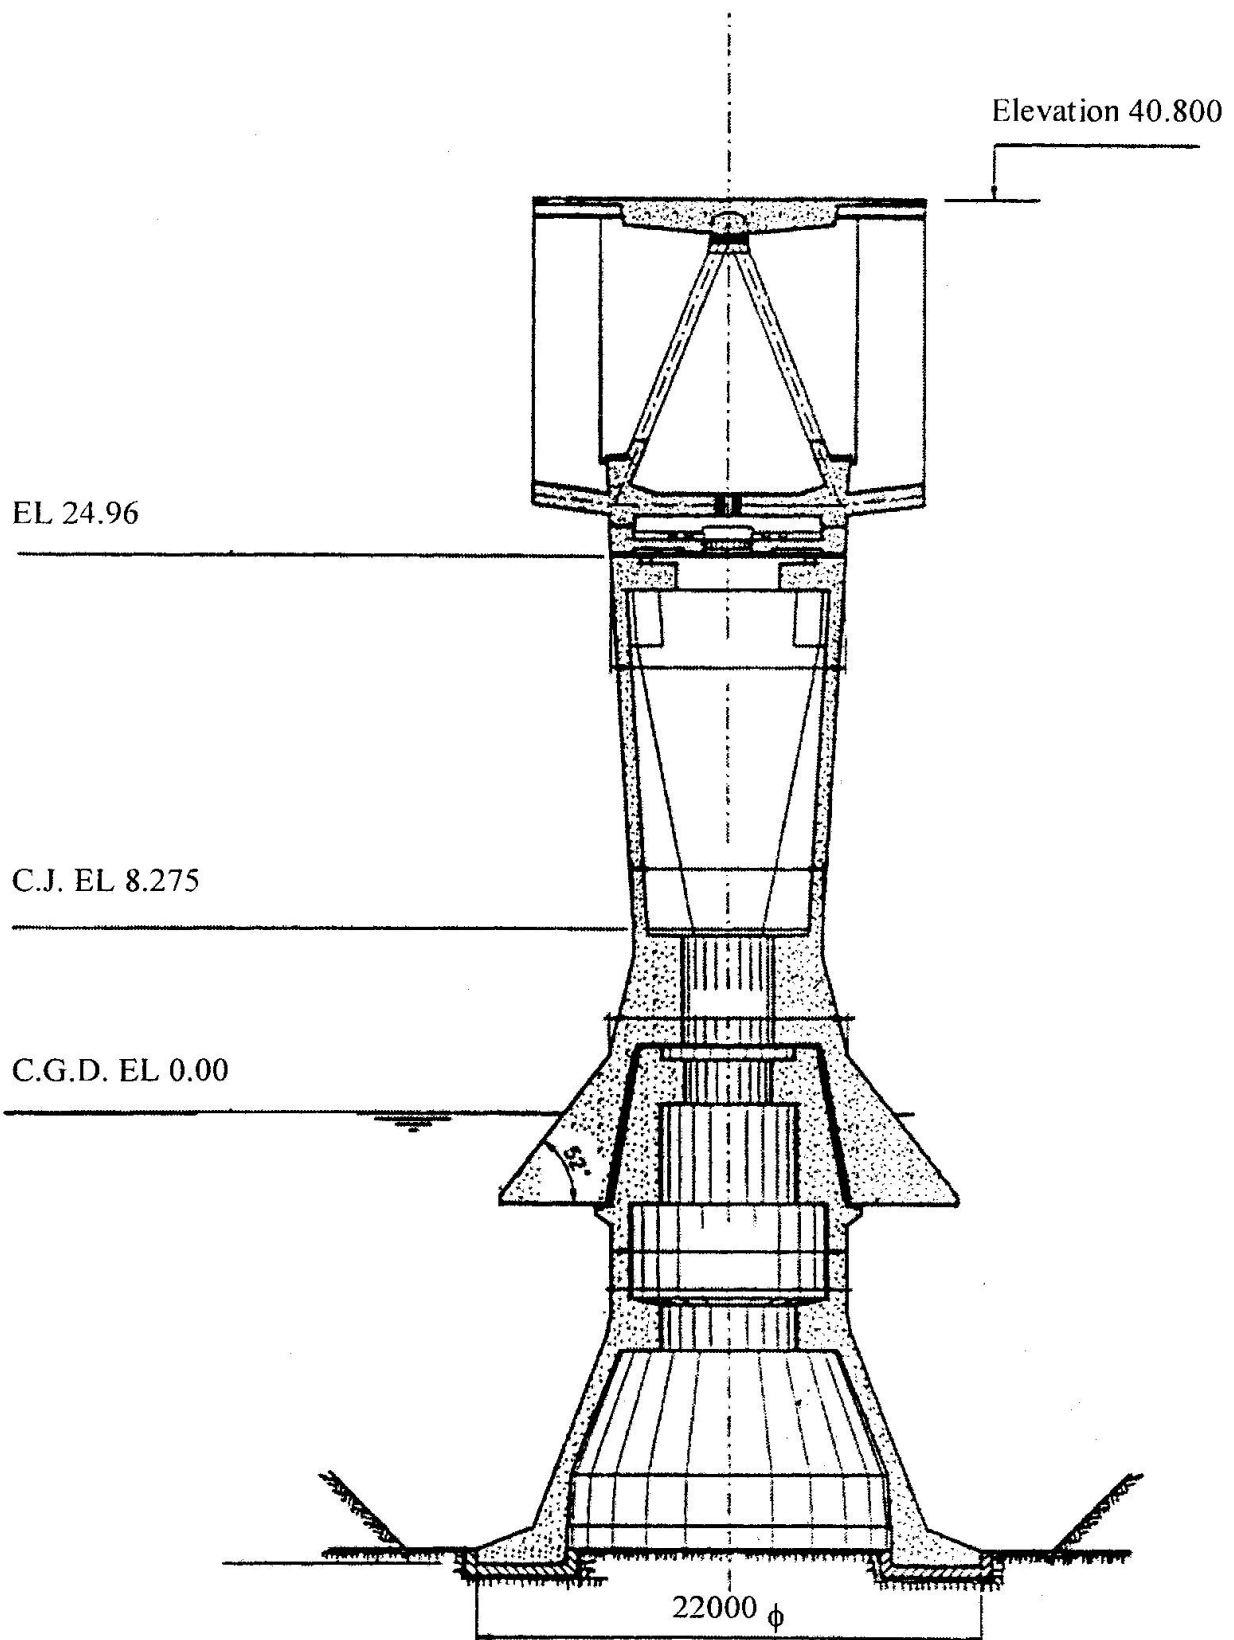
Figure 2: Longitudinal Section

The Confederation Bridge is one of the longest deep-water structure in the world. It was designed for 100-years service life in a harsh environment. Unique precasting methods were used for the substructure and superstructure to allow construction of the bridge within a tight schedule. The bridge substructure was designed to resist ice loads up to 30 MN. This unique structure was opened to traffic on schedule in June 1997.
