Zeitschrift: IABSE reports = Rapports AIPC = IVBH Berichte
Band: 80 (1999)

Rubrik: Session 7: Case studies

Case Studies

Design of Foundations for the Storebælt East Bridge

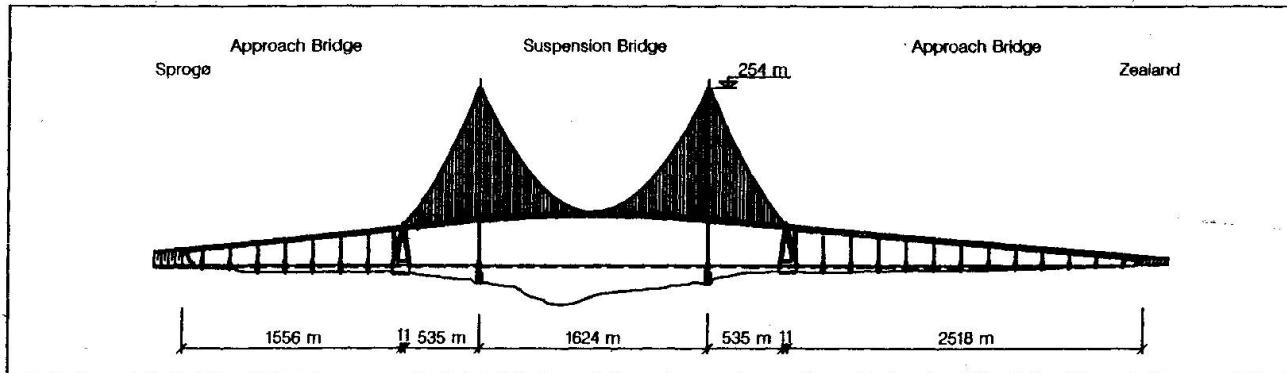
Fig. 1: Longitudinal section of the Storebælt East Bridge (exaggerated vertical scale)

The East Bridge substructures consists of three major structural components

- the pylons,
- the anchor blocks and
- the approach bridge piers.

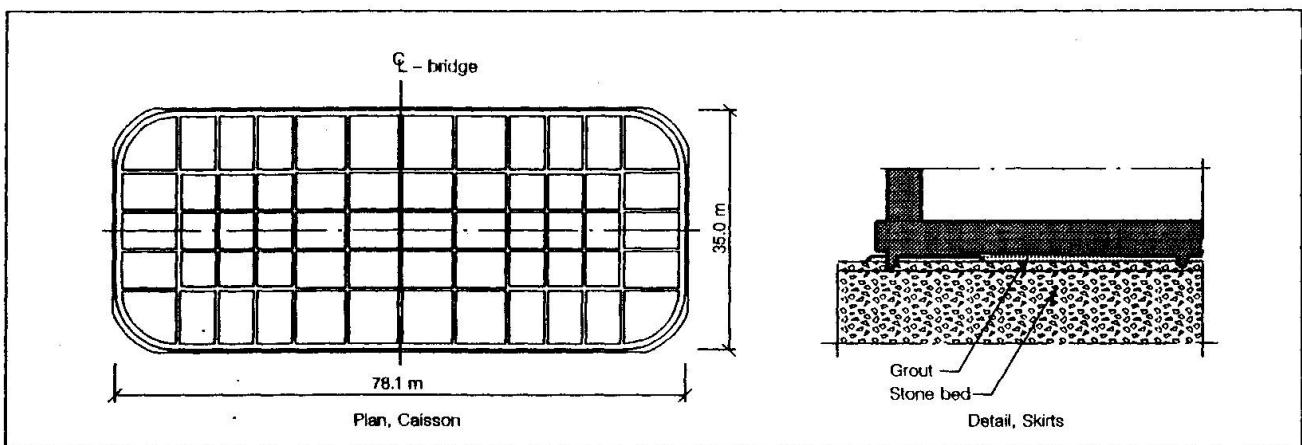
Fig. 2: Plan and Detail of Foundation Caisson

The foundation caissons, each covering an area of $2,770 \text{ m}^2$, are 78 m long and 35 m wide, see Fig. 2. However, the corners and the edges are rounded in order to reduce the water blocking effect and to limit damage to possible colliding ships by avoiding sharp corners and edges. They are divided into 60 cells by internal walls and are 20 m high, including a 3 m thick plinth cast in situ on top of the cellular caissons within a temporary steel cofferdam. This was required because the top of the caisson is kept 3.5 m below water level in order to avoid the undesirable visual effect of the slender pylon legs and the voluminous caisson standing one on top of the other.

The bottom slab of the caissons has a variable thickness between 0.95 m and 1.1 m, creating a roof-shaped underside to the slab. Around the periphery of the slab and below some of the internal walls 0.5 m deep skirts are provided, designed to penetrate about 0.3 m into the uncompacted screeded top layer of the stone beds, see Figure 2. The voids thus formed between the roof-shaped underside of the slab and the stone bed were subsequently filled with sand/cement grout through pre-installed pipes, the skirts serving to confine the grout. For each of the caissons the quantity of grout was some 725 m^3 , placed in about 40 hours

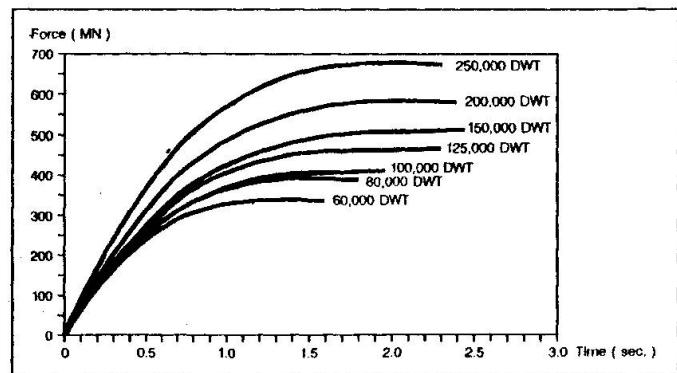
Fig. 3: Idealised load-time curves for ship impacts

The load-time curve for the impact against the non-moving pier was established based on theoretical considerations of the energy dissipated by adding up the contributions during plastic deformation of all basic structural elements of the ships hull. The procedure developed for bow crushing analysis is based on an upper-bound plasticity theory which can also handle rigid body motions of crushed and non-crushed parts of the structure. Validation of the numerically predicted crushing loads has been done by comparison with experimental crushing results of small scale bow models.

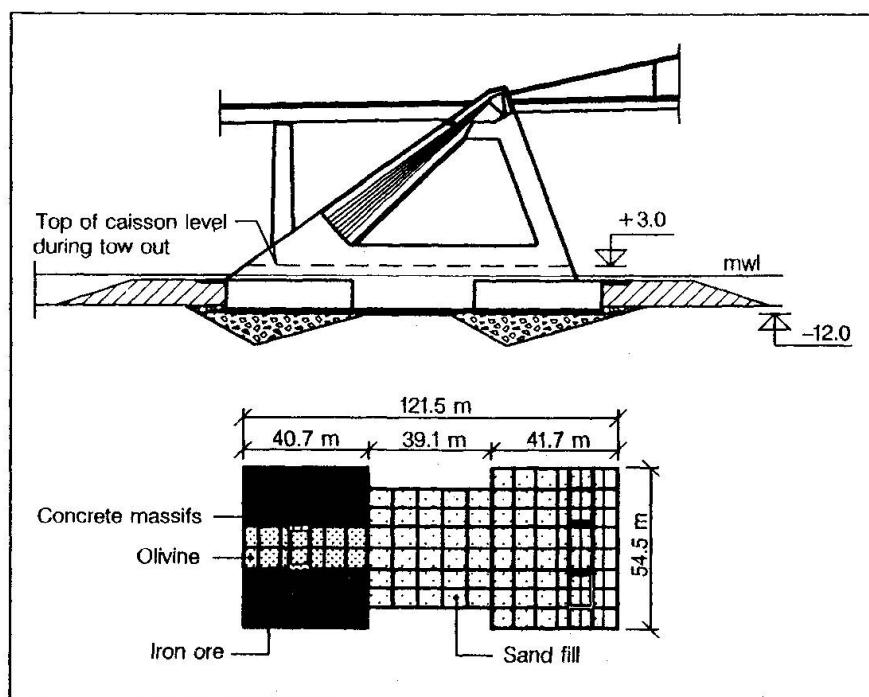
Fig. 4: Elevation and Plan of Anchor Block Caisson.

The foundation caissons, each covering an area of 6,100 m², are 121.5 m long and 54.5 m wide and divided in three parts. Only the front and rear parts are in contact with the supporting stone wedges as explained above. The height of the pre-fabricated part of the caissons is 15 m having a weight of 50,000 tonnes when towed to the bridge site whereas the remaining parts of the anchor blocks above level +3.0 m were cast in-situ.

The rear part of the caissons contains the anchorage massifs comprising 18,000 m³ of concrete which was cast in-situ partly inside some of the cells in the pre-fabricated caisson. Other cells in the rear part were ballasted with olivine (heavy sand) and iron ore.

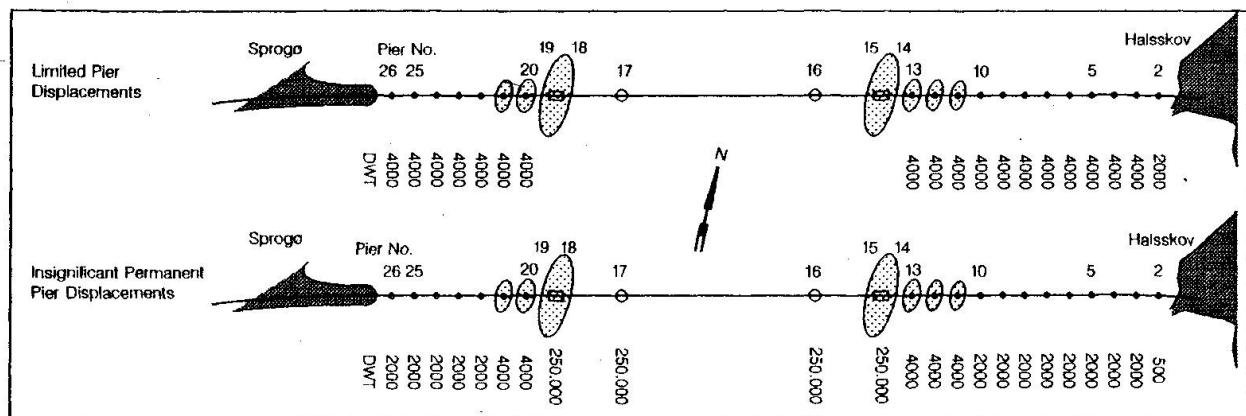
Fig. 5: Design vessels (in DWT) for Head on Bow Collisions with Approach Bridge Piers

Based on the collision risk model the design basis for the ship impact loads was established, see Fig. 5.

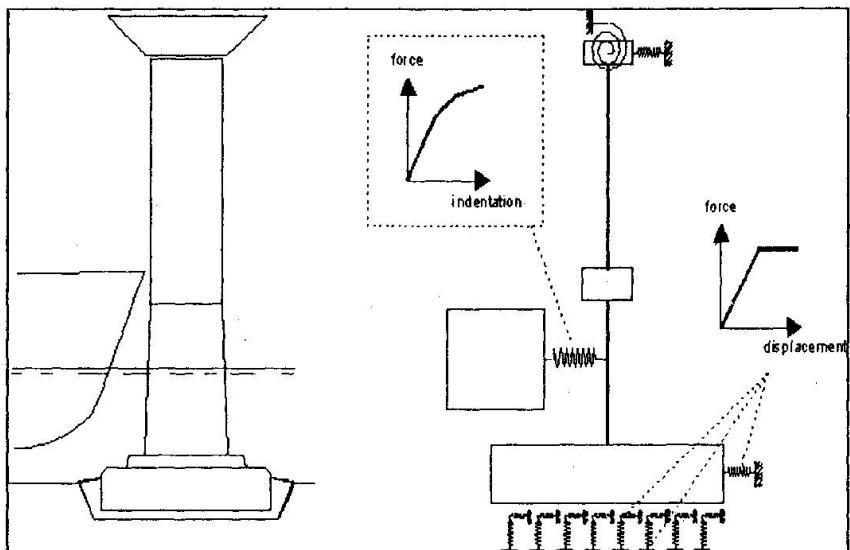
Fig. 6: Idealised model of the Ship Collision.

A simplified but still advanced computer model was developed for the ship impact analyses, see Fig. 6. The model comprises: a non-linear elasto-plastic model of the soil-structure interaction, a stiff foundation caisson, elastic beam elements for the pier shaft and a concentrated mass and spring at the pier top representing the bridge girder. To verify the simplified model, independent 2D finite element analyses were carried out using two different programs ABAQUS and FENRIS. In addition the effects of eccentric impacts were studied by 3D models with a more refined modelling of the soil, including local weak areas etc. in FENRIS.

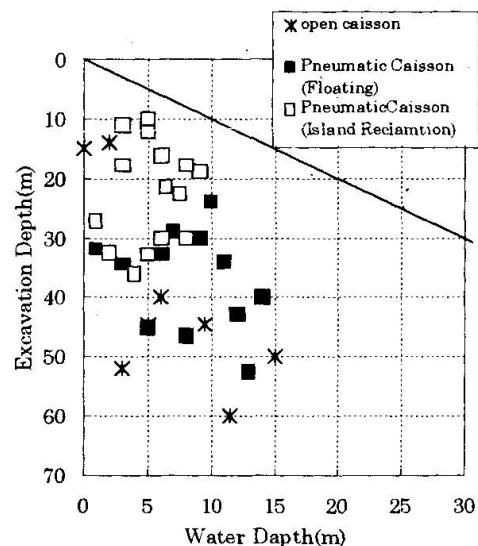
Figure 1 Underwater caisson Foundation Executions in Japan

Fig. 1 shows that many of those caisson foundations, which support long span bridges, have been constructed at locations with very deep water. The reason of this situation is that they are appropriate for deep foundations thanks to the benefits cited above and the large bearing capacity of a caisson foundation.

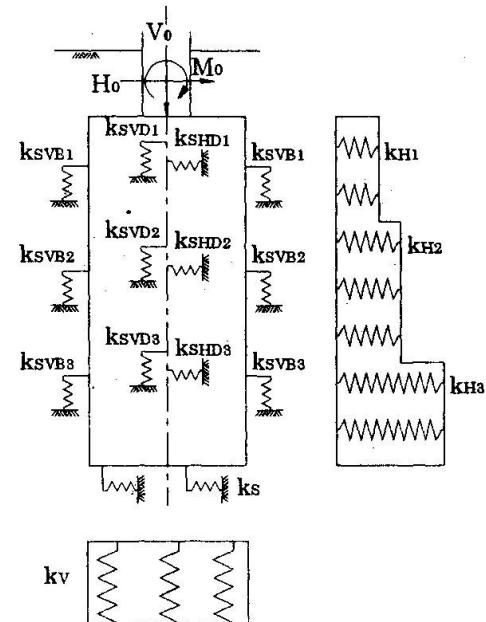
Figure. 2 Ground Resistance

To use the ductility design method, an elasto-plastic spring model with the ultimate bearing capacity of the bottom surface ground obtained from formula (1) as the maximum value is established.

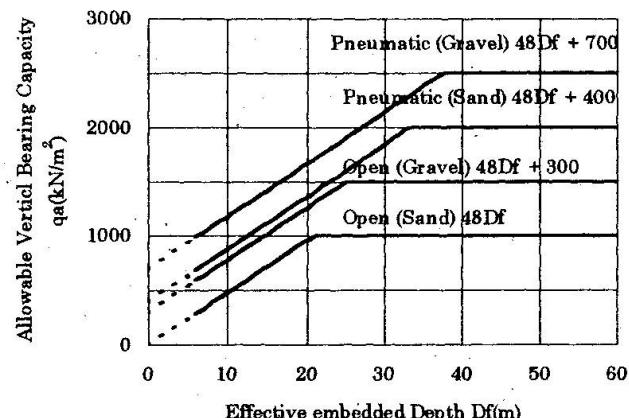
Figure. 3 Maximum Value (Normal Conditions) of the Allowed Vertical Bearing Capacity of the Ground at the Bottom Surface of a Caisson Foundation

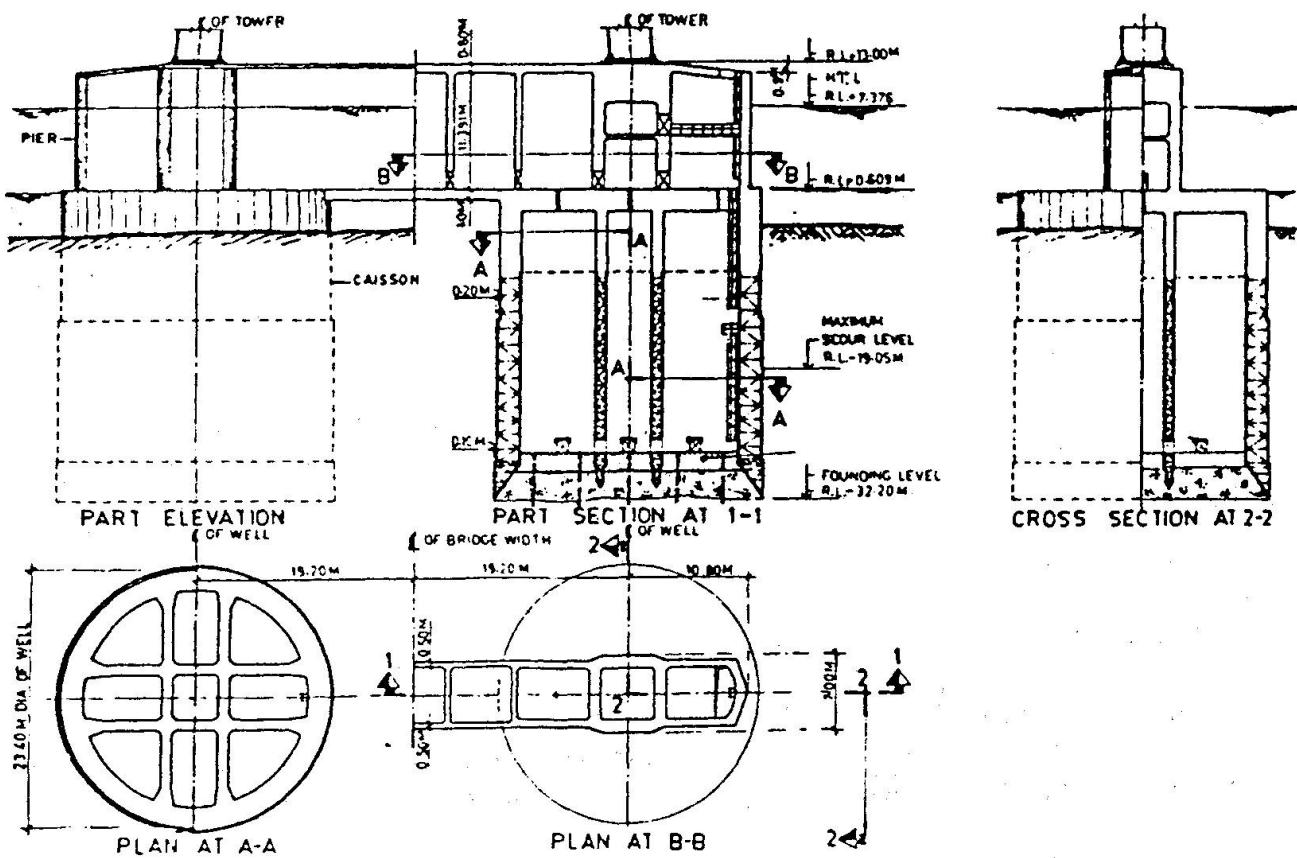
FIG. 2

PIER P3 AND CAISSENS F3

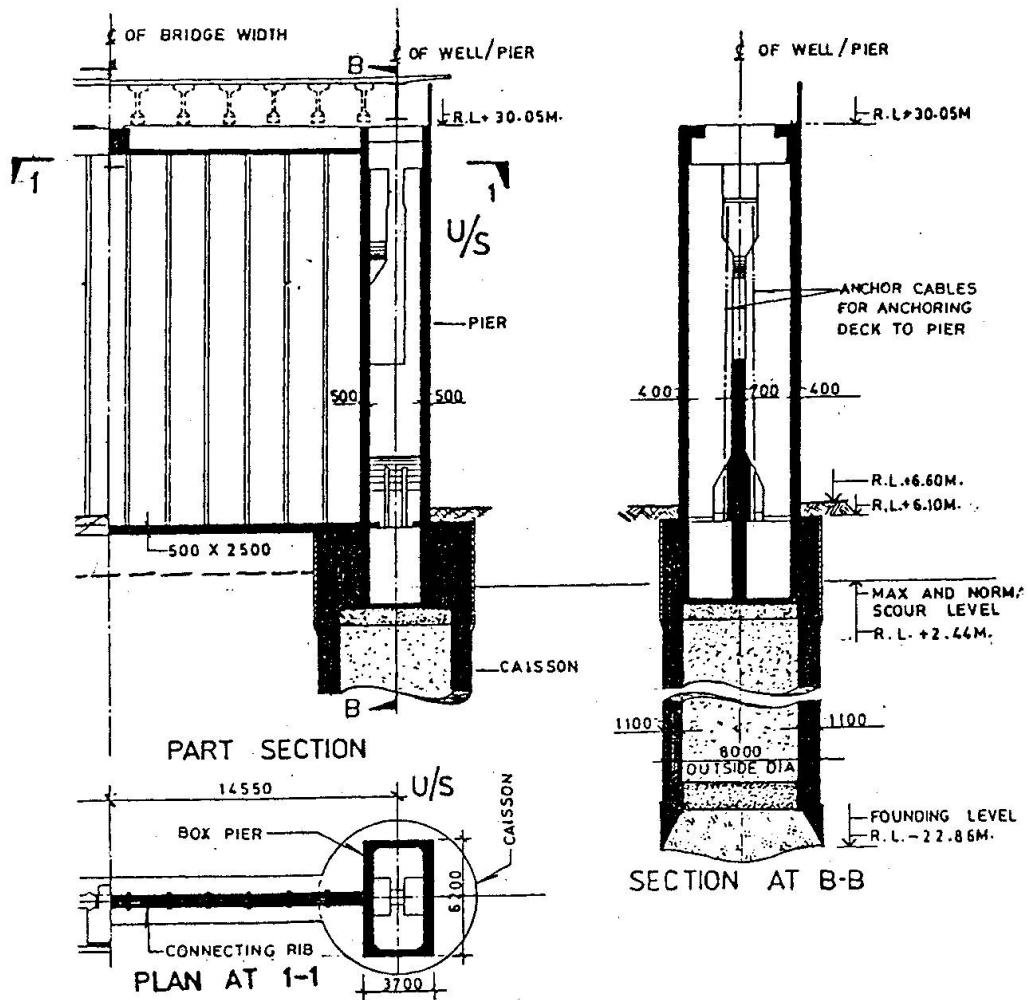
PART PIER P4 AND ONE CAISSON OF F-4
FIG.3

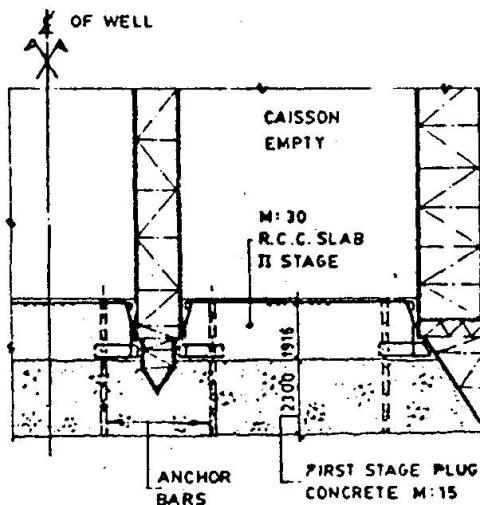
PART CROSS SECTION SHOWING
BOTTOM SLAB REINFORCEMENT.

BOTTOM PLUG FOR CAISSON OF F-3
FIG. 4

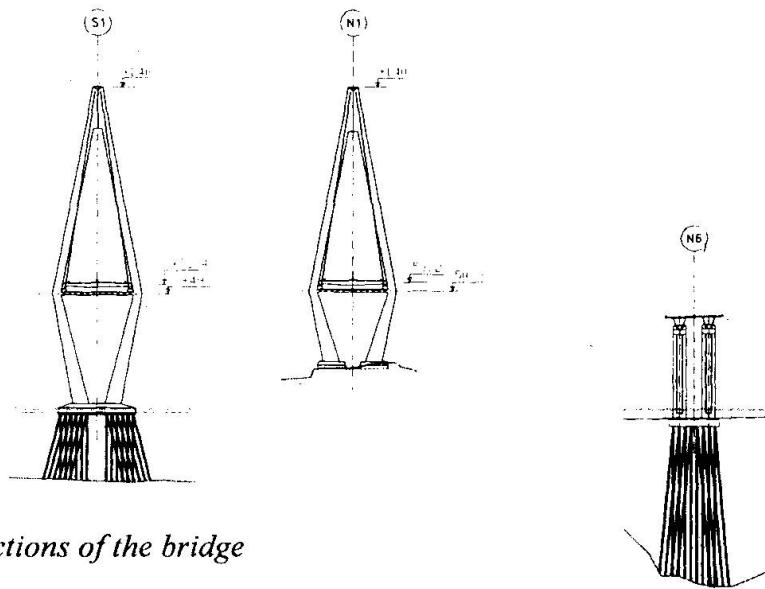
Figure 1b *Sections of the bridge*

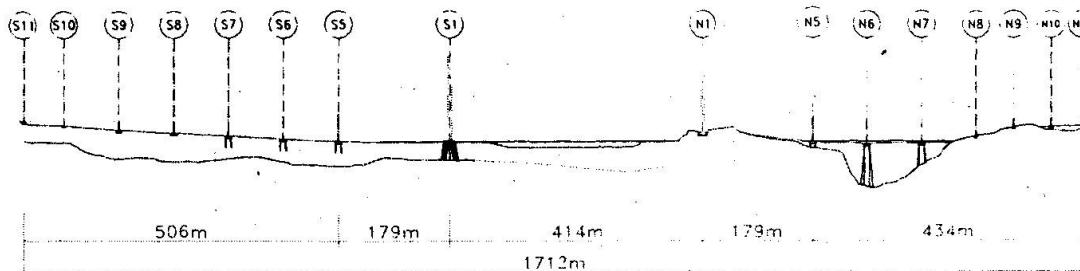
Figure 1a Elevation of the bridge

The main bridge is a cable stayed bridge having a main span of 414 m and two side spans of 179 m each. The superstructure is a steel grid with a composite slab of precast concrete. The two towers have a height of 140 m above the sea level. The towers are built in concrete using self climbing formwork. The southern tower is founded on piles and the northern tower is founded on solid rock.

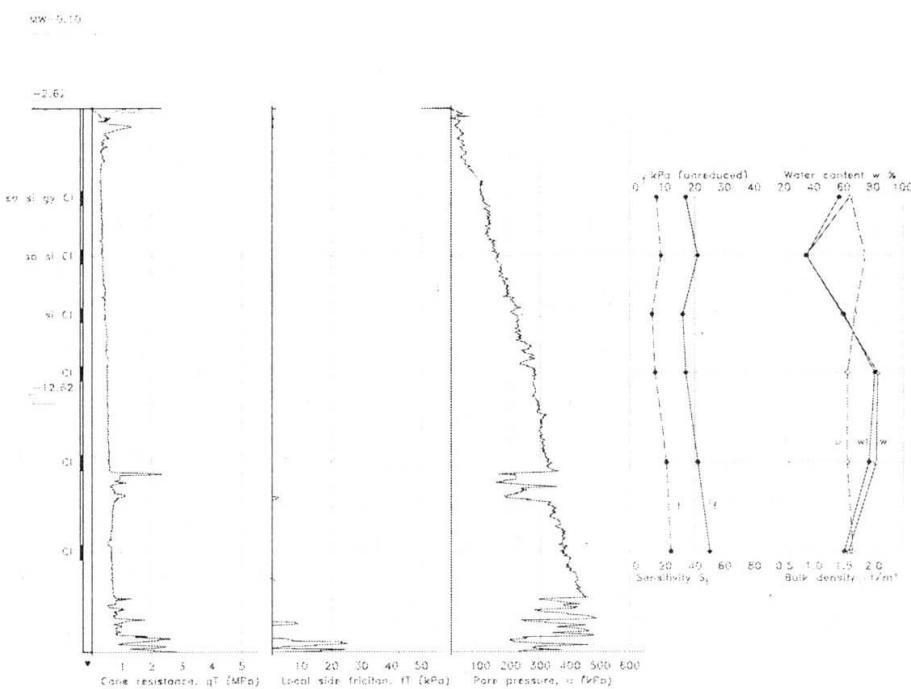
Figure 2 CPT-results and results from laboratory investigations at support N6

underneath follows glacial sediments. The postglacial soils are in the surface layers sand with gyttja, clay and silt. The dominating postglacial soil is however loose clay. This clay is described in figure 2. The glacial sediments are sand and clay with sand layers.

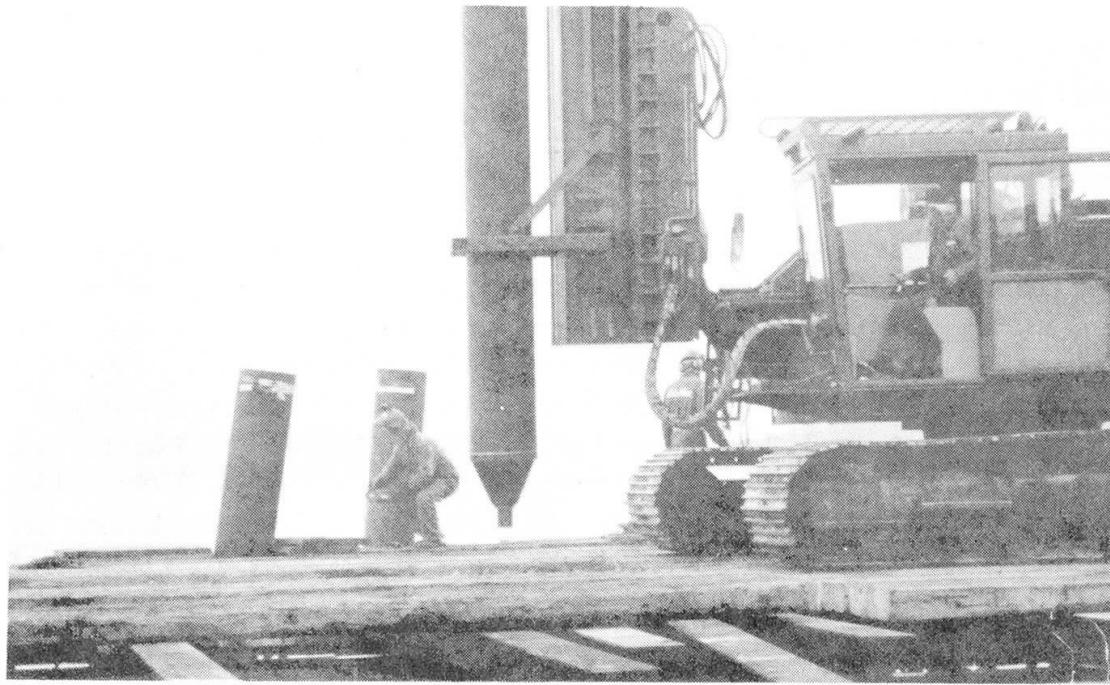
Figure 3. Pile driving equipment used for foundation at support N6 and N7.

To increase the capacity of the pile driving it was necessary to take alternative measures to decrease the amount of blows for the installation with the originally selected equipment or change the equipment to a more efficient one. However the allowed noise level was reached (and in some cases exceeded) with the initially selected pile driving equipment. To avoid exceeding the stated noise level the first alternative was to reduce the amount of blows during the installation through drilling beside the pile during the driving. High water pressures had been observed during the pile driving. The drilling reduced the pore pressure and had a good effect on the capacity of the pile driving, but not good enough. Hence it was decided to add an equipment with a more efficient hammer to make the final driving of the piles. That implied that it was also necessary to take additional measures to increase the noise damping. These were performed in two ways. The first was a tube of concrete with a length of 5 m placed around the pile and the hammer during the final pile driving. The second way was a wall of normal transport containers with a height of about 10 m placed on three sides of the foundation area. Together these measures were efficient to reduce the noise level so it was possible to perform the piled foundation without exceeding the stated maximum noise level in any apparent way.

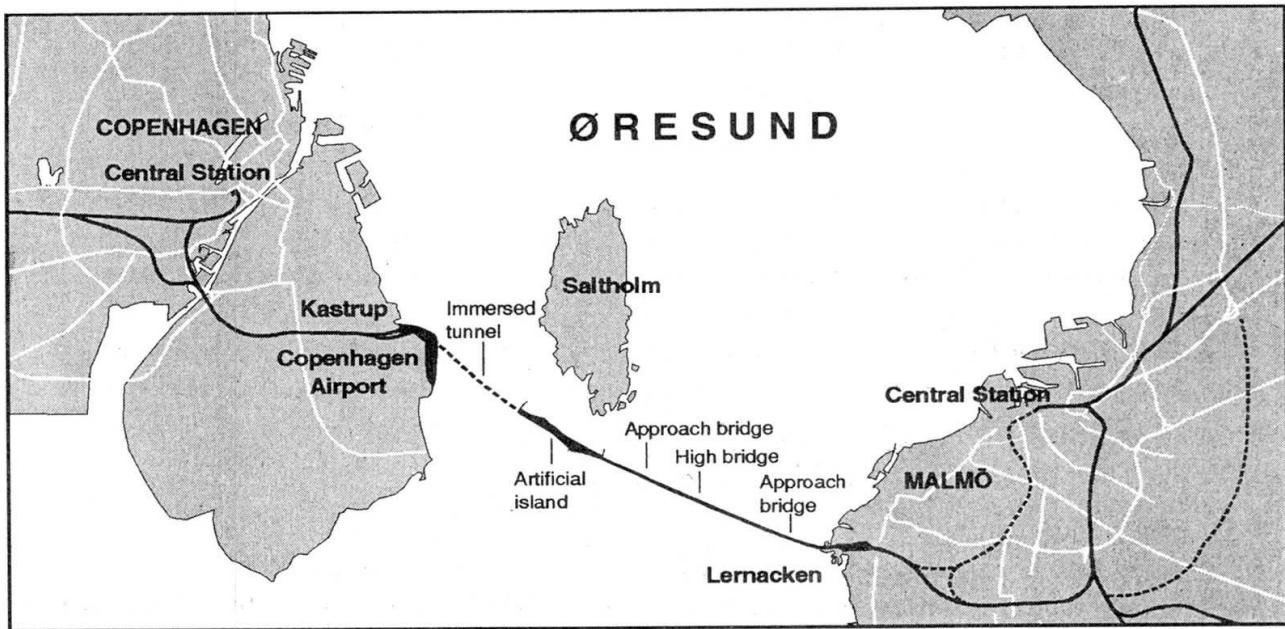
Fig.1. Plan of the Øresund Link

The 15.8km Link comprises, from Copenhagen Airport in Denmark to Lernacken in Sweden, the following main parts (Fig.1):

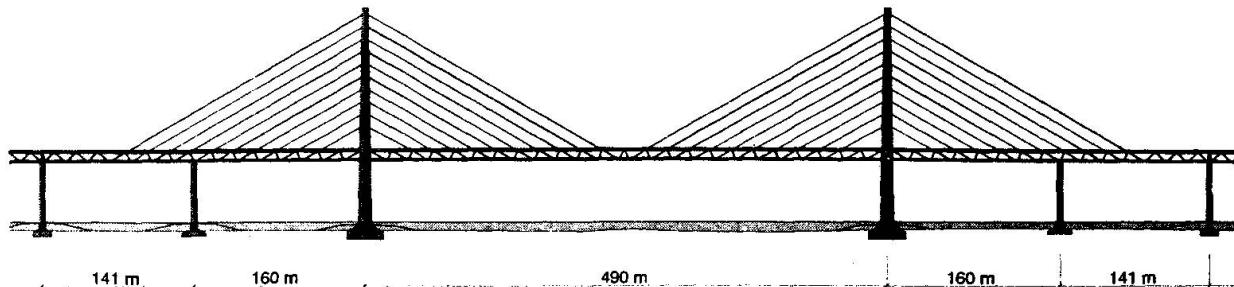
Fig.2 The 490m Main Span crosses an international Shipping Lane

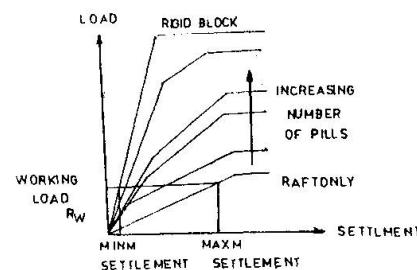
FIG-5 LOAD SETTLEMENT CHARACTERISTICS
OF PILE COMBINED WITH CAP AFTER
POLOUS AND DEVI-SATIJA, (1972)

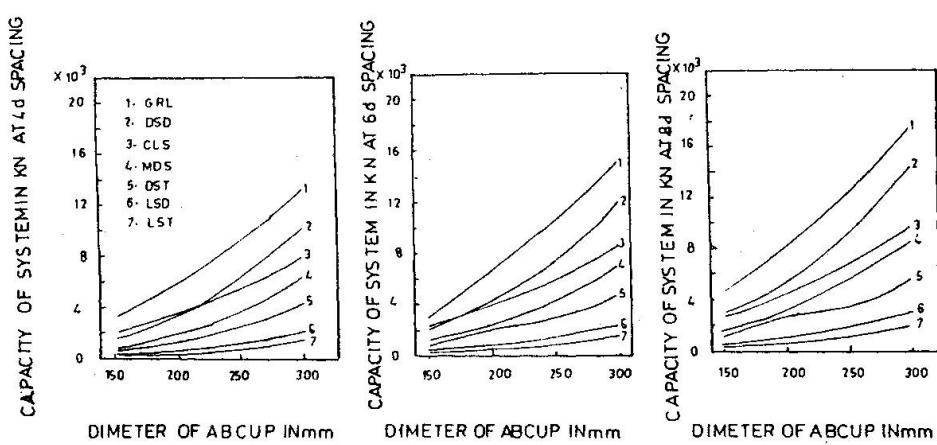
FIG-7 DIAMETER OF ABCUP Vs CAPACITY OF CIDF SYSTEM AT VARIOUS
SPACINGS OF ABCUP

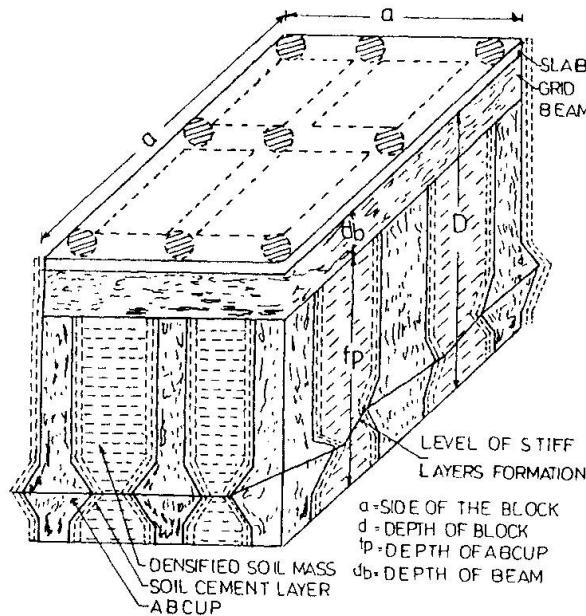
FIG-1 CIDF SYSTEM AS BLOCK FOUNDATION

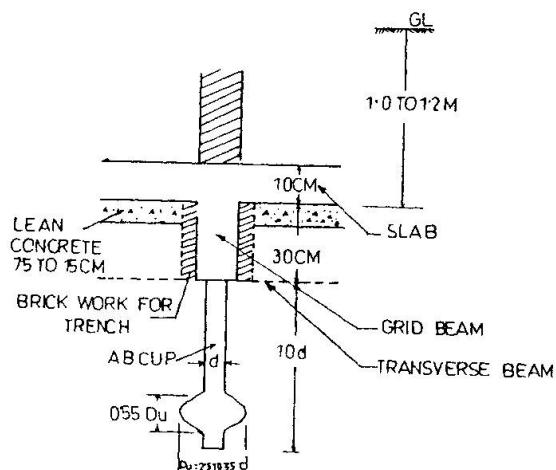
FIG-4-A VIEW OF JUNCTION OF BEAM SLAB & ABCUP

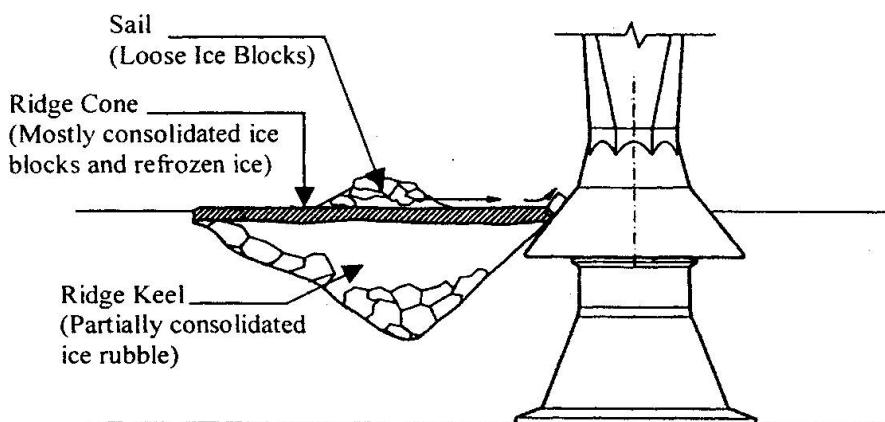
Figure 1: Ice Formations

Generally, the ice season in the Northumberland Strait begins in December or early January, and conditions worsen until late March. The maximum thickness of ice floes, i.e. floating pressure ridges formed from large sheets at the surface of the sea, is about 0.30 m. Floes may occasionally extend over 500 m with a mean of 118 m.

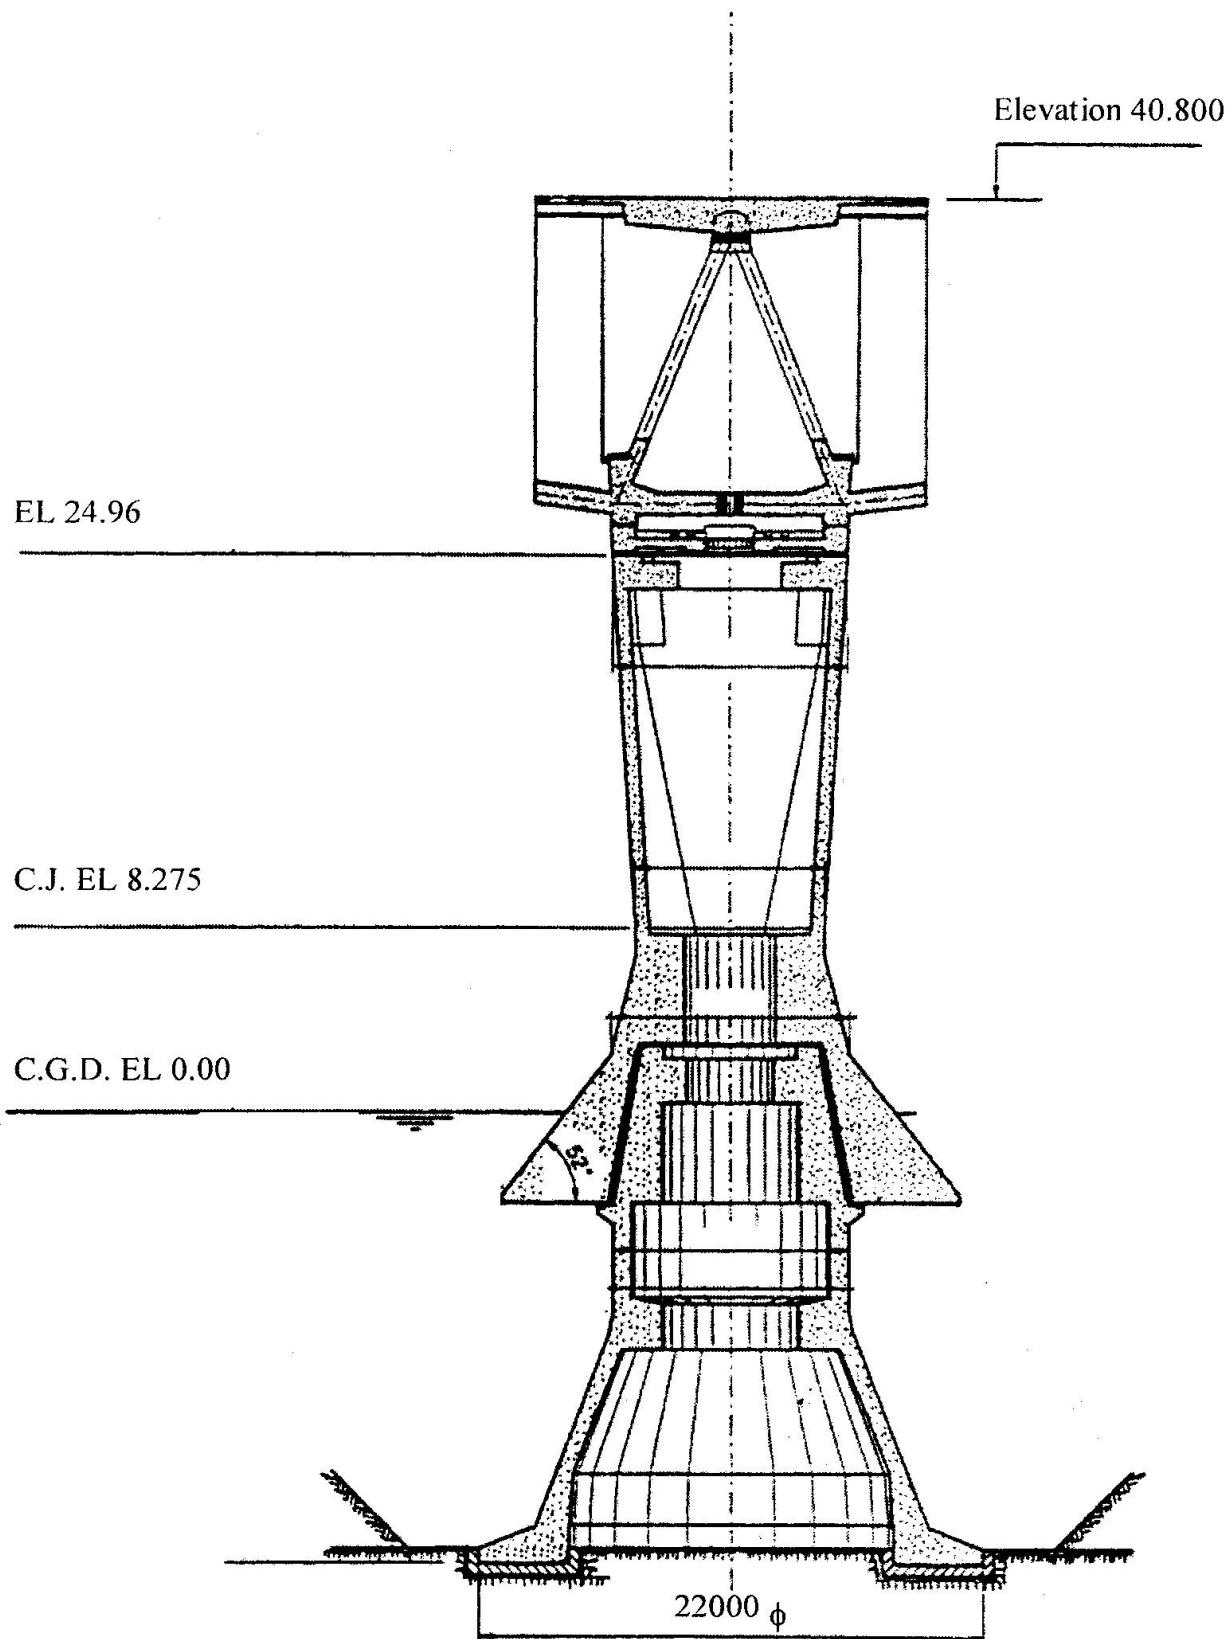
Figure 2: Longitudinal Section
