Zeitschrift: IABSE reports = Rapports AIPC = IVBH Berichte
Band: 82 (1999)

Rubrik: Session 5: Observation, maintenance and repair

Bridge Consolidation by Using Cable - Stayed Method

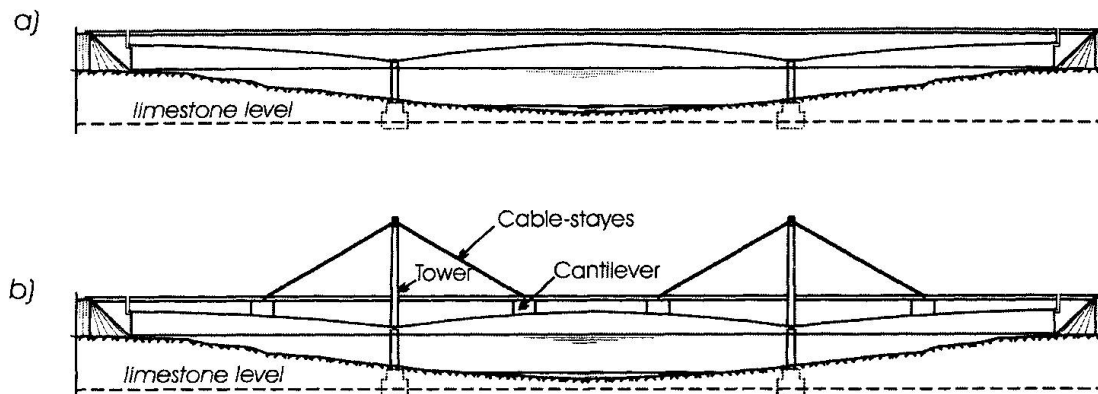
Fig.1 Elevation of a bridge with three-span continuous girders.
a) existing bridge; b) proposed solution.

Fig. 1 shows the elevation of a bridge having the superstructure consisting of three spans continuous prestressed concrete girders requiring only the consolidation of the superstructure.

Fig. 1 and 2 present an example of a bridge consolidation.

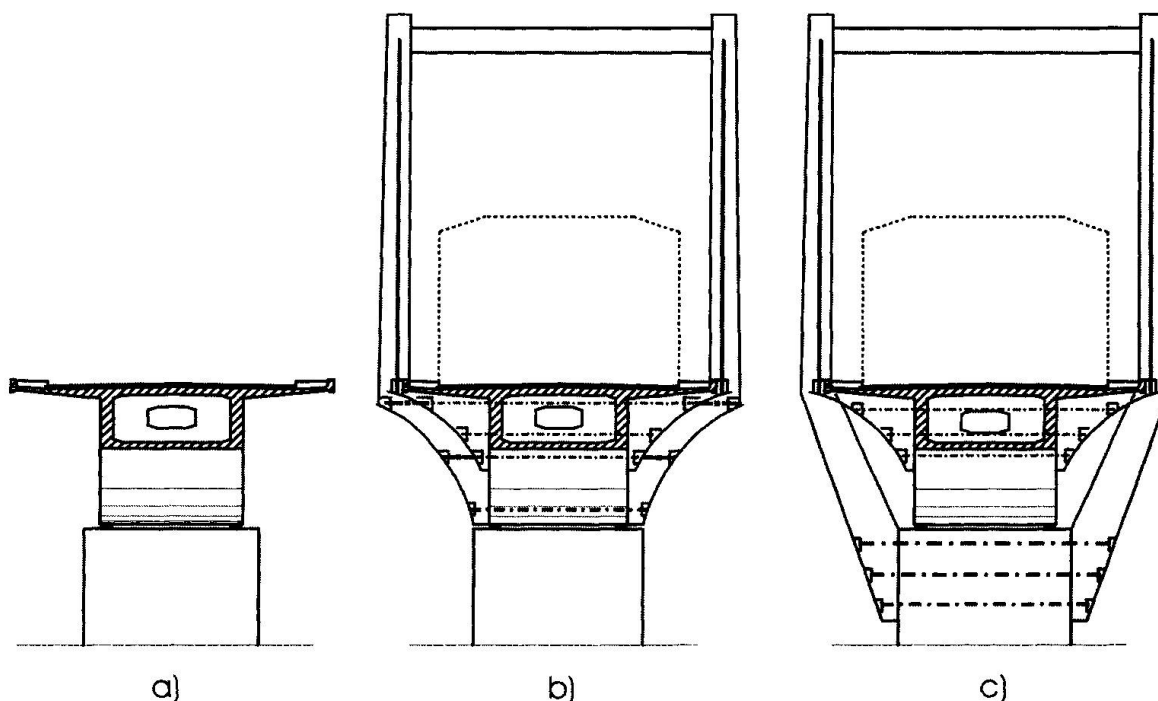
Fig.2 Bridge cross section.
a) existing bridge; b) bridge consolidated with towers supported by the superstructure;
c) bridge consolidated with towers supported by the piers.

The superstructure having a box cross section (fig. 2a) can be consolidated by cable-stayed method by building two towers. The cable anchorage towers may be supported either by the existing superstructure (fig.2b) or by the existing piers (fig.2c).

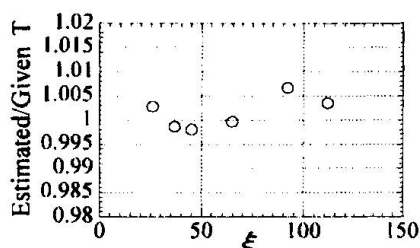
Figure 3: Precision of estimated T

Fig.3 shows the result of the experiment using a test piece of cable for the known boundary condition. The vertical axis is the ratio of the estimated tension to the measured tension by the load cell. It shows that we can identify the precision of the tension to less than 1% in this method.

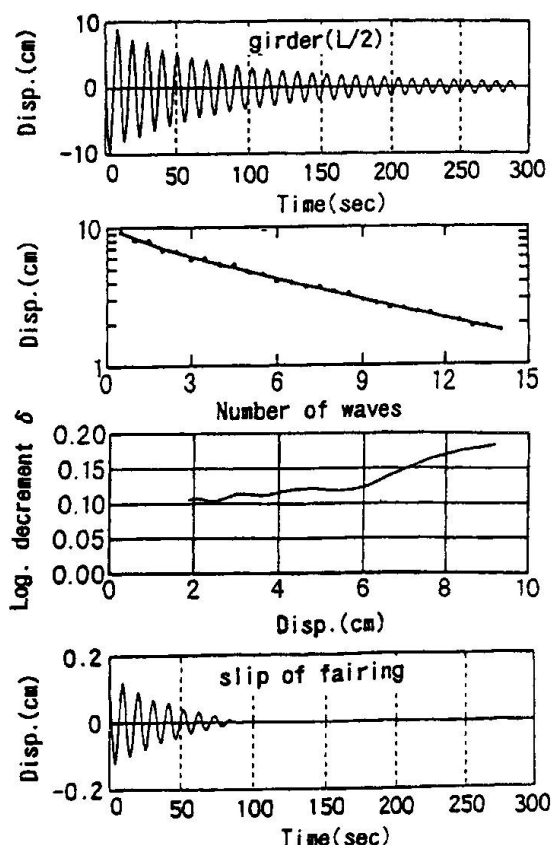
Fig.-1 Free vibration and damping

The structural damping δ in logarithmic decrement in **Table-1** were calculated using the measured free vibration data. The damping is small on the vertical bending and torsional vibrations, however, these are almost same as the wind resistant design code for Honshu-Shikoku Bridge, $\delta=0.02$. On the other hand, the damping is quite large on the horizontal bending vibration. As the reason, it is presumed that the loose-tightened bolts, installed at the edge of girder to fix the attachments such as fairings, have slipped. The free vibration of girder, the slip of fairings and the vibration dependence of damping varies are shown in **Fig.-1**. It shows that slip of fairing has an influence of the structural damping.
