**Zeitschrift:** IABSE reports = Rapports AIPC = IVBH Berichte  
**Band:** 82 (1999)  
**Rubrik:** Session 5: Observation, maintenance and repair

## Bridge Consolidation by Using Cable - Stayed Method

## Application of Simultaneous Identification of Tension and Flexural Rigidity at once to the Bridge Cables

## Dynamic Characteristics of Two Newly Constructed Curved Cable-Stayed Bridges

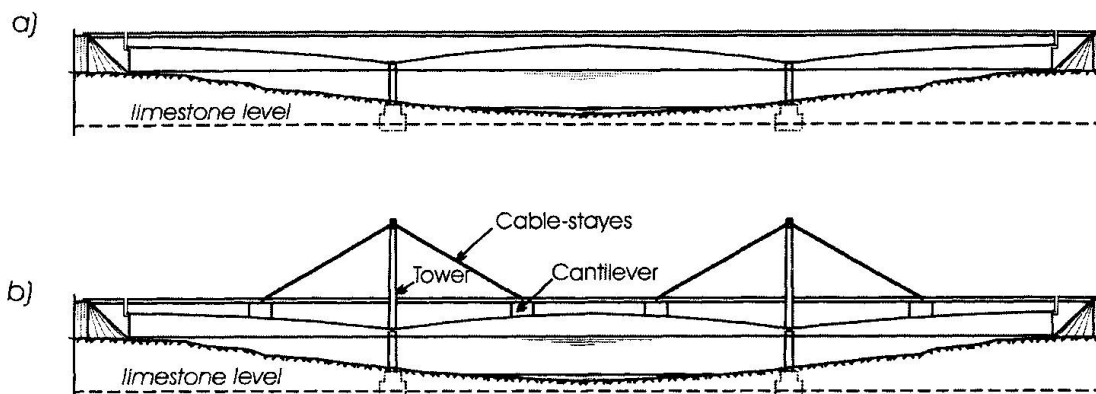
Fig.1 Elevation of a bridge with three-span continuous girders.  
a) existing bridge; b) proposed solution.

Fig. 1 and 2 present an example of a bridge consolidation.

Fig. 1 shows the elevation of a bridge having the superstructure consisting of three spans continuous prestressed concrete girders requiring only the consolidation of the superstructure.

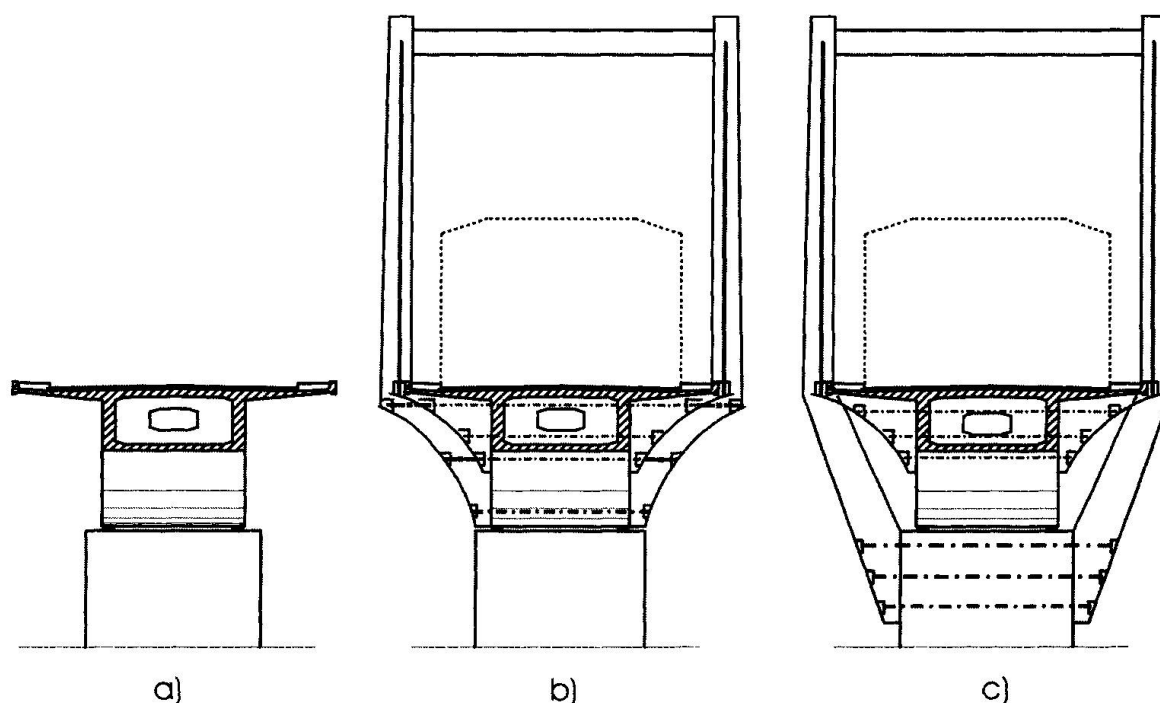
Fig.2 Bridge cross section.  
a) existing bridge; b) bridge consolidated with towers supported by the superstructure;  
c) bridge consolidated with towers supported by the piers.

The superstructure having a box cross section (fig. 2a ) can be consolidated by cable-stayed method by building two towers. The cable anchorage towers may be supported either by the existing superstructure (fig.2b) or by the existing piers (fig.2c).

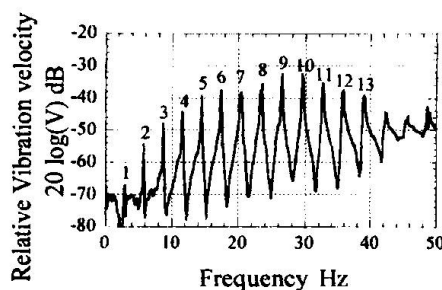
Figure 1: Frequency analysis of cable vibration

A new vibration method to simultaneously identify the tension  $T$  and the flexural rigidity  $EI$  of the cable is examined. This vibration method using natural frequencies of the cable's bending vibration is used for measuring the tension of the cable during erection of cable-stayed bridges. In the practical equation of the usual vibration method, the tension of the cable is estimated by using the first or second natural frequency. In this new vibration method, the plural higher mode natural frequencies, which are usually ignored, are raised by hammer striking, and using their frequencies the tension and the flexural rigidity are identified simultaneously. (Picture1, Fig.1)

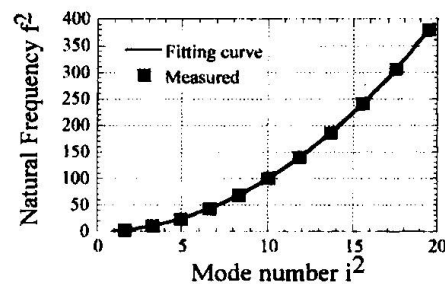
Figure 2: Least-squares fitting for natural frequencies

In this equation the square of the natural frequency can be written as a function of the fourth power of mode  $i$  plus the second power of mode  $i$ . Using this equation we can identify the tension and the flexural rigidity from the coefficient of the term of the second power or the fourth power of the mode  $i$  by least-squares fitting and the iteration technique. (Fig.2)

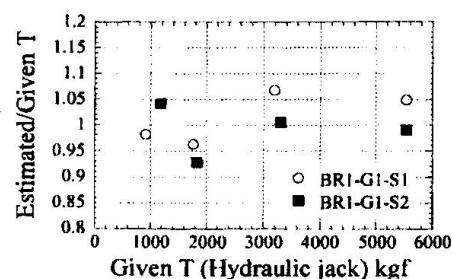
Fig.4 shows the result of the experiment with the actual bridge cable. Assuming the tension of the

hydraulic jack is correct, the precision of tension is less than 8% in this method. This result agrees with the numerical simulation. This precision is sufficient in practical use for the cable erection.

Figure 4: Precision of estimated  $T$

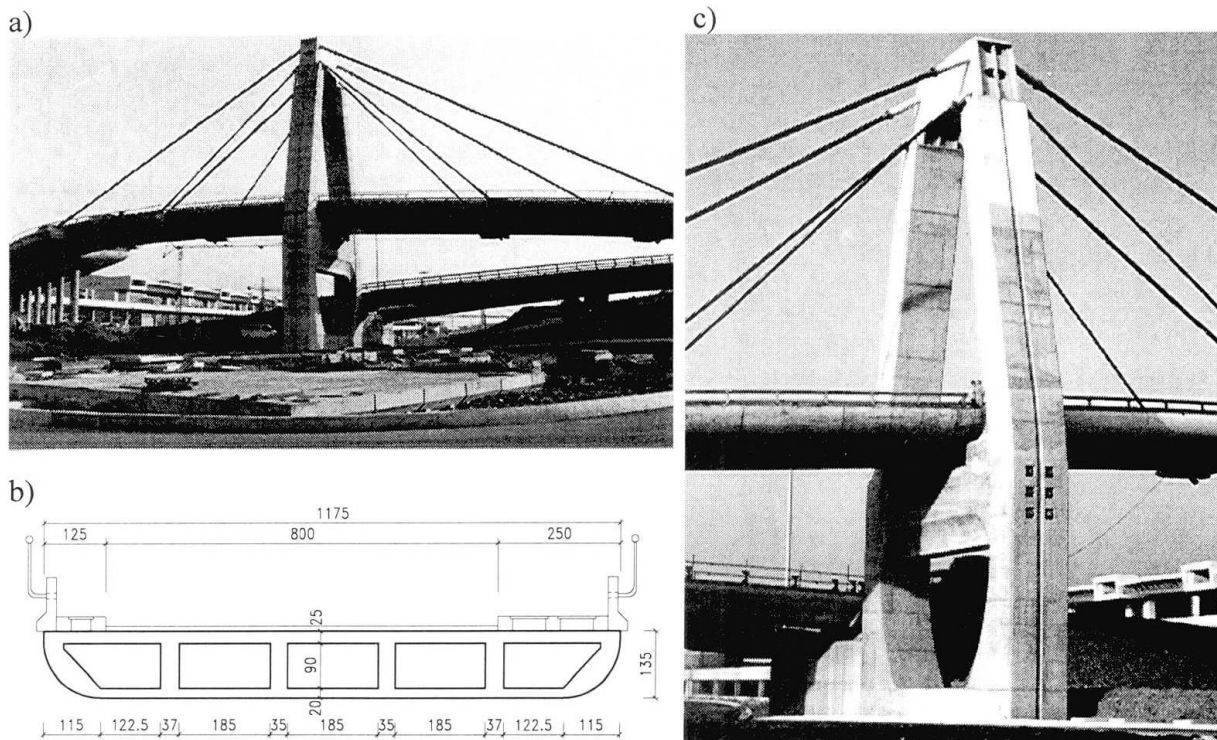
Figure 1. a) View of the north-side bridge; b) Cross-section; c) View of the tower

Theoretical and experimental investigation of a couple of curved cable-stayed bridges is described in the paper. The analysed bridges (Fig. 1) were recently erected in Italy and are part of the road system carrying the traffic to the air terminal of the Malpensa 2000 (Milan) airport from the neighbouring highways. Each curved bridge girder has a centreline length of 140 m with two equal spans which are supported from the pylon by two sets of 2 stay cables. All the stay-cables are composed of strands having from 33 to 77 parallel wires, each of 15.7 mm (0.6" super) diameter; the shorter stays (33 wires) are 27 m long while the length of the longer ones (77 wires) is 47 m. The cast-in-place concrete tower is A-shaped and 36.87 m high. The deck is a five-cell box concrete girder (11.75 m wide and 1.35 m high) which was cast in place and post-tensioned; the girder has 6% longitudinal slope and 4% transverse slope. The design of the tested bridges follows the tendency, which is actually growing in Italy, to use cable-stayed bridges for relatively short spans (60–150 m) with limited height of the deck since this kind of structures had proved to be quite stiff for traffic loads, aesthetically appealing and relatively simple to erect in few time. It is worth underlining that the two bridges are in principle perfectly equal; furthermore, their unusual geometric layout provided a strong motivation to choose these particular systems for dynamic testing.

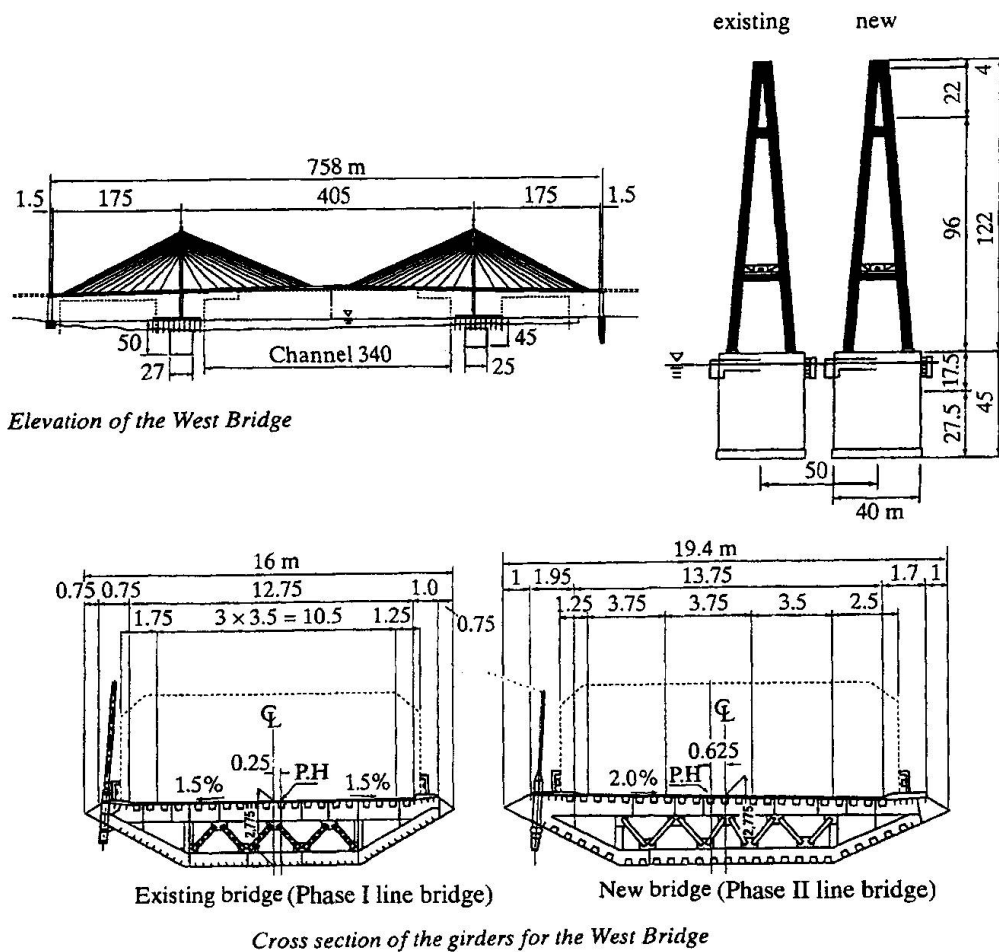
Fig.1 Outline of Meiko West Bridge

The Meiko West Bridge is composed of two cable-stayed bridges with flat box girders. The interval between parallel cable-stayed bridges is 50m as shown in Fig.1. The phase I line bridge completed in 1985 has been put in service, and the phase II line bridge was finished in 1998. Now both bridges become a part of the Ise-Bay Highway that will link the New Tomei and Meishin Expressways.

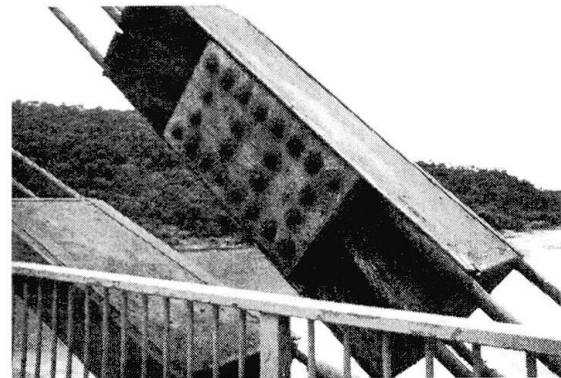
*Fig. 1 Cable Clamps*

- Shortening of stays by applying clamps to improve the vertical alignment of the bridge
- Mounting inside the bridge girder of horizontal compression steel tubes near the towers and horizontal tension cables near the middle of the bridge
- Replacement of failed friction grip bolts in the main steel boxes of the bridge girder.

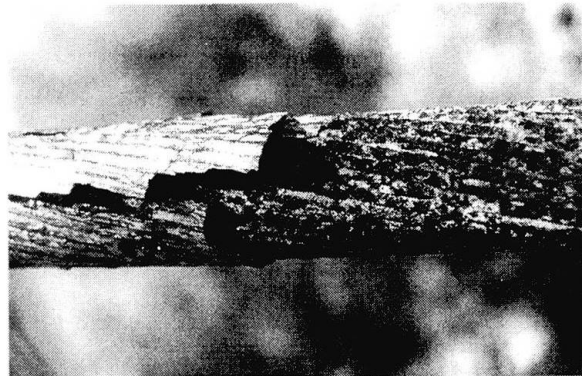
Severe pitting corrosion was found on the cable stays. The painting of the cable stays was cracked and there was virtually no adhesion to the cable surface any more.

*Fig. 2 Severe pitting of cables*

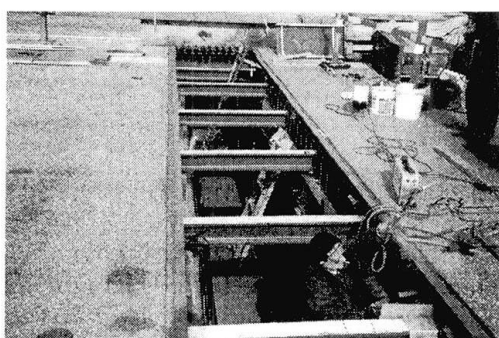
*Figure 2 Replacement of expansion joints*

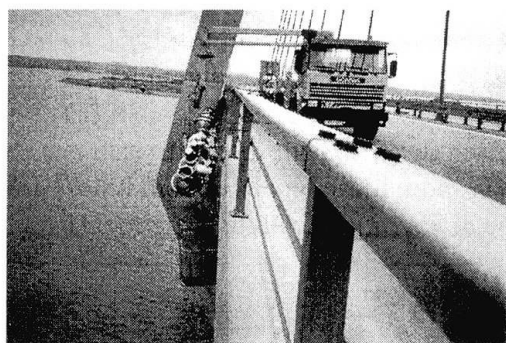
*Figure 3 Access equipment, Bucket snooper boom and Skyclimber platform*

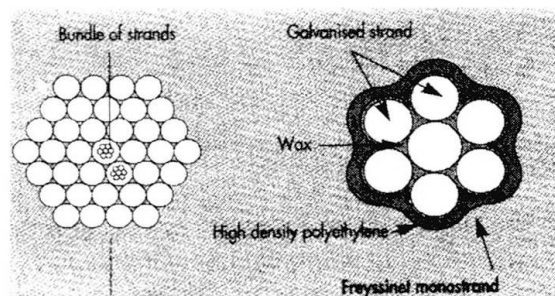
- hot dip galvanization before wire drawing ;
- extrusion around the strand of a high density polyethylene sheath (i.e. 1.5 mm thick minimum) after coating the wires with wax.

*The Freyssinet monostrand*

The stay cable system consists of parallel individually protected seven wire strands with wedge anchorages and additional corrosion protection system consisting of an outer HDPE pipe. The stay cable design is such that the replacement of any cable can be done, if required, strand by strand, in order to reduce to a minimum any traffic disruption. The anchorages are filled with wax.
