Zeitschrift: IABSE reports = Rapports AIPC = IVBH Berichte
Band: 83 (1999)
Rubrik: Session 1: Durability & robustness

Search for Quality in the Vasco da Gama Bridge Project

A description of the Vasco da Gama Bridge crossing is presented, highlighting the special design studies developed to achieve the quality standards defined for this large project.

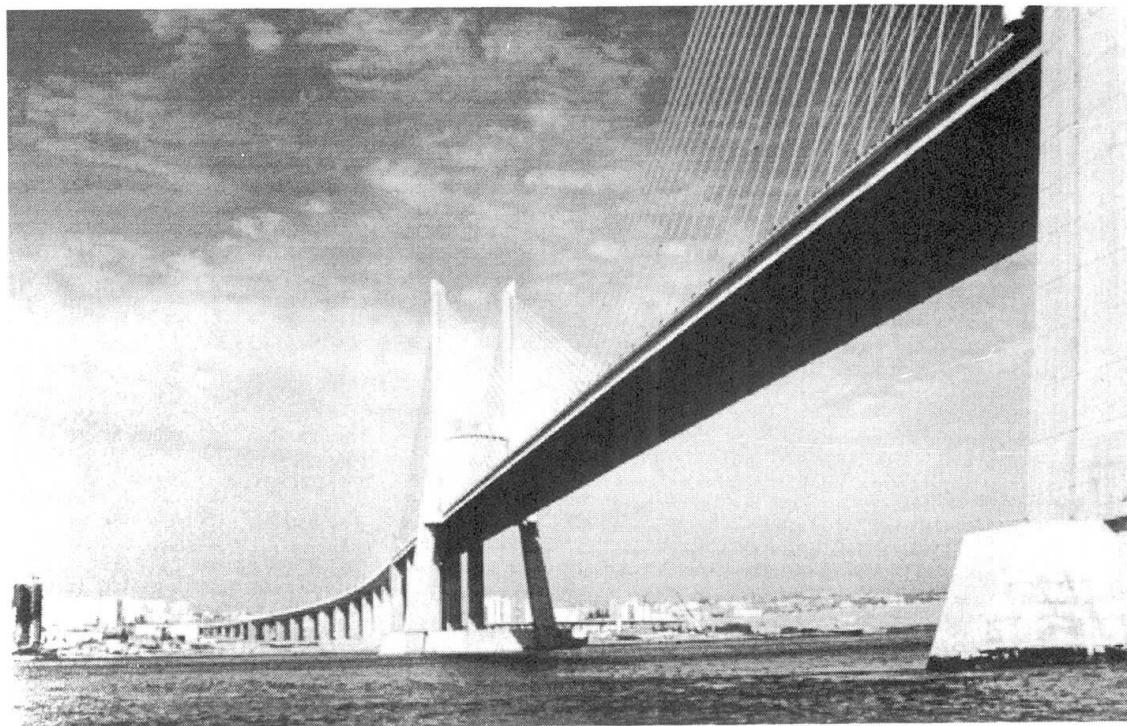
Fig.1 The Vasco da Gama Bridge

The Vasco da Gama Bridge Project consists of a 12km crossing of the Tagus River in Lisbon, being the longest bridge in Europe. This large project was developed under the supervision of a Government Office, GATTEL, who was quite active during the tender, design and construction phases, aiming to obtain a bridge with high quality standards. In this paper some of the studies developed to achieve quality in terms of structural safety, durability and aesthetics are presented.

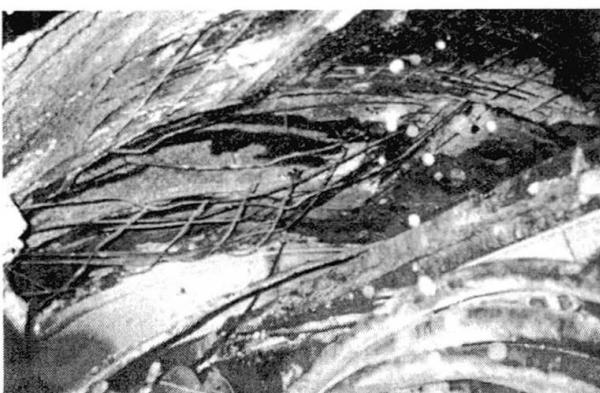
Great Belt Tunnel after a fire during construction.

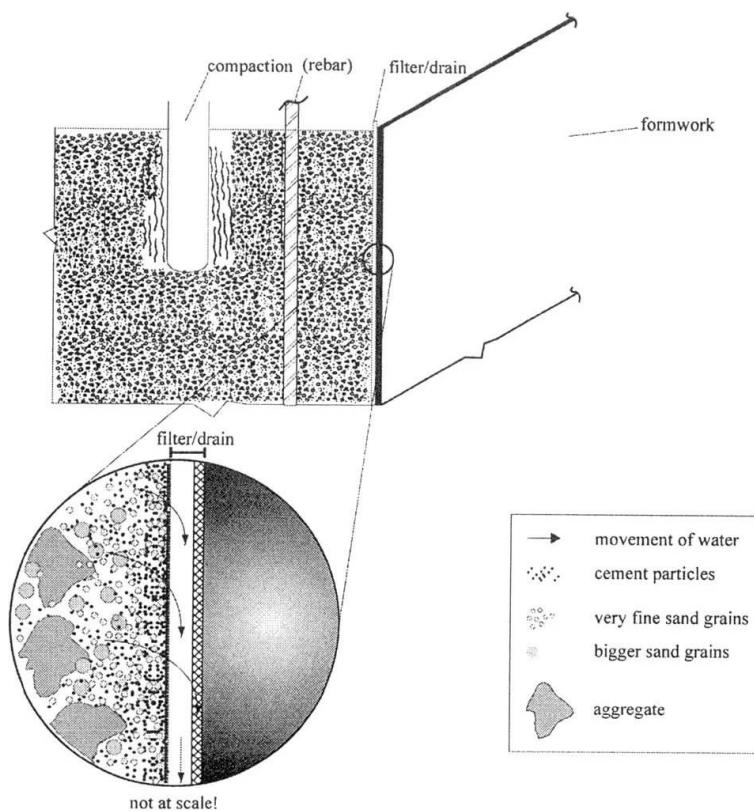
When concrete is cast, the first particles in contact with the liner cannot proceed their way through and as compaction is carried out, more and more particles are retained further and further to the inside of the surface layer of the concrete. At the same time water and air bubbles manage their way out easily.

All this process leads to a very dense outer concrete layer with a very low water/cement ratio where it is most needed - the outer layer. This is, where concrete is usually of poorer quality. If the CPF formwork is not stripped off too soon, the liner will also induce hydration as the filter makes enough water available at the right time.

Fig. 1 - Controlled Permeability Formwork - a schematic representation.

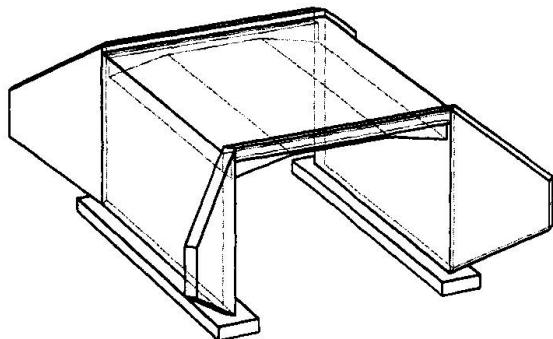
Fig. 1, Integral slab frame bridge.

For over 70 years, the integral reinforced concrete slab frame bridge, according to *Fig. 1*, has been one of the most common bridge type in Sweden. In the latter years, another integral bridge type is increasingly popular with road and railway holders, bridges with integrated abutments according to *Fig. 2*.

In Sweden there are at least 8 000 bridges out of 14 000 bridges owned by the Swedish Road Administration, of the type shown in *Fig. 1*. A great part of medium span bridges up to a total length of 80 m are now designed using integrated breast walls in principle according to *Fig. 2*. Both road and railroad bridges with composite or concrete superstructure are designed with integrated abutments. The experiences of these types of bridges are very good and the cost for maintenance is lower than for other bridge types. There is however many design problems not yet properly solved i.e.:

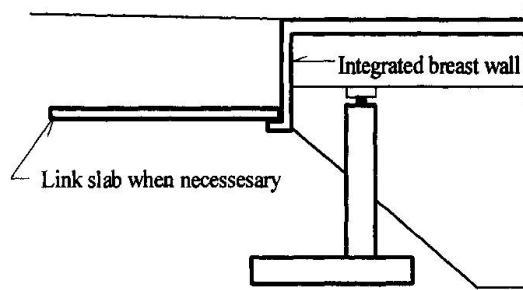
Fig. 2, Integrated breast wall.

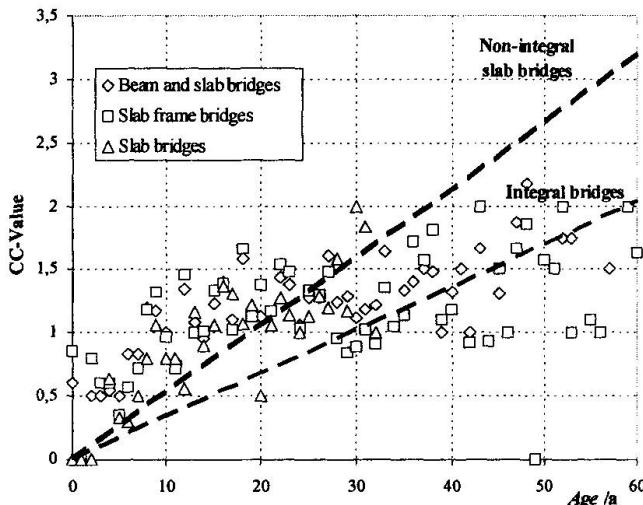
Fig. 3 Development of damage measured as the equivalent overall condition class for the three compared bridge types. The bridges of integral type slab frame bridges and beam and slab bridges compared with the non-integral type slab bridge. The evaluation shows that the integral type has a slower increase of damage than the non-integral type.

Information from elderly inspections has been collected, and put into a database called BEA (Bridge Element Analysis), Racutanu (1998). The information in the database shows how the structural members have served in time. *Fig. 3* shows an example of the development of total condition class (CC) where condition class 3 means that the bridge must be repaired immediately

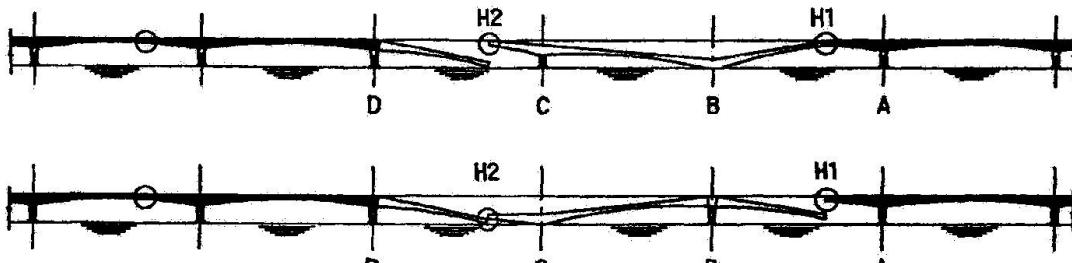
A collapse triggered by the failure of pier B or pier C should come to a halt, at the latest, at hinge H1 and at pier D (see *Fig. 1*). It is assumed that the bridge girder slides off its bearings at hinges H1 and H2 so that the vertical supports, at these locations, are lost.

Fig. 1 Working hypothesis on progressive collapse onset

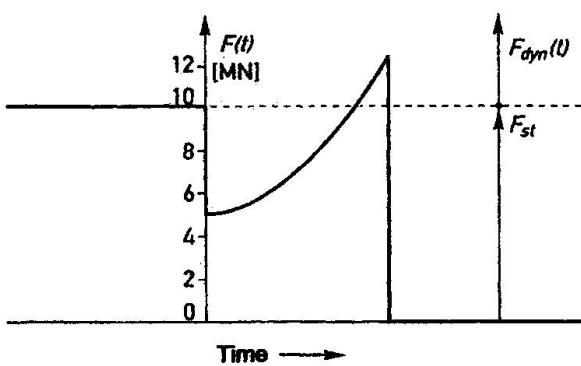
to be a sudden event. Instead, sudden loss of the opposite hinge might occur leaving the drop-in girder connected, for some time during its fall, to hinge H1. The vertical hinge force at H1, during this more gradual event, has been analyzed by establishing and solving nonlinear equations of motion (*Fig. 2*). The response of the remaining structure to this force was investigated in a linear time-history analysis and in a quasi-static plastic analysis. The latter method required determination of a dynamic amplification factor. In view of the accidental nature of the considered loading, the formation of plastic hinges was deemed allowable, and the plastic reserves of the structural system were utilized in the detailed design.

Fig. 2 Vertical force at H1

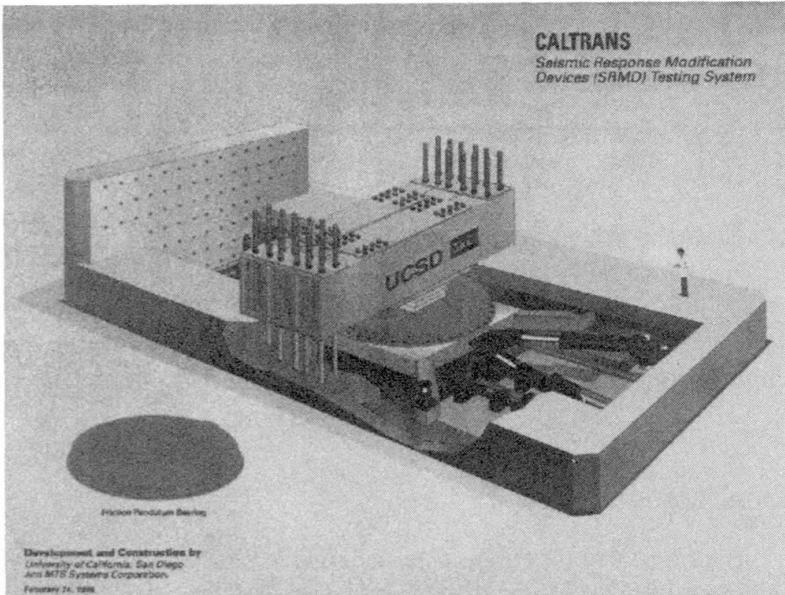
Fig 1 SRMD Test System

considered were the Friction Pendulum System (FPS) and high damping rubber or lead core elastomeric isolation bearings, proposed solutions for the Benicia-Martinez and Coronado bridges, respectively, as well as viscous dampers and lock-up devices, common to almost all the toll bridge retrofit projects. Testing objectives ranged from slow speed uni-directional testing for basic performance characterization to high speed, 3-D testing for energy based analysis. The investigation of the effect of wear and aging was also an important issue in the proposed test program, through re-characterization of the performance of the prototype SRMDs already exposed to the actual bridge loads, deformations and environmental conditions. The testing system consists of a horizontal prestressed concrete reaction frame (concrete box), and of a moving platen, connected by four horizontal actuators to the concrete box. The platen slides over four hydraulic hydrostatic low friction bearings attached to the floor of the concrete structure. The platen also extends with four steel outrigger arms that support four low friction-sliding actuators at their tops. The testing system is completed by two additional reaction structures: a steel cross beam, removable and linked to the concrete box through a tie-down rod system, and a heavily prestressed reaction wall on one end of the machine. Due to the large displacements of the test specimens in the longitudinal and transverse directions, the traditional solution of a platen with hinge connection to horizontal and vertical actuators was not practical. This configuration would have required very long stroke vertical actuators, with deep excavation inside the existing building. Space limitations, difficulties of access for tall excavating equipment and the need to maintain the rest of the existing laboratory in working condition during construction made this solution impractical. The adopted solution was the use of 4 vertical hydraulic sliding bearings which support the moving platen, apply the vertical load, and allow horizontal motion and swivel capacity with very low friction (less than 0.2% of vertical force). The four horizontal actuators have a 2.5m stroke, 800 ton capacity and dual 20m³/min. servo-valves, and the 4 vertical low friction bearing actuators have 0.25m stroke, 2,000 ton capacity and 11m³/min. servo-valves each.

Vertical Force	53,400 kN
Longitudinal Force	8,900 kN
Lateral Force	4,450 kN
Vertical Displacement	±0.127 m
Longitudinal Displacement	±1.22 m
Lateral Displacement	± 0.61 m
Vertical Velocity	±254 mm/s
Long. Velocity	±1,778 mm/s
Lateral Velocity	±762 mm/s
Height of Specimen	Up to 1.52 m
Relative Platen rot.	±2°

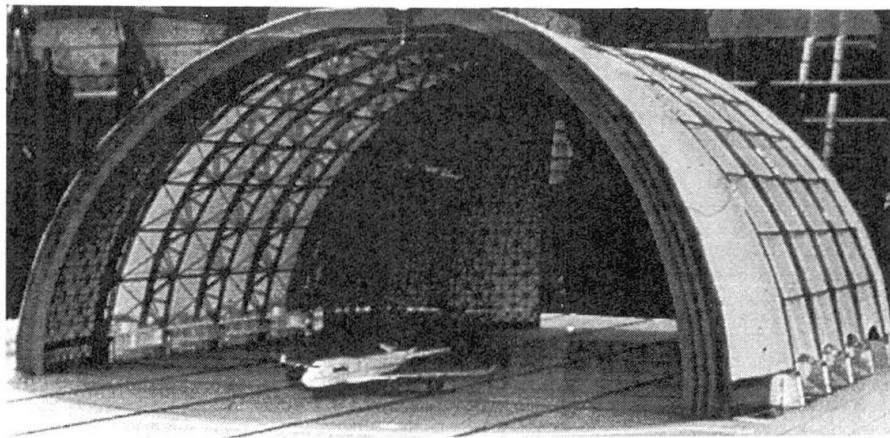
The structural concept distinguishes two main parts of the building. The central part is of a cylindrical shape consisting of five steel arches at 35 m centres - each of the four bays being covered with a textile fabric - and at both ends of the building are the doors which consist of two fixed and six moving elements. Both doors form a semi-circle in plan and a quarter-segment of a circle in elevation. The shape of the building is oriented closely on the clearance diagram for two airships. In addition, this solution is suitable to avoid excessive wind turbulence. The structure has been designed using steel grade S355.

The arches of the cylindrical part have a structural height of 8 m and span over 225 m. The top chords (diameter 559 mm) are at 3,441 m centres and the bottom chords (559 mm) at 2,0 m centre. All the chords of the truss-arch are brace-connected to each other by diagonals (355 mm) and posts (273 mm), with the exception of the two bottom-chords; these are connected by only straight members (355 mm) at 4,135 m, forming a Vierendeel-system.

Fig. 1 Perspective of the hangar (model SIAT)

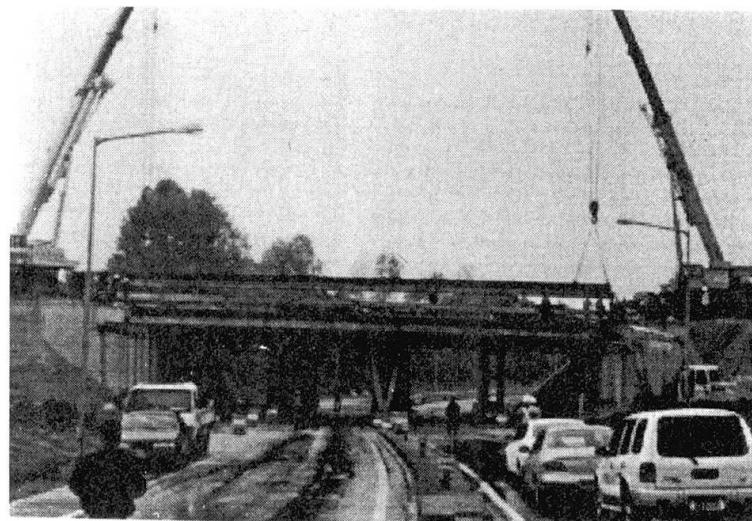
Construction site of RPF, located in Jeonju, Korea

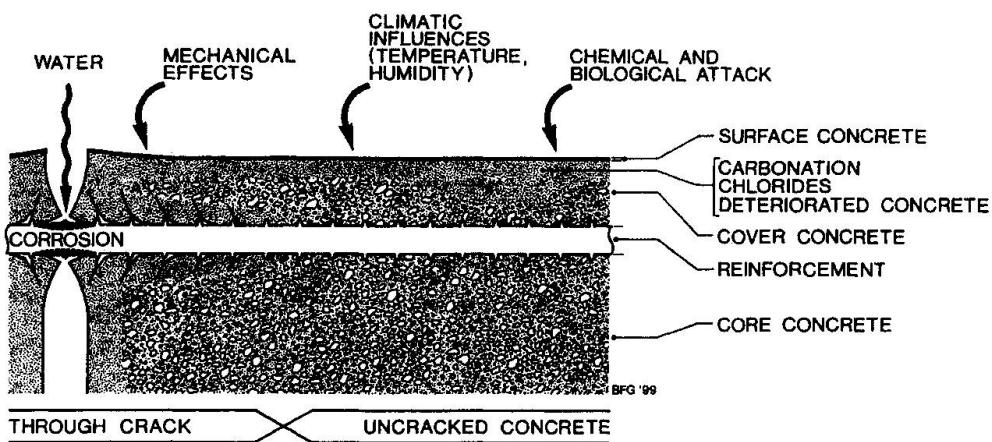
Damage to concrete structures is the result of the interaction between the material and the environment. Gas, liquid and ionic transport mechanisms play a major role in the concrete deterioration. The nature of the damage can be chemical, such as rebar corrosion or sulfate and acid attacks on cement paste, and physical, such as abrasion or freeze-thaw cycles (Fig.1). Both the quality of cover concrete and the presence of cracks (especially those which allow water seepage) have a predominant influence on the durability of a concrete structure. Concrete not only has a load bearing function, but also acts as a protective coating for the steel reinforcement.

Fig. 1 Vulnerability of reinforced concrete
