**Zeitschrift:** IABSE reports = Rapports AIPC = IVBH Berichte  
**Band:** 83 (1999)  
**Rubrik:** Session 1: Durability & robustness

## Search for Quality in the Vasco da Gama Bridge Project

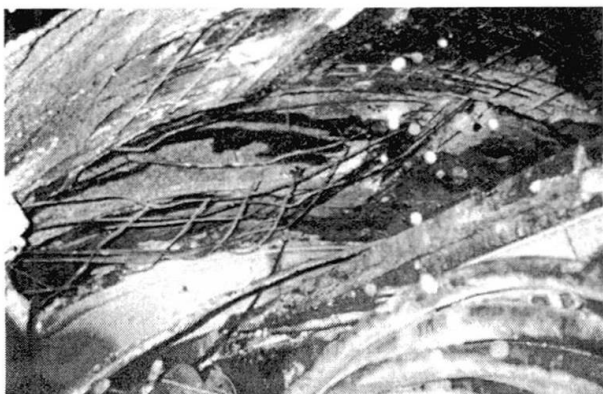
*Great Belt Tunnel after a fire during construction.*

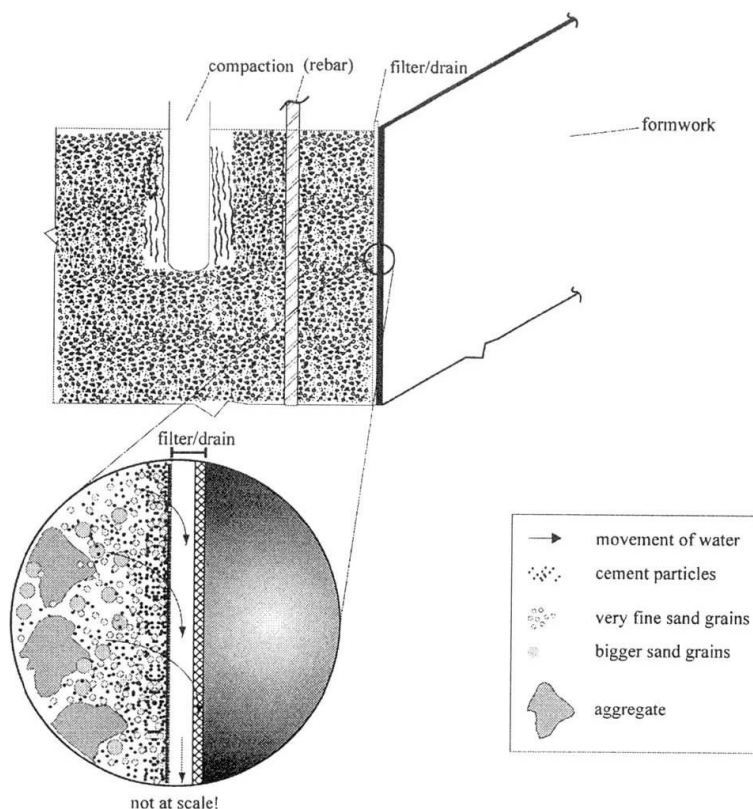
Fig. 1 - Controlled Permeability Formwork - a schematic representation.

When concrete is cast, the first particles in contact with the liner cannot proceed their way through and as compaction is carried out, more and more particles are retained further and further to the inside of the surface layer of the concrete. At the same time water and air bubbles manage their way out easily.

All this process leads to a very dense outer concrete layer with a very low water/cement ratio where it is most needed - the outer layer. This is, where concrete is usually of poorer quality. If the CPF formwork is not stripped off too soon, the liner will also induce hydration as the filter makes enough water available at the right time.

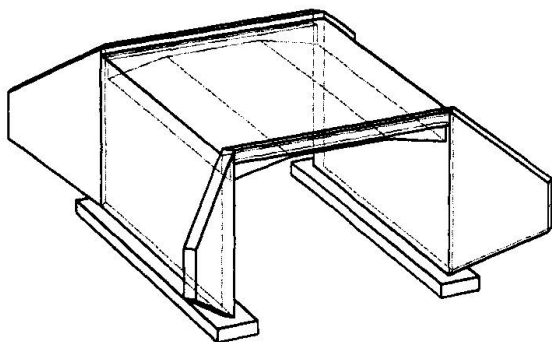
*Fig. 1, Integral slab frame bridge.*

For over 70 years, the integral reinforced concrete slab frame bridge, according to *Fig. 1*, has been one of the most common bridge type in Sweden. In the latter years, another integral bridge type is increasingly popular with road and railway holders, bridges with integrated abutments according to *Fig. 2*.

In Sweden there are at least 8 000 bridges out of 14 000 bridges owned by the Swedish Road Administration, of the type shown in *Fig. 1*. A great part of medium span bridges up to a total length of 80 m are now designed using integrated breast walls in principle according to *Fig. 2*. Both road and railroad bridges with composite or concrete superstructure are designed with integrated abutments. The experiences of these types of bridges are very good and the cost for maintenance is lower than for other bridge types. There is however many design problems not yet properly solved i.e.:

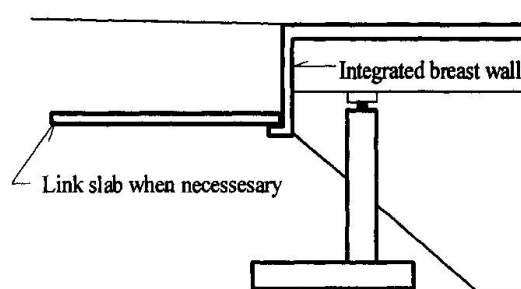
*Fig. 2, Integrated breast wall.*

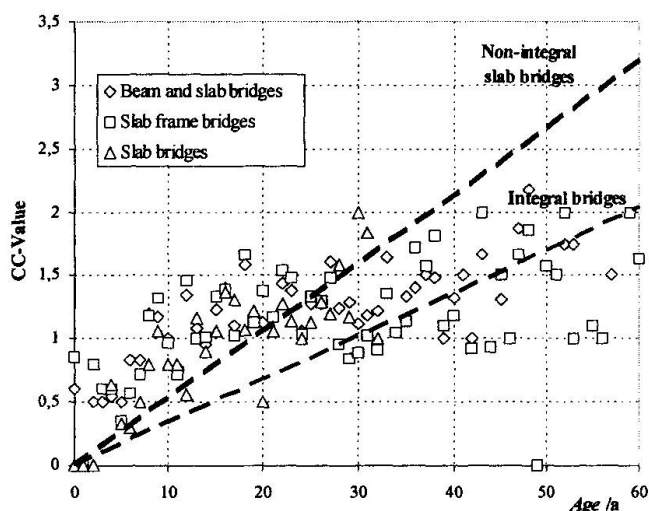
Fig. 3 Development of damage measured as the equivalent overall condition class for the three compared bridge types. The bridges of integral type slab frame bridges and beam and slab bridges compared with the non-integral type slab bridge. The evaluation shows that the integral type has a slower increase of damage than the non-integral type.

Information from elderly inspections has been collected, and put into a database called BEA (Bridge Element Analysis), Racutanu (1998). The information in the database shows how the structural members have served in time. Fig. 3 shows an example of the development of total condition class (CC) where condition class 3 means that the bridge must be repaired immediately

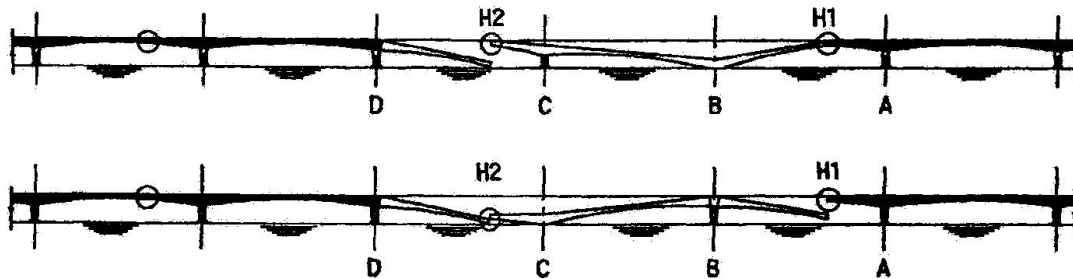
Fig. 1 Working hypothesis on progressive collapse onset

A collapse triggered by the failure of pier B or pier C should come to a halt, at the latest, at hinge H1 and at pier D (see Fig. 1). It is assumed that the bridge girder slides off its bearings at hinges H1 and H2 so that the vertical supports, at these locations, are lost.

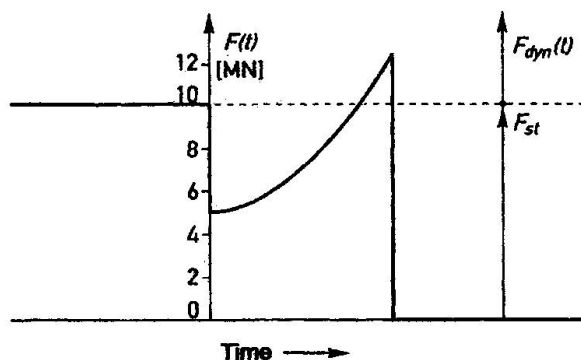
Fig. 2 Vertical force at H1

to be a sudden event. Instead, sudden loss of the opposite hinge might occur leaving the drop-in girder connected, for some time during its fall, to hinge H1. The vertical hinge force at H1, during this more gradual event, has been analyzed by establishing and solving nonlinear equations of motion (Fig. 2). The response of the remaining structure to this force was investigated in a linear time-history analysis and in a quasi-static plastic analysis. The latter method required determination of a dynamic amplification factor. In view of the accidental nature of the considered loading, the formation of plastic hinges was deemed allowable, and the plastic reserves of the structural system were utilized in the detailed design.

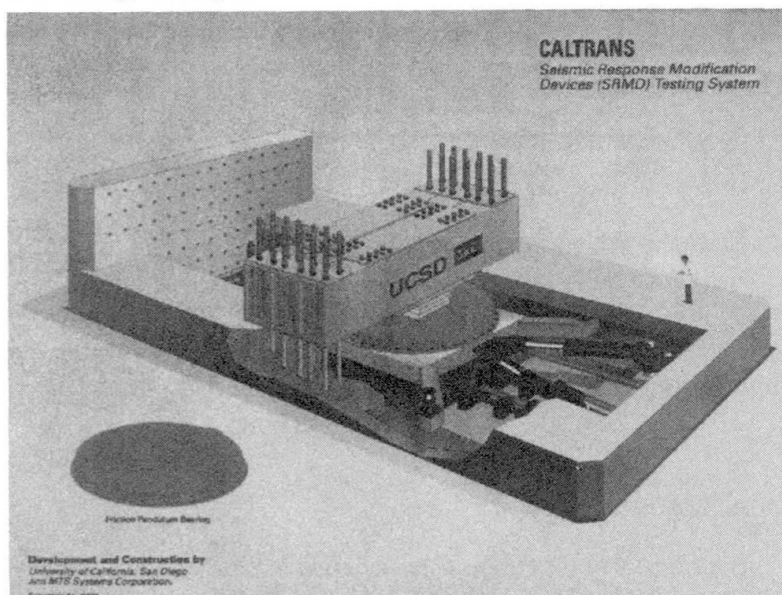
Fig 1 SRMD Test System

The Caltrans Seismic Response Modification Device Test System (SRMD), developed jointly by Caltrans, UCSD, and MTS, requires an exceptional hydraulic power, equal to about 19,000 liters (5,000 gal) of oil storage and pressurization through nitrogen gas up to 34 Mpa (5,000 psi), in order to achieve the technical specifications indicated in Table 1. The machine performance, the different types of isolating devices and dampers to be tested, and the testing objectives and procedures, drove the overall design approach. The isolating devices

considered were the Friction Pendulum System (FPS) and high damping rubber or lead core elastomeric isolation bearings, proposed solutions for the Benicia-Martinez and Coronado bridges, respectively, as well as viscous dampers and lock-up devices, common to almost all the toll bridge retrofit projects. Testing objectives ranged from slow speed uni-directional testing for basic performance characterization to high speed, 3-D testing for energy based analysis. The investigation of the effect of wear and aging was also an important issue in the proposed test program, through re-characterization of the performance of the prototype SRMDs already exposed to the actual bridge loads, deformations and environmental conditions. The testing system consists of a horizontal prestressed concrete reaction frame (concrete box), and of a moving platen, connected by four horizontal actuators to the concrete box. The platen slides over four hydraulic hydrostatic low friction bearings attached to the floor of the concrete structure. The platen also extends with four steel outrigger arms that support four low friction-sliding actuators at their tops. The testing system is completed by two additional reaction structures: a steel cross beam, removable and linked to the concrete box through a tie-down rod system, and a heavily prestressed reaction wall on one end of the machine. Due to the large displacements of the test specimens in the longitudinal and transverse directions, the traditional solution of a platen with hinge connection to horizontal and vertical actuators was not practical. This configuration would have required very long stroke vertical actuators, with deep excavation inside the existing building. Space limitations, difficulties of access for tall excavating equipment and the need to maintain the rest of the existing laboratory in working condition during construction made this solution impractical. The adopted solution was the use of 4 vertical hydraulic sliding bearings which support the moving platen, apply the vertical load, and allow horizontal motion and swivel capacity with very low friction (less than 0.2% of vertical force). The four horizontal actuators have a 2.5m stroke, 800 ton capacity and dual 20m<sup>3</sup>/min. servo-valves, and the 4 vertical low friction bearing actuators have 0.25m stroke, 2,000 ton capacity and 11m<sup>3</sup>/min. servo-valves each.

Vertical Force	53,400 kN
Longitudinal Force	8,900 kN
Lateral Force	4,450 kN
Vertical Displacement	±0.127 m
Longitudinal Displacement	±1.22 m
Lateral Displacement	± 0.61 m
Vertical Velocity	±254 mm/s
Long. Velocity	±1,778 mm/s
Lateral Velocity	±762 mm/s
Height of Specimen	Up to 1.52 m
Relative Platen rot.	±2°

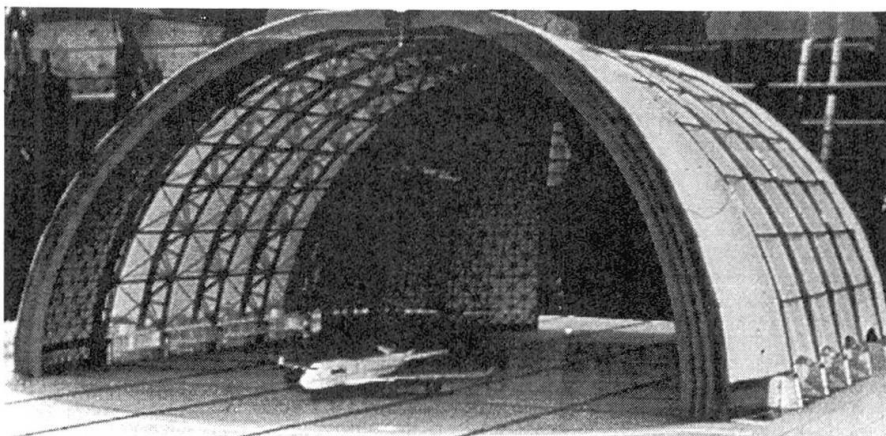
*Fig. 1 Perspective of the hangar (model SIAT)*

The structural concept distinguishes two main parts of the building. The central part is of a cylindrical shape consisting of five steel arches at 35 m centres - each of the four bays being covered with a textile fabric - and at both ends of the building are the doors which consist of two fixed and six moving elements. Both doors form a semi-circle in plan and a quarter-segment of a circle in elevation. The shape of the building is oriented closely on the clearance diagram for two airships. In addition, this solution is suitable to avoid excessive wind turbulence. The structure has been designed using steel grade S355.

The arches of the cylindrical part have a structural height of 8 m and span over 225 m. The top chords (diameter 559 mm) are at 3,441 m centres and the bottom chords (559 mm) at 2,0 m centre. All the chords of the truss-arch are brace-connected to each other by diagonals (355 mm) and posts (273 mm), with the exception of the two bottom-chords; these are connected by only straight members (355 mm) at 4,135 m, forming a Vierendeel-system.

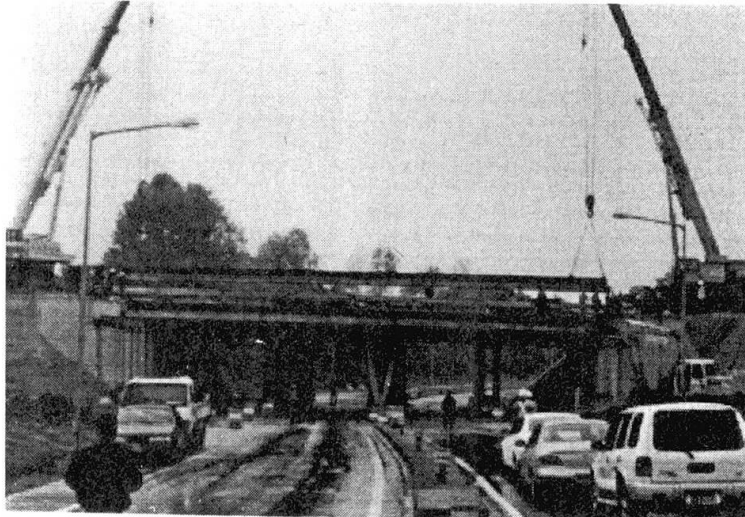
*Construction site of RPF, located in Jeonju, Korea*

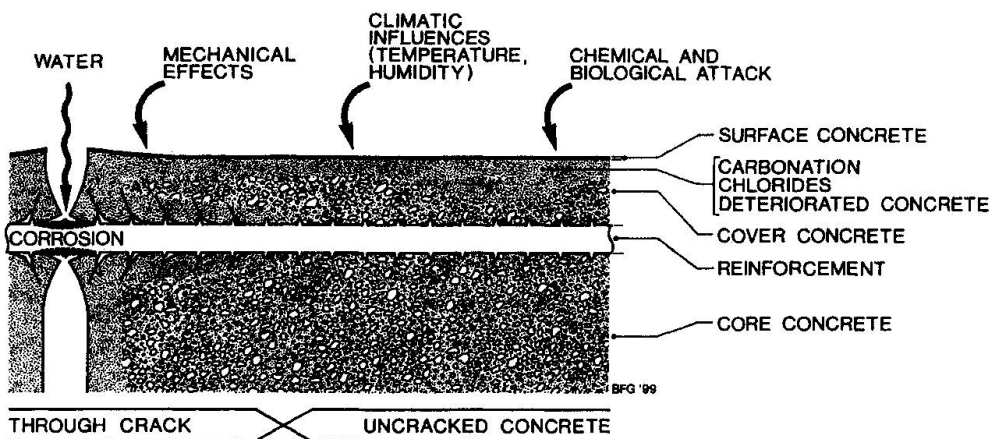
*Fig. 1 Vulnerability of reinforced concrete*

Damage to concrete structures is the result of the interaction between the material and the environment. Gas, liquid and ionic transport mechanisms play a major role in the concrete deterioration. The nature of the damage can be chemical, such as rebar corrosion or sulfate and acid attacks on cement paste, and physical, such as abrasion or freeze-thaw cycles (Fig.1). Both the quality of cover concrete and the presence of cracks (especially those which allow water seepage) have a predominant influence on the durability of a concrete structure. Concrete not only has a load bearing function, but also acts as a protective coating for the steel reinforcement.
