Zeitschrift: IABSE reports = Rapports AIPC = IVBH Berichte
Band: 83 (1999)

Rubrik: Session 1: Durability & robustness

Search for Quality in the Vasco da Gama Bridge Project

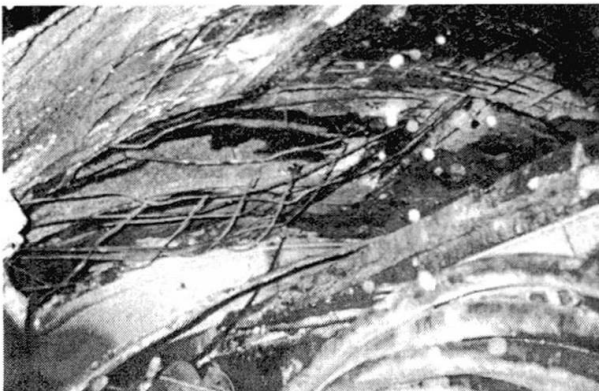
Great Belt Tunnel after a fire during construction.
