Autor(en): **Chiarugi, A. / Fanelli, M. / Giuseppetti, G.**

Zeitschrift: **IABSE reports = Rapports AIPC = IVBH Berichte**

Band (Jahr): **70 (1993)**

Diagnosis and Strengthening of the Brunelleschi Dome

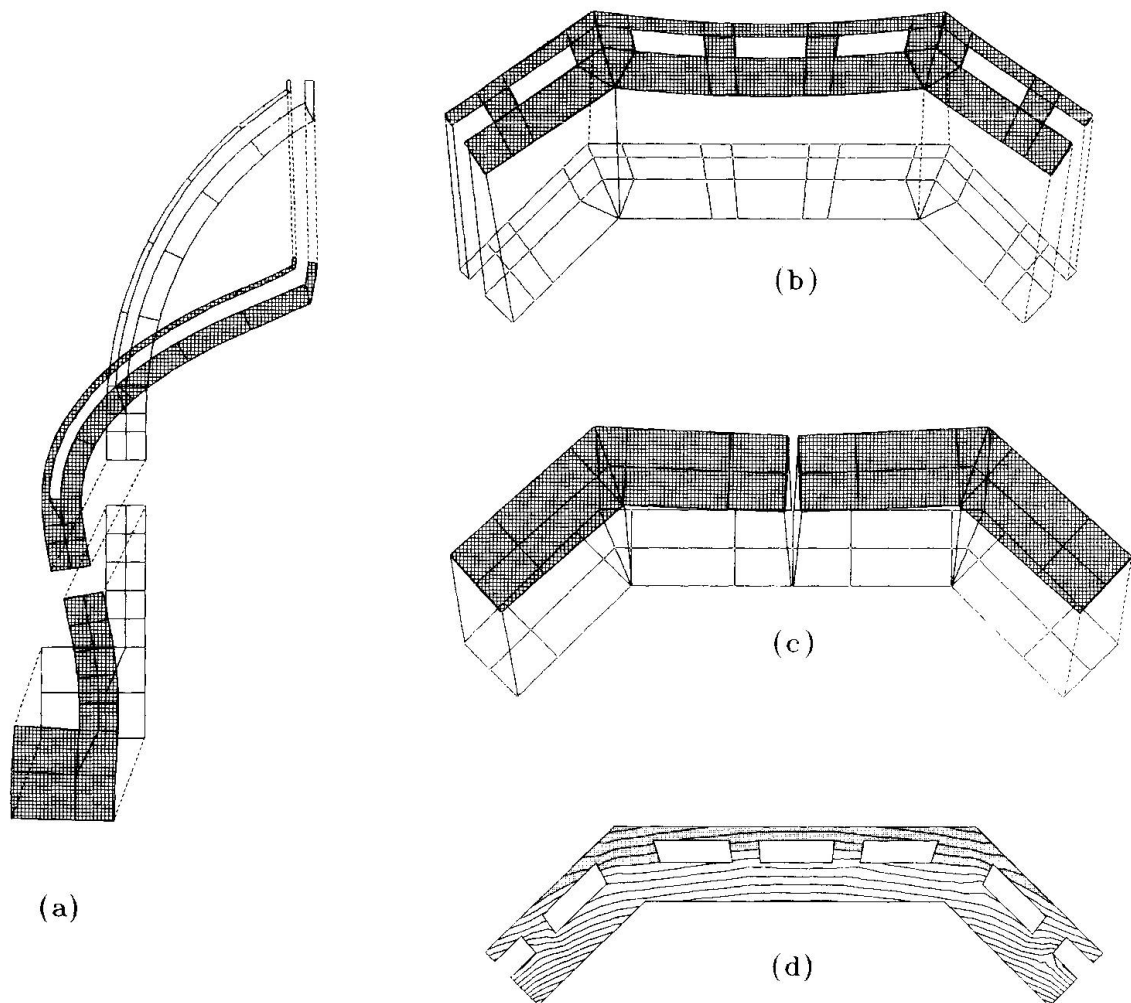
Fig. 4 "First identification model" with type A and B cracks:

- (a) deformed line of vertical section;
- (b) deformed line of section 3-3 at 66 m level
(note inflexion on the section plane);
- (c) deformed line of section under circular window
(note opening crack B);
- (d) stress distribution σ_z vertical in section 3-3
(note effects of bending with vertical tension
localized in external panels with odd numbering).
Tension zone shaded.

The results of the analysis carried out on this second model confirm the indications of the crack pattern, explaining in particular the origin of the cracks "type C and D". It is observed also that the external shell on the odd-numbered sides is subjected to vertical tensile stresses, whereas the highest level of vertical compressive stresses is found in the internal corners of cracks "type A".

This distribution of vertical stresses has been confirmed experimentally through another "continuous monitoring" operation using the flat jack technique (fig. 4 a, b, c, d; fig. 5 a, b, c).

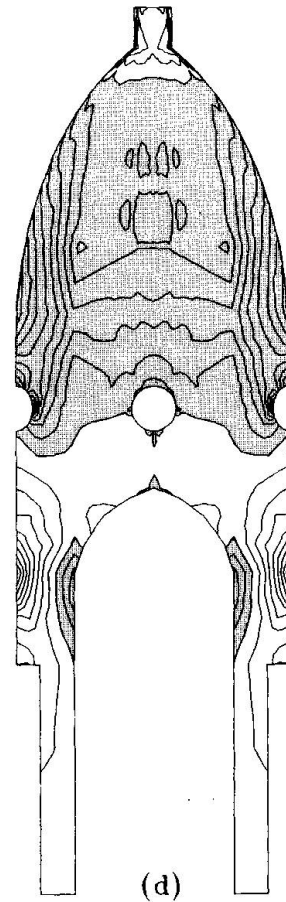
Fig. 6

"First identification model" under only strengthening effect:

- (a) deformed line of vertical section;
- (b) deformed line of section 3-3 at 66 m level;
- (c) stress distribution σ_z vertical in the section 3-3; with opponent distribution with respect to the dead-weight;
- (d) stress distribution σ_z vertical on intrados face;

Tension zone shaded.

The strengthening intervention could be effected through harmonic-steel cables placed at floor level in the first walking. The shape of these belts, pulled on at the midpoint of each side, would be octagonal; thus the interaction with the existing structure (apart from local effect) could be schematized by a system of radial forces, applied in the edges at the springing section of the dome.

Perusing the numerical simulation of this strengthening carried out on the "first-identification" model, one is surprised by the close-fitting antagonistic effect brought about by the intervention as against the dead-weight stress pattern (fig. 6 a, b, c, d).
