Artikel: Corrosion of lead sheathed cables in plastics multiway ducts : Part I

Autor: Brunold, Armin

4 Results of investigation of water and sediment samples

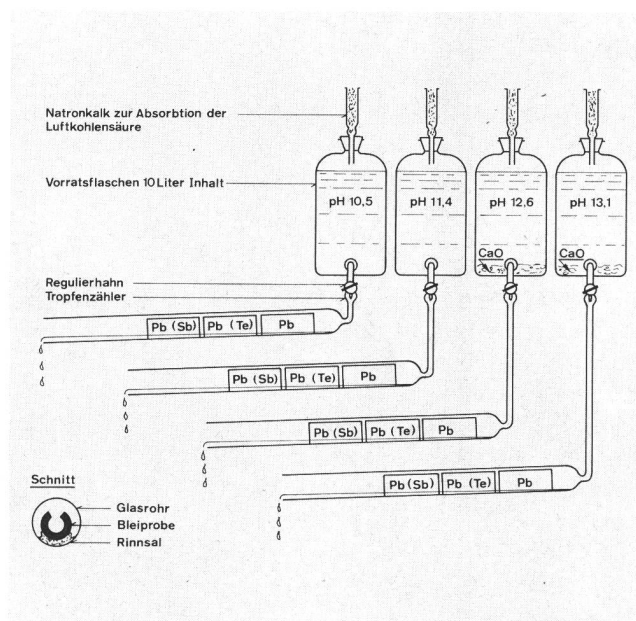
Fig. 11
Corrosion experiment with calcium solutions of different pH values
Skizze der Versuchsanordnung — Sketch of the experimental arrangement

Natronkalk zur Absorption der Luftkohlensäure — Soda lime to absorb atmospheric carbonic acid
Vorratsflaschen 10 l Inhalt — 10 l stock bottles
Regulierhahn — Stop cock
Tropfenzähler — Drop counter
Schnitt — Cross-section
Glasrohr — Glass tube
Bleiprobe — Lead sample
Rinnsal — Streamlet

For the purposes of the experiment lead strips of 100 × 30 mm and 2 mm thickness of the cable lead qualities pure lead, tellurium lead (0.04 % Te + 0.04 % Cu) and antimony lead (0.7 % Sb) were formed into small tubes of about 15 mm diameter and inserted into gently sloped glass tubes through which the corrosive solutions were fed in the form of streamlets. The experimental arrangement is sketched in Figure 11. Four calcium solutions were used with pH values of 10.5, 11.4, 12.6 and 13.1. For the two lower values, 1 n calcium acetate solution was titrated to the desired pH with 1/10 n caustic soda solution. For pH 12.6, saturated calcium hydroxide solution (slaked lime) was used and for the value 13.1 roasted lime (CaO) was slaked with 1/10 n caustic soda solution. All the solutions were produced with low

carbonic acid, desalted water and were fed in drops (10...20 drops per minute) from 10 l stock bottles into glass tubes which contained the lead samples. During the 120 day period of the experiment, 100 l of solution flowed over each of the lead samples. The surface of the lead tubes was not wetted uniformly but only in the regions of the resting surfaces just as in the case of cables lying in the plastics ducts. The corrosion pattern found after termination of the experiment was correspondingly inhomogeneous.

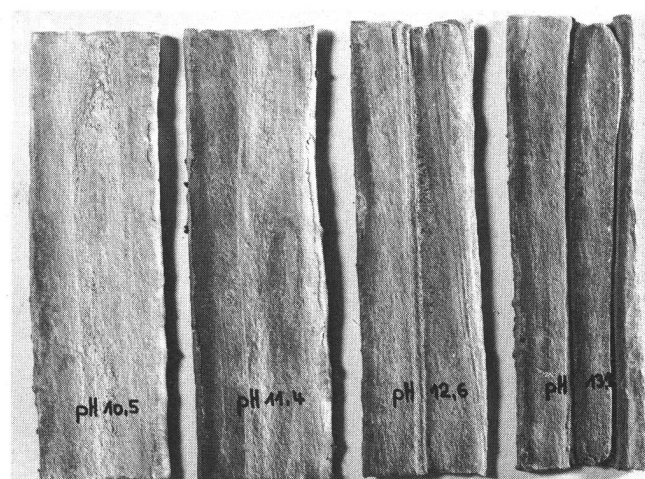
Fig. 12
Condition of the pure lead samples after termination of the experiment

The samples lay for 120 days in streamlets of calcium solutions of pH values 10.5, 11.4, 12.6 and 13.1. The two strongly basic solutions have eaten deep trenches into the lead surface while the two samples in the weakly basic solutions are only superficially corroded (half natural size)

The fact that solutions with pH values of 12.6 and 13.1 are many times more aggressive than solutions having pH values of 11.4 and 10.5 is clearly expressed in the removal rate determined as weight losses and related to the total surface. The difference in corrosivity between the strongly and weakly basic calcium solutions is seen even more impressively in the appearance of the lead samples at the end of the experiment. *Figure 12* shows the tubes of pure lead which have been slit longitudinally and then flattened into lead strips. Whereas the first two lead strips, over which the weakly basic solutions have flowed, are merely superficially discoloured

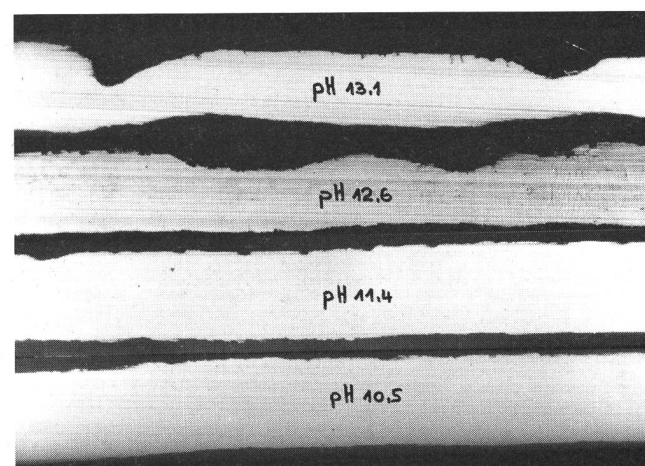
Fig. 13
Cross-sections through the lead samples illustrated in Figure 12
At pH 10.5 and 11.4 hardly any lead removal can be detected whereas at pH 12.6 and 13.1 substantial quantities of lead have been dissolved and corrosion trenches of varying depth have appeared (magnification 5.6-fold)

and covered with thin layers of white and yellow corrosion products, the other two samples, which have been rinsed by the strongly basic solutions, show deep corrosion trenches along the liquid/air boundary line. The depth of the corrosion trenches and the trough-shaped to planar lead removal zones of the lead samples exposed to the strongly basic solutions can be discerned particularly clearly in a comparison with the cross-sections depicted in *Figure 13* of the pure lead samples. There are no covering layers or deposited corrosion products present at those sites where lead has visibly been removed (in planar or trench formation). As can be seen in *Figure 14*, these sites are indeed quite bare and even appear clearly etched so that grain boundaries can be recognized. Adhering yellow and red lead oxide has been formed mainly on lead surfaces located above the flowing solution but moistened by vapour and by capillary action. In contrast, in the case of lead samples exposed to the weakly basic solutions, deposits of corrosion products appeared predominantly in the surface region rinsed in the liquid. The samples of tellurium

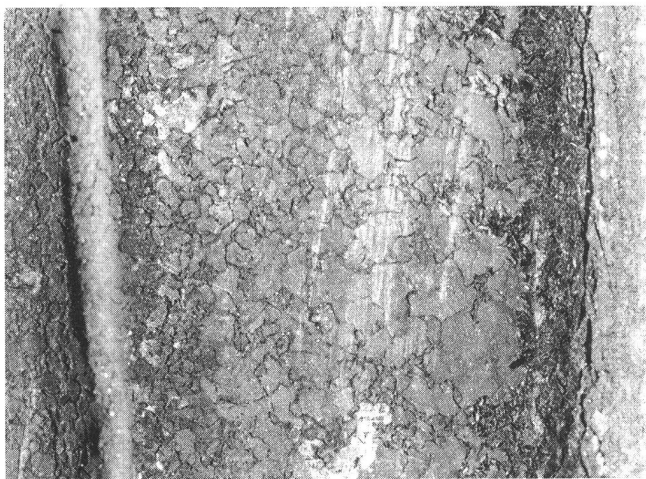
Fig. 14
There are no corrosion products on the surfaces rinsed with strongly basic solutions, indeed they have been strongly etched
As a result the grain boundaries are clearly visible in this enlarged section of the sample treated at pH 13.1 (magnification 5.1-fold)

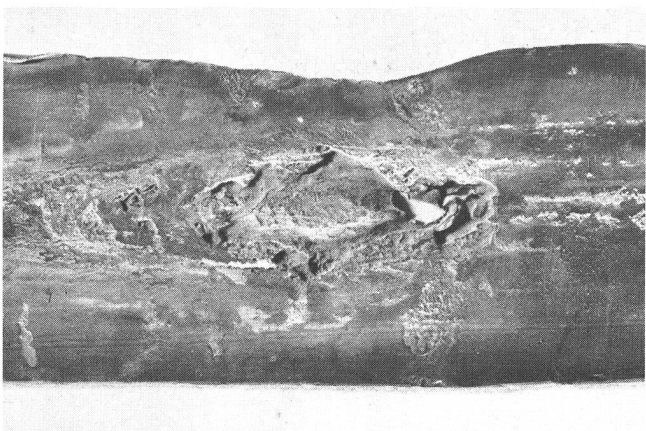
Fig. 16
Fault site in the lead sheath of a subscriber cable in the multiway duct at Arbon
The cable was in contact with the wet concrete support only over a short stretch (a few cm) so that this oval corrosion surface formed where the lead has been removed by the lime lye in trough-like and trench formations until rupture occurred (half natural size)

and Arbon in a short time (1...2 years) is especially typical of the type of corrosion caused by streamlets of strongly basic water containing calcium hydroxide. Thus, *Figure 15* shows the fault site on JC 20084 Colombier—Auvèrner and *Figure 16* shows the fault site in a subscriber cable from the Arbon installation. In both cases, deep corrosion grooves have been eaten into the lead sheath so that a rupture has finally occurred at one point. There are practically no corrosion products present and the lead sheath is completely intact, bare and free of deposits outside the corroded resting surface. The areas eaten away — deep, narrow trenches and flat troughs — have erosion type rounded edges and smooth walls as can be seen from the example in *Figure 17* of a cross-section through two adjacent corrosion grooves.

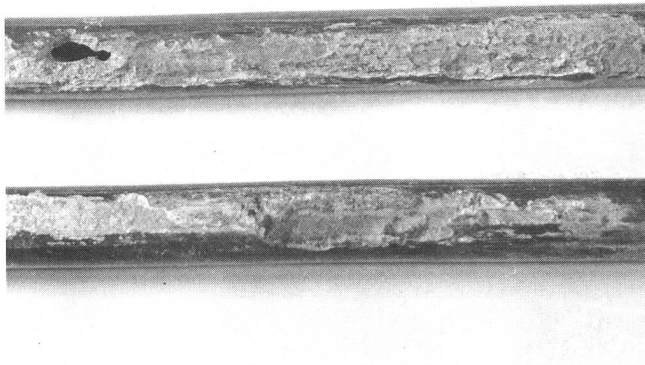
Fig. 18
Fault in a subscriber cable within a plastics duct in Eschen
 The small cable (diameter 10 mm) has been corroded along the resting surface in the form of flat, elongate troughs with rounded boundaries. The intact lead surface outside the zone of attack is covered with a thin compact layer of red lead oxide (natural size)

- A small subscriber cable within a duct in Eschen was corroded through in a similar manner after one year of operation. As can be seen in *Figure 18*, the lead sheath was again eaten away solely along the resting surface in flat, elongate trough formations with rounded boundaries. In this case, however, the intact

lead surface is covered with a thin compact red lead oxide layer (which appears dark in the picture). The resting surface being attacked over a length of about 2 m is bare and contains no deposited corrosion products.

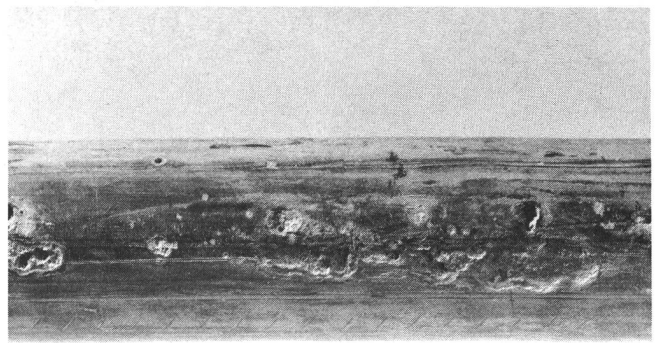
Fig. 19
Fault site in JC 20006 in a duct between Vesenz and La Capite
 In the region of the resting surface, in addition to flat, round troughs, some small areas of corrosion are present which are similar to electrolysis craters, and annular traces of white deposits can be discerned around some holes (three quarters natural size)

- Occasionally however corrosion patterns appear which at first glance are comparable to patterns arising from external current electrolysis. For example, JC 80056 in the plastics multiway duct at Altdorf and JC 20006 in a multiway duct between Vèsenz and La Capite, illustrated in *Figures 19...21*, were corroded in this fashion. The corrosion rupture occurred in 1976 after six years of operation within the duct section. The cable sheath has been eaten away in round patches at several points in the region of the resting surface along a length of about 1 m. As is shown in *Figure 19*, in addition to flat, round troughs there are some small perforations present which are like electrolysis craters and still contain some corrosion products. However, electrolysis processes caused by external currents are scarcely imaginable in plastics ducts so that we assume that the electrolytic corro-

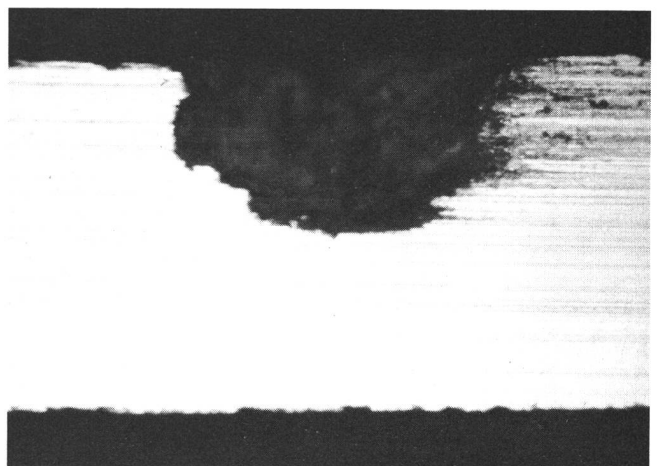
Fig. 21
 Cross-section through a crater-shaped corrosion in the lead sample illustrated in *Figure 19* (magnification 20-fold)

sion components are attributable to the formation of aeration elements or concentration chains. Cross-sections through the lead sheath also show electrolysis type craters with undercut edges (Fig. 21) in addition to the trough formations (Fig. 20) typical of cement water corrosion. Annular traces of white deposits around individual corrosion sites (barely discernible in Fig. 19) lead to the presumption that corrosion formations of this type arise if cement water reaches the interior of the plastics duct only in very small quantities and evaporates again in time.

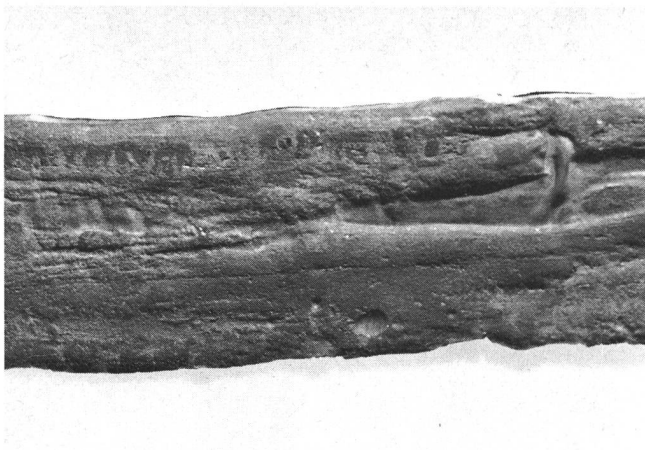
Fig. 22

Lead sheath sample from JC Wollerau—Freienbach

The whole surface is covered with a thick porous layer of lead oxide. The wall thickness of the lead sheath has been reduced throughout and large areas are present where the remaining lead sheath is only a few tenths of a millimetre thick (one third natural size)

- A completely different corrosion pattern appeared in the lead sample shown in *Figure 22*. This cable sheath section of antimony alloyed lead (0,7 % Sb) comes from the plastics multiway duct at Wollerau. The lead sheath is covered over its whole surface with a thick, porous crust of red and yellow lead oxide so that the lead wall thickness is more or less reduced over the whole cable cross-section. As can be seen in *Figure 23*, the lead seam eventually tore since it was preferentially removed as a structural inhomogeneity by the attacking solution. The formation of this type of corrosion is attributable on the one hand to the fact that the cable length affected was completely flooded with basic water having a pH value of only 10.3 at the time of investigation but which must have reacted much more strongly basically from time to time as can be concluded from the lime deposits found (Fig. 10). On the other hand, antimony alloyed lead is obviously removed more homogeneously and over a wider surface area by basic water than is the case for pure lead or low alloy tellurium lead. We were able to observe this in the experiment described in Section 61.

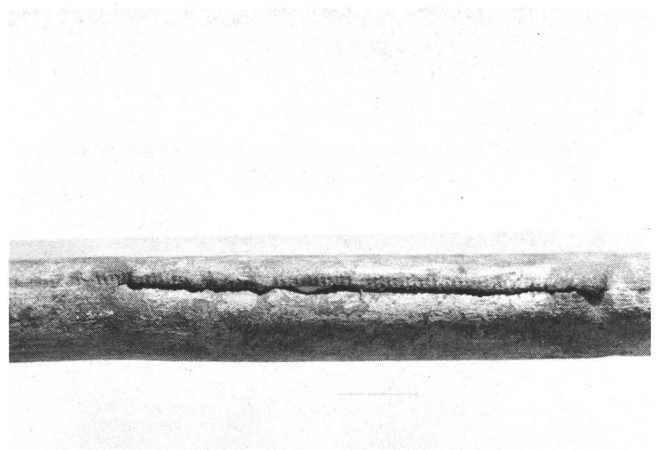
Fig. 23

Fault site of JC Wollerau—Freienbach

After the lead sheath had been removed in planar fashion to varying depths over its whole circumference, a crack finally formed in the region of the lead seam which forms a structure inhomogeneity (half natural size)
