Artikel: Corrosion of lead sheathed cables in plastics multiway ducts : Part I

Corrosion of Lead Sheathed Cables in Plastics Multiway Ducts (End)¹

Armin BRUNOLD, Berne

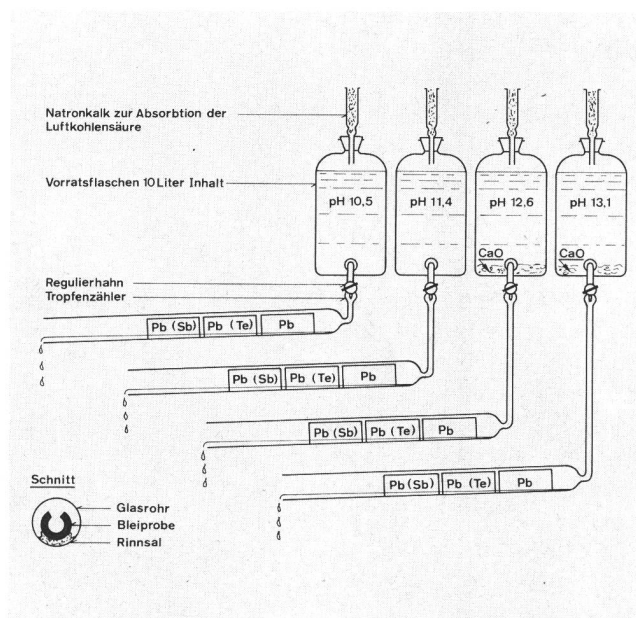
Fig. 11
Corrosion experiment with calcium solutions of different pH values
Skizze der Versuchsanordnung — Sketch of the experimental arrangement

Natronkalk zur Absorption der Luftkohlensäure — Soda lime to absorb atmospheric carbonic acid
Vorratsflaschen 10 l Inhalt — 10 l stock bottles
Regulierhahn — Stop cock
Tropfenzähler — Drop counter
Schnitt — Cross-section
Glasrohr — Glass tube
Bleiprobe — Lead sample
Rinnsal — Streamlet

For the purposes of the experiment lead strips of 100 × 30 mm and 2 mm thickness of the cable lead qualities pure lead, tellurium lead (0.04 % Te + 0.04 % Cu) and antimony lead (0.7 % Sb) were formed into small tubes of about 15 mm diameter and inserted into gently sloped glass tubes through which the corrosive solutions were fed in the form of streamlets. The experimental arrangement is sketched in Figure 11. Four calcium solutions were used with pH values of 10.5, 11.4, 12.6 and 13.1. For the two lower values, 1 n calcium acetate solution was titrated to the desired pH with 1/10 n caustic soda solution. For pH 12.6, saturated calcium hydroxide solution (slaked lime) was used and for the value 13.1 roasted lime (CaO) was slaked with 1/10 n caustic soda solution. All the solutions were produced with low

carbonic acid, desalted water and were fed in drops (10...20 drops per minute) from 10 l stock bottles into glass tubes which contained the lead samples. During the 120 day period of the experiment, 100 l of solution flowed over each of the lead samples. The surface of the lead tubes was not wetted uniformly but only in the regions of the resting surfaces just as in the case of cables lying in the plastics ducts. The corrosion pattern found after termination of the experiment was correspondingly inhomogeneous.

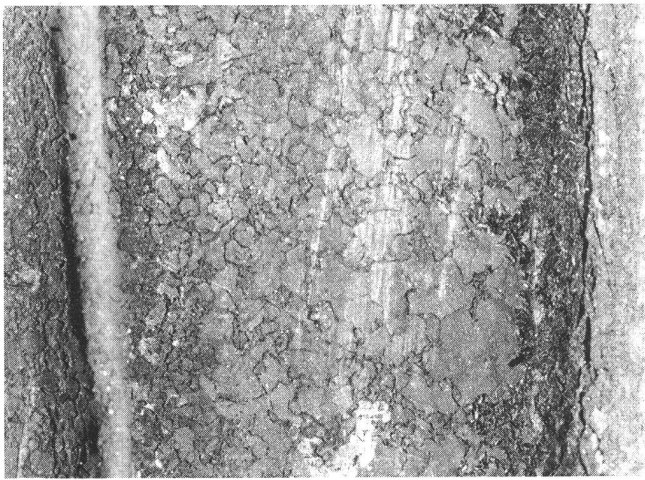
Fig. 14
There are no corrosion products on the surfaces rinsed with strongly basic solutions, indeed they have been strongly etched
 As a result the grain boundaries are clearly visible in this enlarged section of the sample treated at pH 13.1 (magnification 5.1-fold)
