Artikel: Soil erosion forms in the Simen Mountains, Ethiopia : with map 1:25000
Autor: Hurni, Hans
DOI: <https://doi.org/10.5169/seals-960247>

Soil Erosion Forms in the Simen Mountains-Ethiopia (with map 1:25 000)

By Hans Hurni*

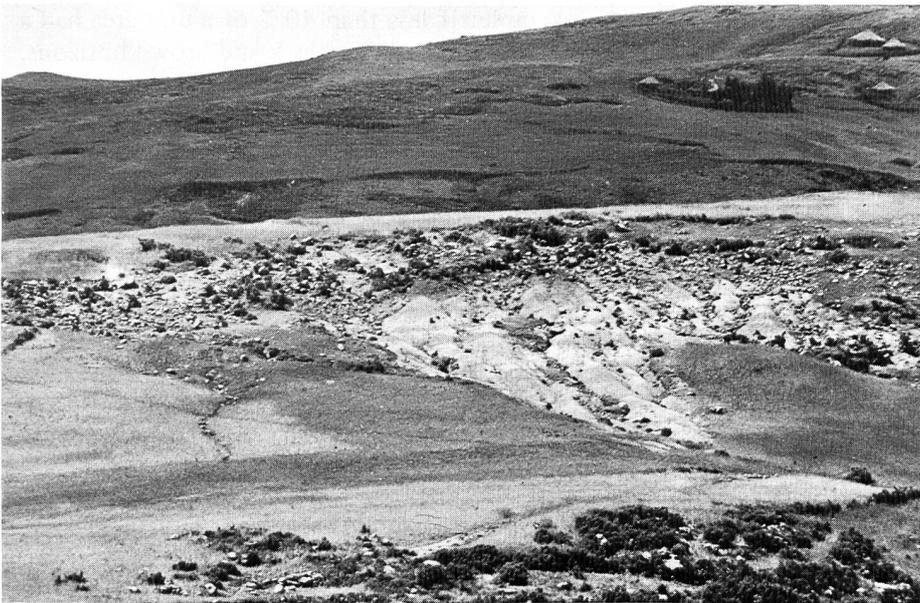
Typical Eastern-exposed slope in the Jinbar valley.

The soil is extremely damaged by soil erosion. In many places the rock is completely denuded. Gullies are numerous. Yields are minimal.

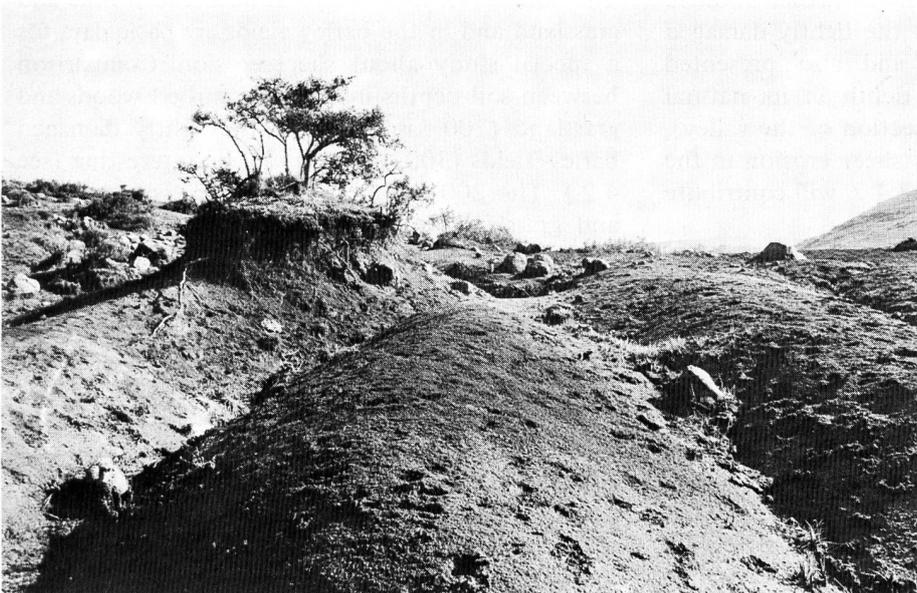
Bushes retain some earth in extremely eroded areas. On both sides of the bush, gullies are washed into the weathered basaltic rock.

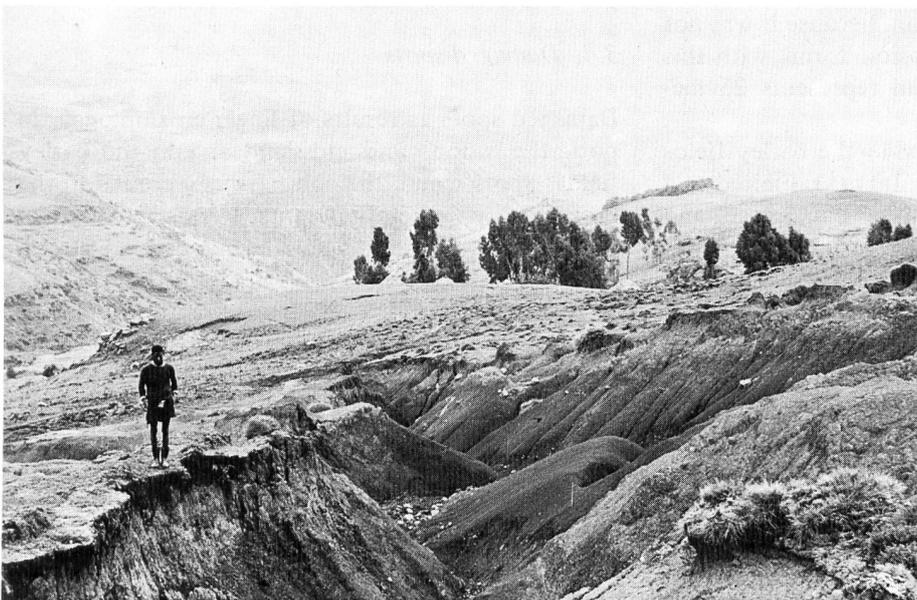
Immense gully on one of the barley fields of the Jinbar valley.
