Soil Erosion Forms in the Simen Mountains-Ethiopia (with map 1:25000)

By Hans Hurni*

Summary

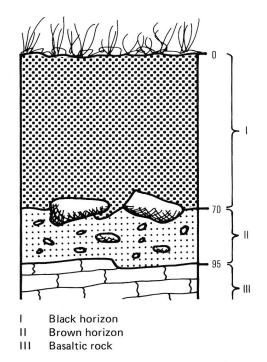
Figure 2: Ideal Profile

I Black horizon: Very fine-grained, mouldy black soil, which dries out quickly from the top in the dry season and changes to a brown colour. Many sharp cornered and rounded corns of quartz and feldspar show a secondary supply of volcanic material (ashes). The depth of the black horizon, which varies slightly with the slope form, is about 70 cm on the average.

II Brown horizon: It consists of a clayey, silty, yellowbrown matrix with a lot of stones (diameter 1-10 cm). Quartz and feldspar corns show that I and II correspond pedogenetically. The depth of the brown horizon – if existant – varies very much from a few centimeters to meters. On its top, erosion seems to have diminished the brown horizon before the uplay of the black one. Rills and gullies are proof of such an erosion phase. Since it has a lower limit at about 3000 to 3300 m above sea level and becomes deeper with higher elevation, this horizon seems to correlate with the young Pleistocene glaciation on the very tops of some Simien mountains.

III Basaltic rock: The rocky underground is weathered to a high degree, even if the porphyric texture remained. Crystals and the matrix are completely transformed into clay minerals and amorphic substance. Remnants of an old cambisol between II and III are sometimes existant.

If there were no human influence, the whole upper Jinbar valley would have had a more or less uniform soil profile. In the upper part of the valley, where only woods and grassland occur, damage by soil erosion is not apparent and therefore the soil profiles could be studied in their almost natural conditions. Results of a mineral analysis by the Department of Mineralogy, University of Berne (Prof. Peters) with soil samples by Prof. Messerli (Department of Geography, University of Berne) were available. With little restriction, the soil can be typified in an ideal profile (fig. 2 and on the map).

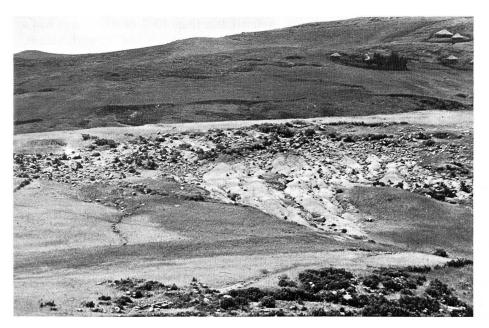
Typical Eastern-exposed slope in the Jinbar valley.

The soil is extremely damaged by soil erosion. In many places the rock is completely denuded. Gullies are numerous. Yields are minimal.

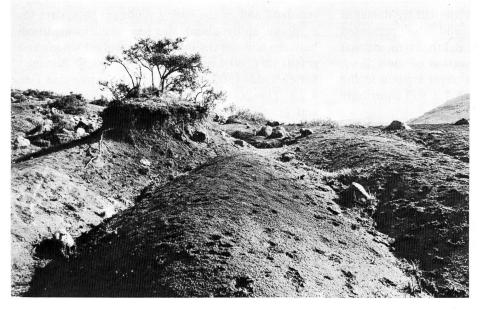
Bushes retain some earth in extremely eroded areas. On both sides of the bush, gullies are washed into the weathered basaltic rock.

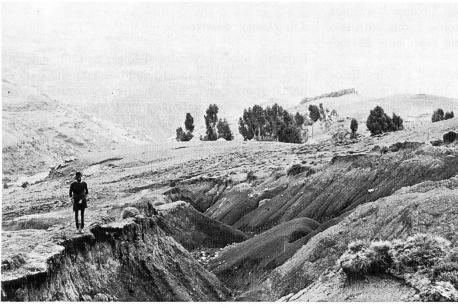
Immense qully on one of the barley fields of the Jinbar valley.
