**Artikel:** Soil erosion forms in the Simen Mountains, Ethiopia : with map 1:25000  
**Autor:** Hurni, Hans  
**DOI:** <https://doi.org/10.5169/seals-960247>

# Soil Erosion Forms in the Simen Mountains-Ethiopia (with map 1:25 000)

By Hans Hurni\*

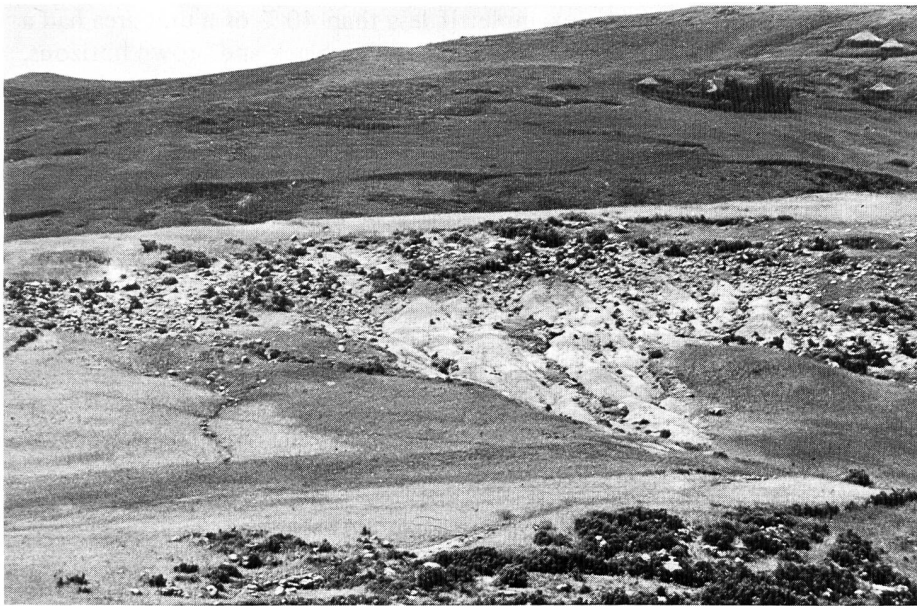
Typical Eastern-exposed slope in the Jinbar valley.

The soil is extremely damaged by soil erosion. In many places the rock is completely denuded. Gullies are numerous. Yields are minimal.

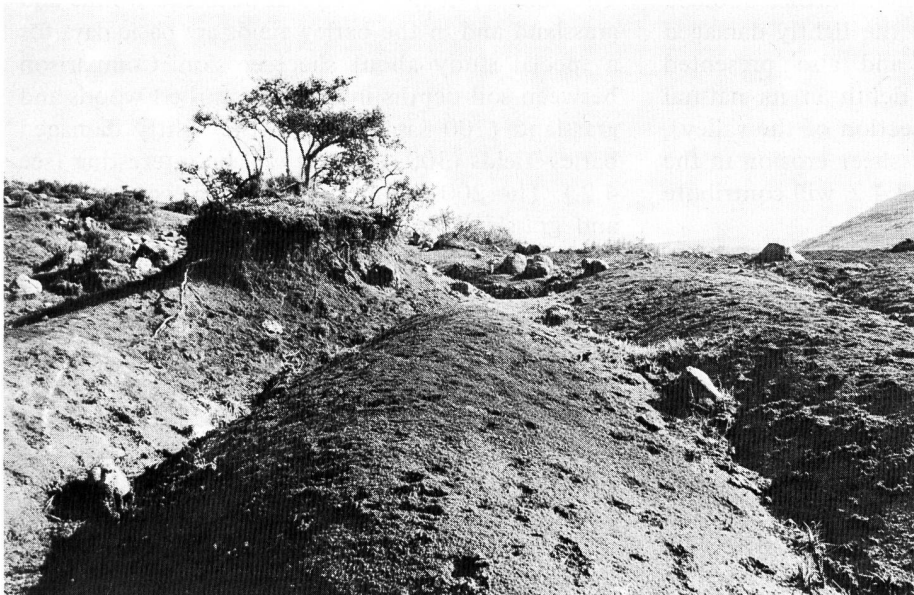
Bushes retain some earth in extremely eroded areas. On both sides of the bush, gullies are washed into the weathered basaltic rock.

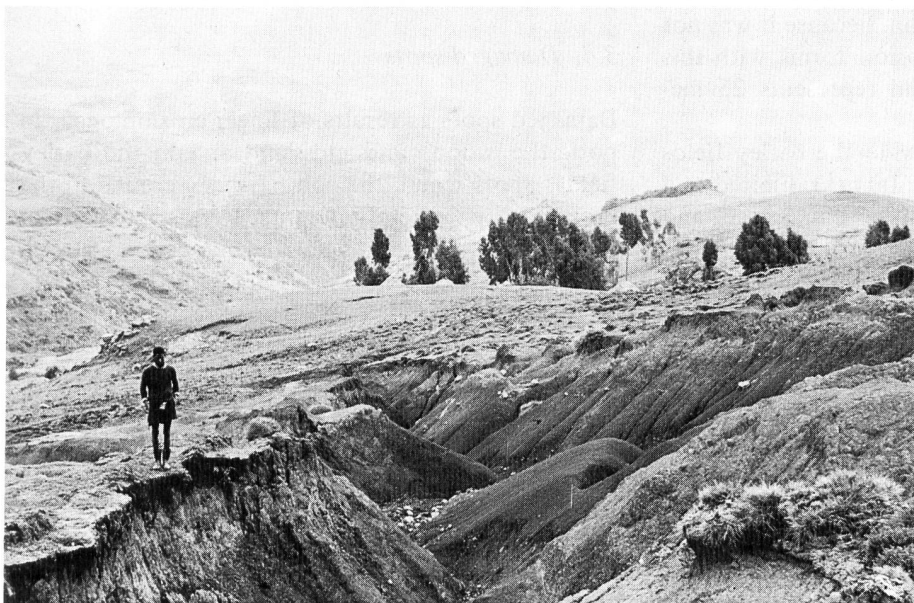
Immense gully on one of the barley fields of the Jinbar valley.
