**Artikel:** Soil erosion forms in the Simen Mountains, Ethiopia: with map 1:25000

Autor: Hurni, Hans

# Soil Erosion Forms in the Simen Mountains-Ethiopia (with map 1:25000)

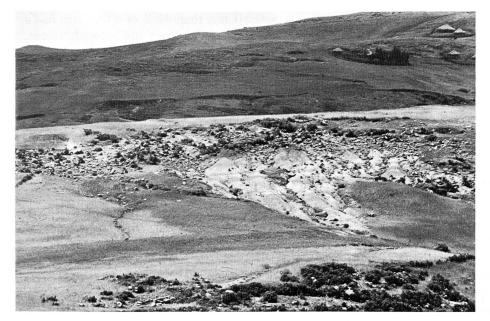
Typical Eastern-exposed slope in the Jinbar valley.

The soil is extremely damaged by soil erosion. In many places the rock is completely denuded. Gullies are numerous. Yields are minimal.

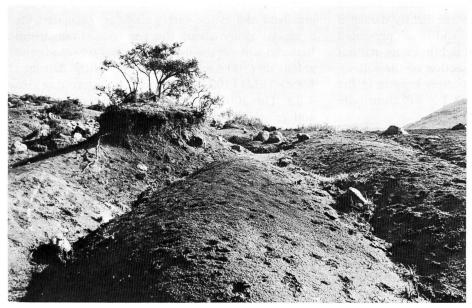
Bushes retain some earth in extremely eroded areas. On both sides of the bush, gullies are washed into the weathered basaltic rock.

Fields which can not be used for cultivation any more are left fallow. Hypericum bushes grow on the patches of soil and protect it against further erosion.

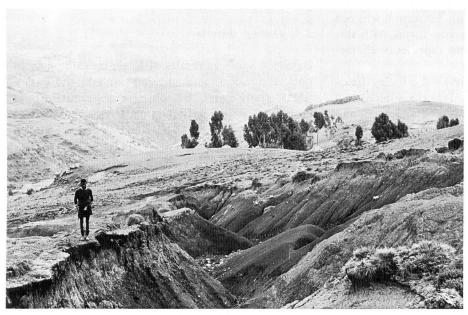
Immense qully on one of the barley fields of the Jinbar valley.
