Zeitschrift:	Beiheft zum Jahrbuch der Geographischen Gesellschaft von Bern
Herausgeber:	Geographische Gesellschaft Bern
Band:	5 (1978)
Artikel:	Soil erosion forms in the Simen Mountains, Ethiopia : with map 1:25000
Autor:	Hurni, Hans
DOI:	https://doi.org/10.5169/seals-960247

Soil Erosion Forms in the Simen Mountains-Ethiopia (with map 1:25000)

By Hans Hurni*

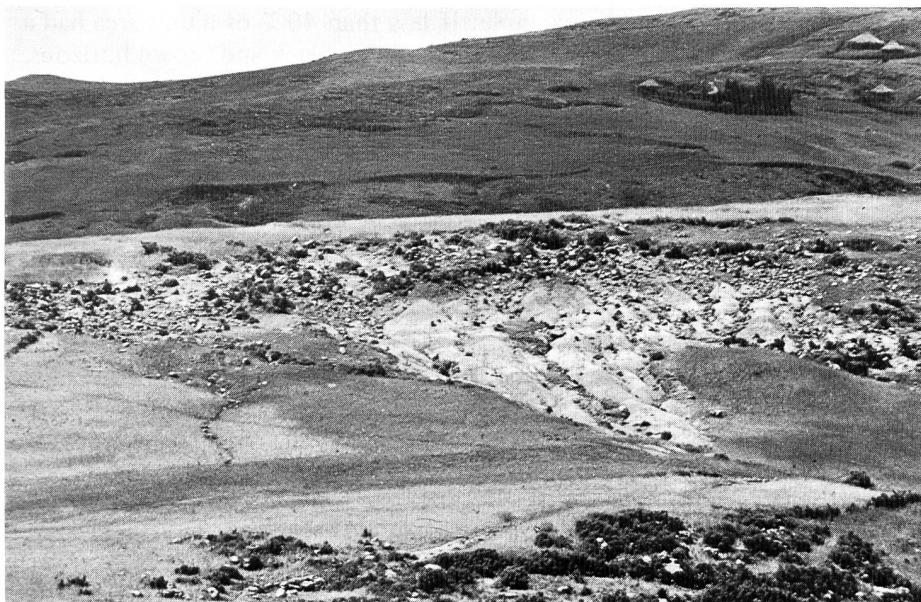
Typical Eastern-exposed slope in the Jinbar valley. The soil is extremely damaged by soil erosion. In many places the rock is completely denuded. Gullies are numerous. Yields are minimal.

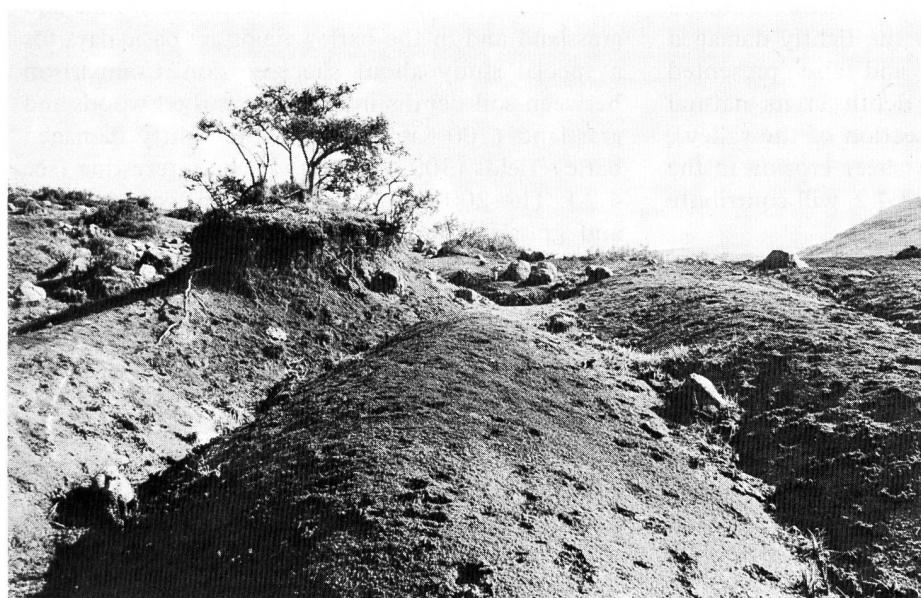
Bushes retain some earth in extremely eroded areas. On both sides of the bush, gullies are washed into the weathered basaltic rock.

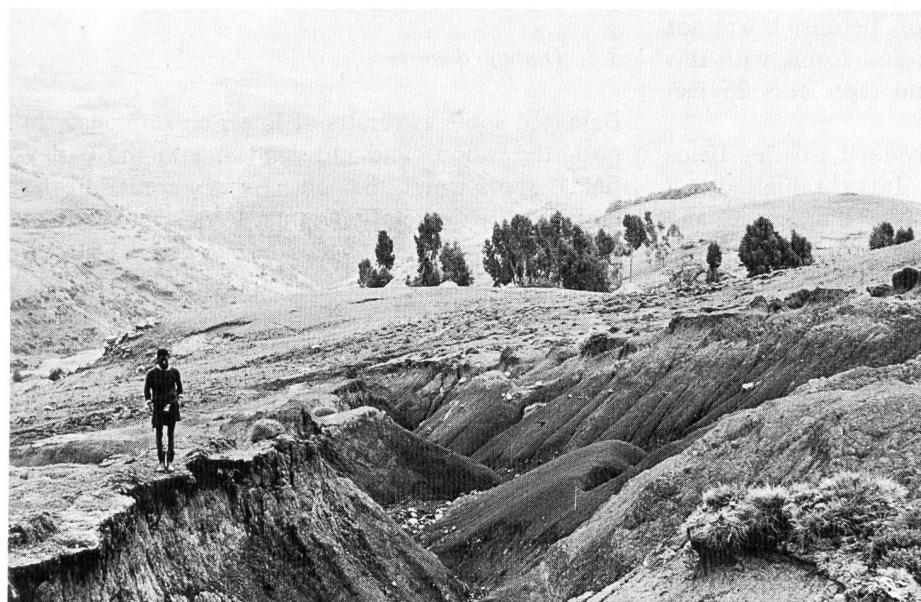
Immense gully on one of the barley fields of the Jinbar valley.
