Artikel: Salem Abbey : conservation of molasse sandstone
Autor: Kieferle, Albert
DOI: <https://doi.org/10.5169/seals-1053494>

Salem Abbey

Conservation of Molasse Sandstone

Albert Kieferle

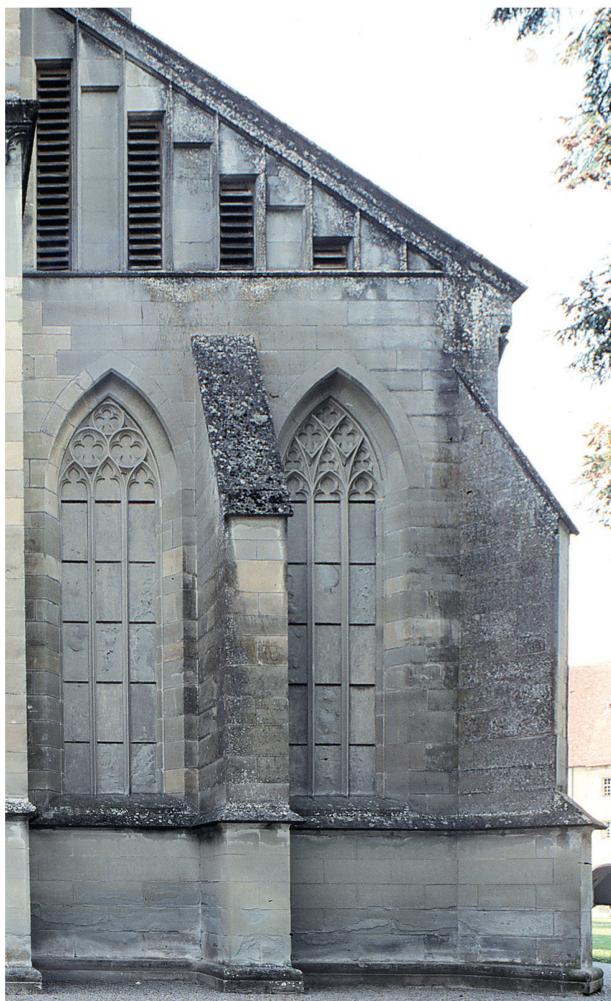
1 Eastern façade before restauration in 1992 (Photo A. Kieferle).

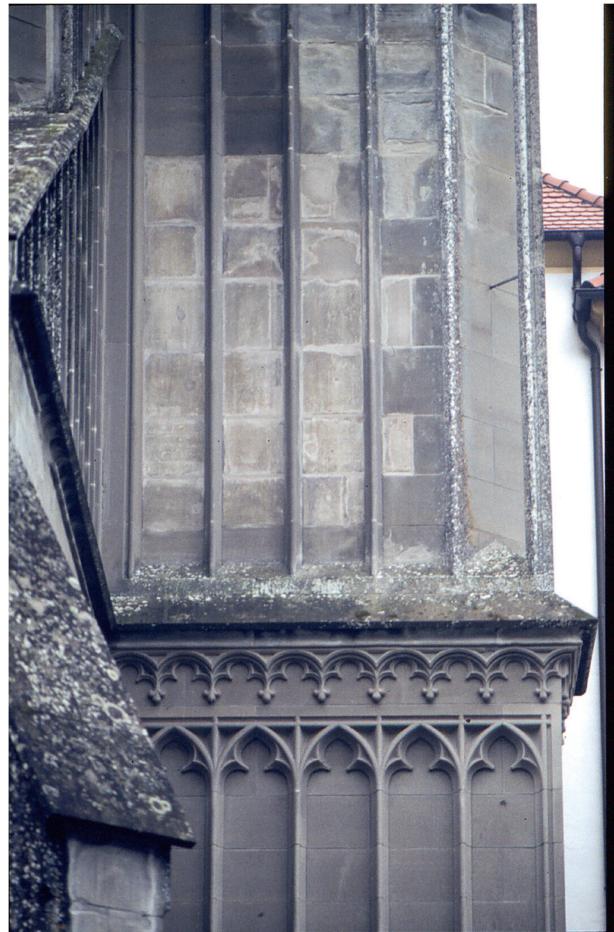
2 West façade after restauration in 2000 (Photo A. Kieferle).

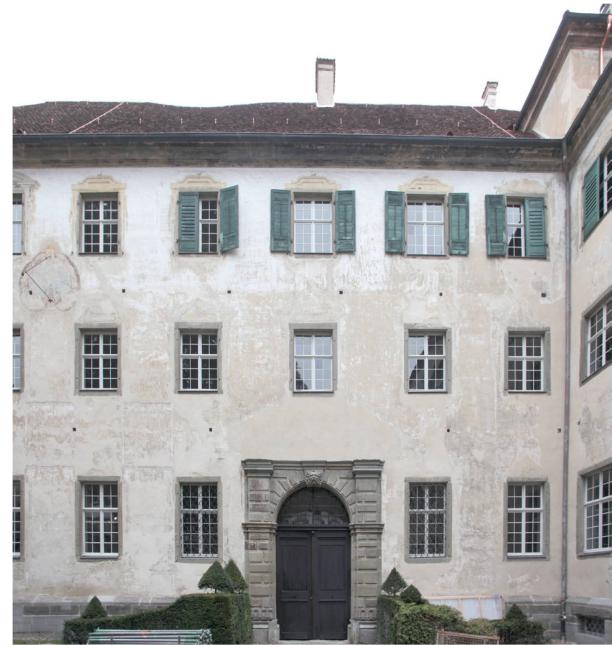
3 Façade of the eastern court (Sternenhof) after restauration 2011 (Photo AeDis).

flaking areas. The windowsills that were strongly damaged and are very much exposed to weathering were covered by sills made of lead.

Georg Schmid was the restorer mainly in charge of these works from our side. The concept for the plastering includes consolidation with silicic-acid-ester and silica-sol, reattaching of detached surfaces, filling of cracks with lime and rendering of lost areas with a mortar, closely resembling the original mortar. In the mean time four out of six facades have been treated by a large number of restorers. The conservation of the sandstone surfaces has been done by Bauer-Bornemann from Bamberg, who had already done this at the minster, as well as by Frank Eger from Balingen. The stone masonry was carried out by Eduard Schnell, Fridingen and by Johannes Abel from Auggen⁹.
