Salem Abbey

Conservation of Molasse Sandstone

Albert Kieferle

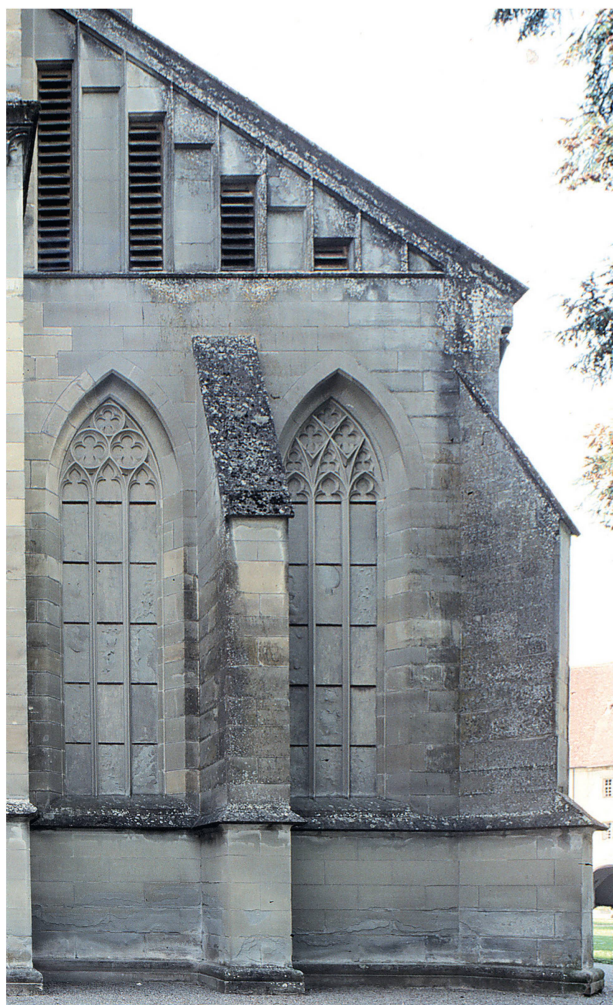
1 Eastern façade before restoration in 1992 (Photo A. Kieferle).

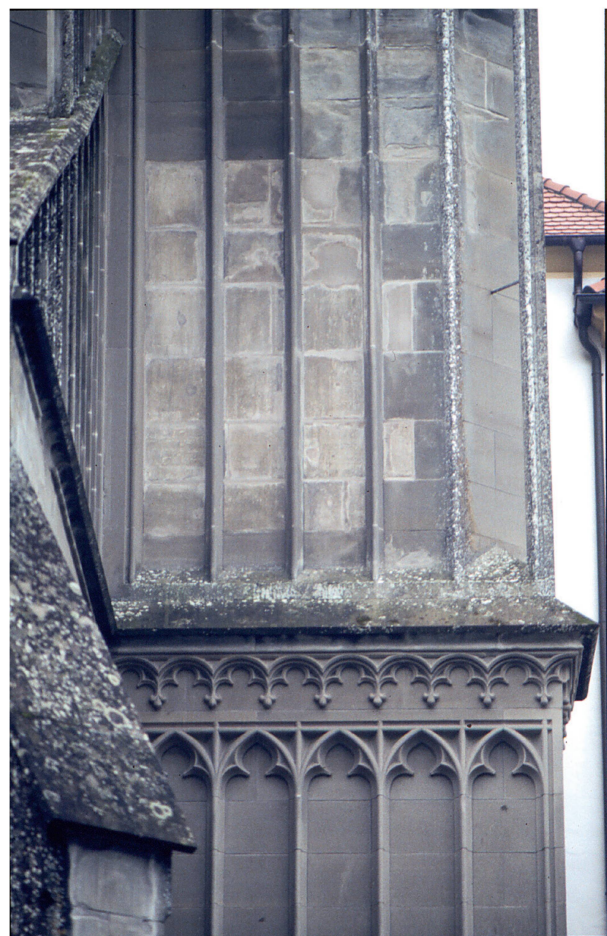
2 West façade after restauration in 2000 (Photo A. Kieferle).
