Salem Abbey

Conservation of Molasse Sandstone

Albert Kieferle

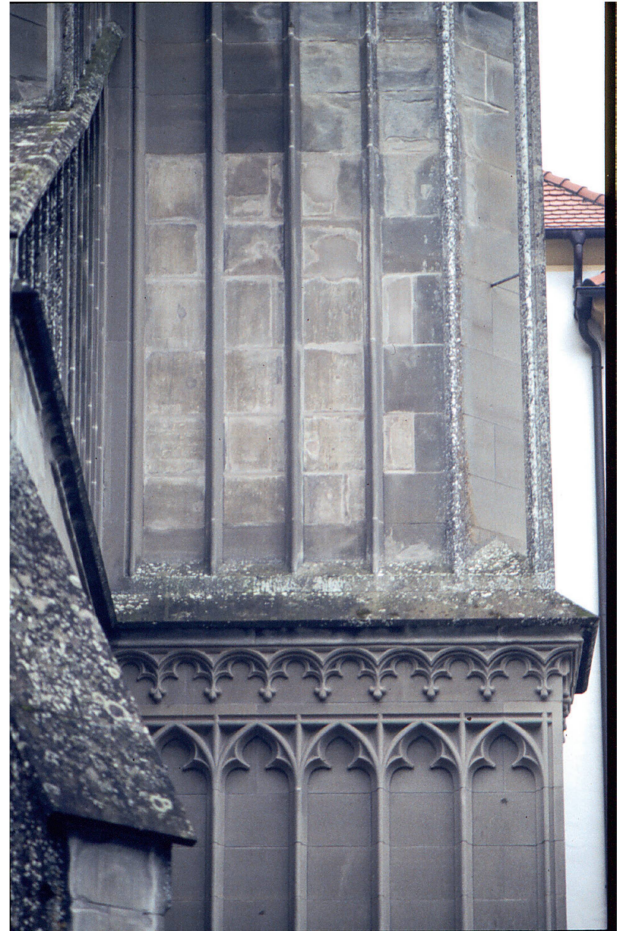
2 West façade after restoration in 2000 (Photo A. Kieferle).
