Replacement of Natural Stone on the Royal Palace in Stockholm

A Technical and Ethical Dilemma

Andreas Heymowski

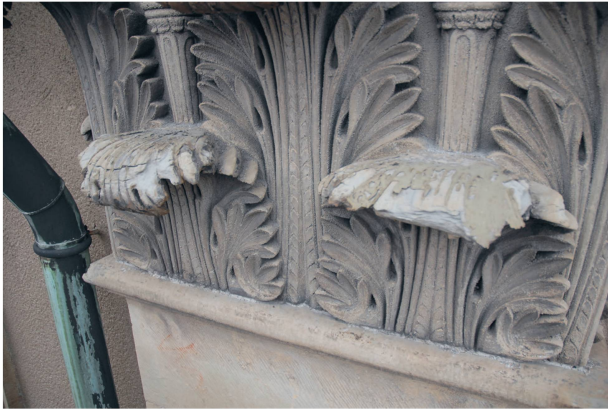
2 A Corinthian capital, bearing traces of a vain attempt around 1970 to preserve its protruding acanthus leaves by coating them with fiberglass reinforced plastics (Photo Mikael Traung).

Essentially this is something very positive but for the Royal Palace some of the consequences were not altogether favourable. I am here speaking about the very strong appreciation of the authentic material. In most cases this interest in the material authenticity aspect of the heritage has lead to a better understanding of the functioning of old buildings. It has also lead to refraining from the previous, extensive use of unsuitable modern materials in conservation (fig. 2).

But in the case of the Palace this wish to preserve the authentic material at any cost, lead to extensive conservation – with modern chemical substances – of decayed stone, instead of the traditional replacement. As a result, today the stone had disintegrated even further. In the process, Sweden's many skilled stone-masons became a more or less extinct species, due to lack of job opportunities within the country.

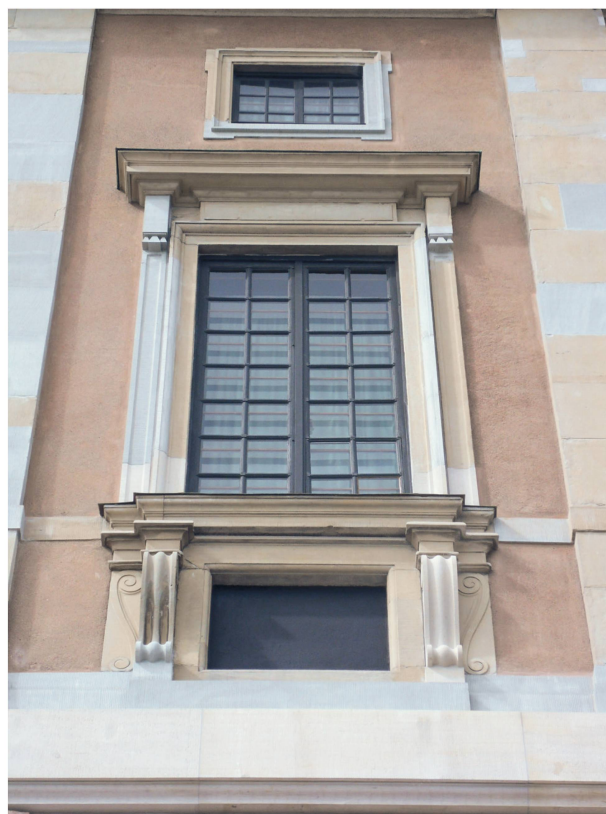
But eventually most things have turned out in a satisfactory way. I would say 80-85 % of the work is quite good and, luckily, most of the flaws are not visible from the ground. Still, as you can see, the new stone is detectable, the yellow Obernkirchener and the blueish grey Rorschacher (and in some places new Gotland). In Sweden we have a tradition to patinate new stone, so as to make it blend with the old one. We made a test, giving the new stone a very thin coat of paint. Here you cannot say which is new and which is old. But we've decided to wait and see what happens to the new stone, hoping that with time it will blend in without us having to patinate it.

3 *The façade after stone replacement. Old Gotland stones are a dark yellowish grey, new Gotland or Roschacher stones are a blueish grey and new Obernkirchener stones are a light yellowish grey. Whether the colour differences are acceptable or not is a matter of ideology and taste (Photo A. Heymowski).*

So, our final recommendation became to use both Rorschacher and Obernkirchener Sandstone for the restoration work on the façades of the Royal Palace. In 2010 we started preparing the working drawings and other documentation for the first pilot phase of the work. It comprises two façades on the North-East Wing of the Palace. The actual replacement work began in March 2011 and was completed by May 2012.

I will not tire you with tales of the complicated processes of finding craftsmen, of purchasing and of hewing the new stone. We have learnt a lot about the stone market, stone hewing, stone mounting, etc. Many times we have been on the brink of despair when stone hasn't been delivered at all, or delivered much too late, or in the wrong colour or with incorrect hewing (fig. 3).
