# Replacement of Natural Stone on the Royal Palace in Stockholm

## A Technical and Ethical Dilemma

Andreas Heymowski

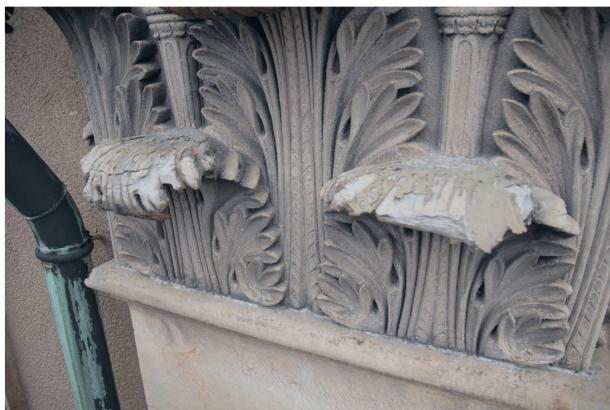
2 A Corinthian capital, bearing traces of a vain attempt around 1970 to preserve its protruding acanthus leaves by coating them with fibreglass reinforced plastics (Photo Mikael Traung).

Essentially this is something very positive but for the Royal Palace some of the consequences were not altogether favourable. I am here speaking about the very strong appreciation of the authentic material. In most cases this interest in the material authenticity aspect of the heritage has lead to a better understanding of the functioning of old buildings. It has also lead to refraining from the previous, extensive use of unsuitable modern materials in conservation (fig. 2).

But in the case of the Palace this wish to preserve the authentic material at any cost, lead to extensive conservation – with modern chemical substances – of decayed stone, instead of the traditional replacement. As a result, today the stone had disintegrated even further. In the process, Sweden's many skilled stone-masons became a more or less extinct species, due to lack of job opportunities within the country.
