Replacement of Natural Stone on the Royal Palace in Stockholm

A Technical and Ethical Dilemma

Andreas Heymowski

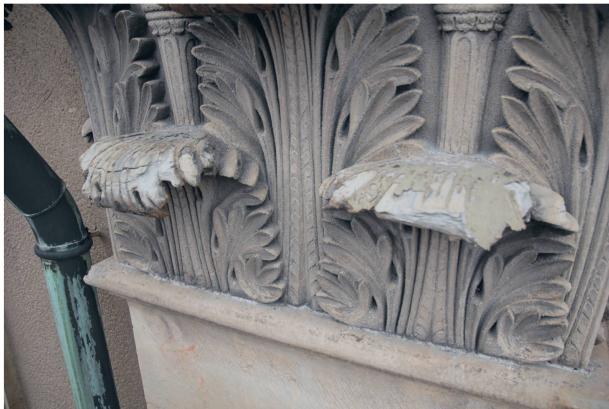
2 A Corinthian capital, bearing traces of a vain attempt around 1970 to preserve its protruding acanthus leaves by coating them with fibreglass reinforced plastics (Photo Mikael Traung).

Essentially this is something very positive but for the Royal Palace some of the consequences were not altogether favourable. I am here speaking about the very strong appreciation of the authentic material. In most cases this interest in the material authenticity aspect of the heritage has lead to a better understanding of the functioning of old buildings. It has also lead to refraining from the previous, extensive use of unsuitable modern materials in conservation (fig. 2).

But in the case of the Palace this wish to preserve the authentic material at any cost, lead to extensive conservation – with modern chemical substances – of decayed stone, instead of the traditional replacement. As a result, today the stone had disintegrated even further. In the process, Sweden's many skilled stone-masons became a more or less extinct species, due to lack of job opportunities within the country.

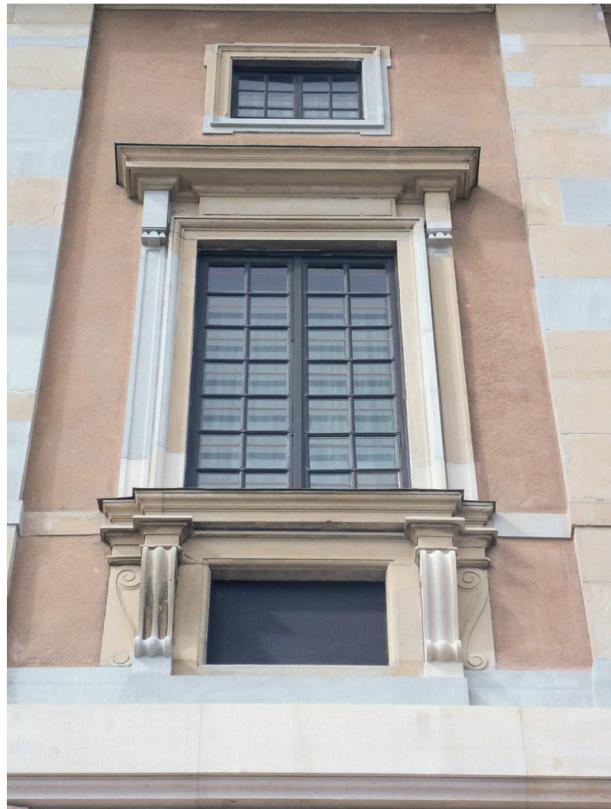
3 *The façade after stone replacement. Old Gotland stones are a dark yellowish grey, new Gotland or Roschacher stones are a blueish grey and new Obernkirchener stones are a light yellowish grey. Whether the colour differences are acceptable or not is a matter of ideology and taste (Photo A. Heymowski).*

I will not tire you with tales of the complicated processes of finding craftsmen, of purchasing and of hewing the new stone. We have learnt a lot about the stone market, stone hewing, stone mounting, etc. Many times we have been on the brink of despair when stone hasn't been delivered at all, or delivered much too late, or in the wrong colour or with incorrect hewing (fig. 3).

But eventually most things have turned out in a satisfactory way. I would say 80-85% of the work is quite good and, luckily, most of the flaws are not visible from the ground. Still, as you can see, the new stone is detectable, the yellow Obernkirchener and the blueish grey Rorschacher (and in some places new Gotland). In Sweden we have a tradition to patinate new stone, so as to make it blend with the old one. We made a test, giving the new stone a very thin coat of paint. Here you cannot say which is new and which is old. But we've decided to wait and see what happens to the new stone, hoping that with time it will blend in without us having to patinate it.
