# Replacement of Natural Stone on the Royal Palace in Stockholm

## A Technical and Ethical Dilemma

Andreas Heymowski

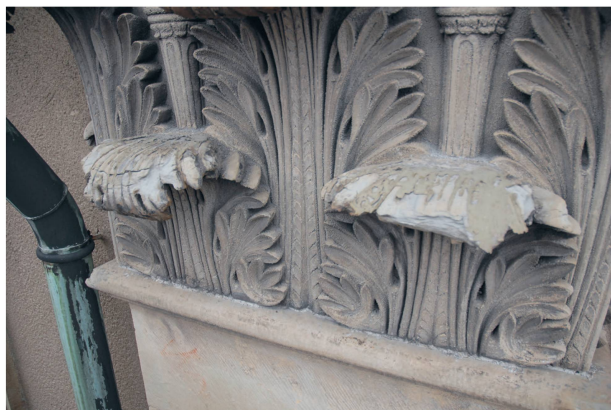
2 *A Corinthian capital, bearing traces of a vain attempt around 1970 to preserve its protruding acanthus leaves by coating them with fibreglass reinforced plastics (Photo Mikael Traung).*

Essentially this is something very positive but for the Royal Palace some of the consequences were not altogether favourable. I am here speaking about the very strong appreciation of the authentic material. In most cases this interest in the material authenticity aspect of the heritage has lead to a better understanding of the functioning of old buildings. It has also lead to refraining from the previous, extensive use of unsuitable modern materials in conservation (fig. 2).

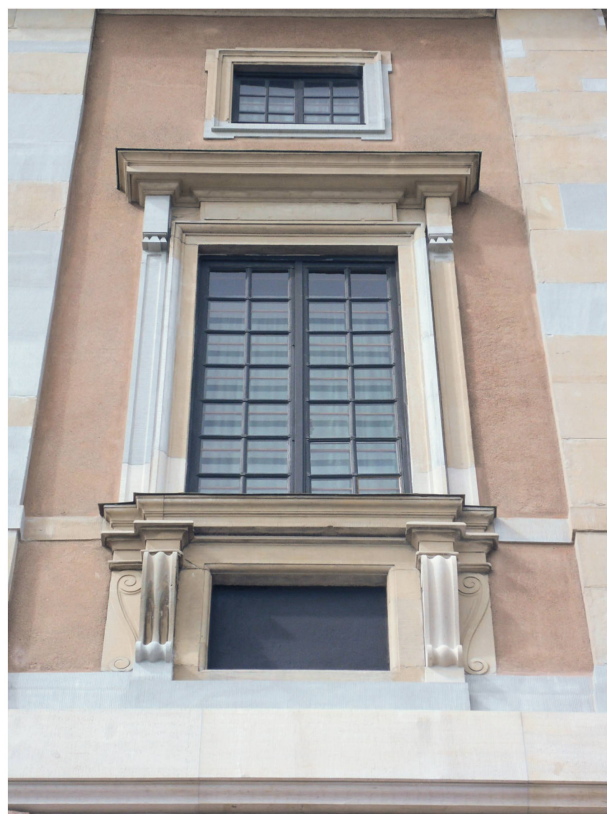
3 The façade after stone replacement. Old Gotland stones are a dark yellowish grey, new Gotland or Rorschacher stones are a blueish grey and new Obernkirchener stones are a light yellowish grey. Whether the colour differences are acceptable or not is a matter of ideology and taste (Photo A. Heymowski).

I will not tire you with tales of the complicated processes of finding craftsmen, of purchasing and of hewing the new stone. We have learnt a lot about the stone market, stone hewing, stone mounting, etc. Many times we have been on the brink of despair when stone hasn't been delivered at all, or delivered much too late, or in the wrong colour or with incorrect hewing (fig. 3).

But eventually most things have turned out in a satisfactory way. I would say 80-85 % of the work is quite good and, luckily, most of the flaws are not visible from the ground. Still, as you can see, the new stone is detectable, the yellow Obernkirchener and the blueish grey Rorschacher (and in some places new Gotland). In Sweden we have a tradition to patinate new stone, so as to make it blend with the old one. We made a test, giving the new stone a very thin coat of paint. Here you cannot say which is new and which is old. But we've decided to wait and see what happens to the new stone, hoping that with time it will blend in without us having to patinate it.
