**Zeitschrift:** Schweizerische Bauzeitung  
**Herausgeber:** Verlags-AG der akademischen technischen Vereine  
**Band:** 94 (1976)  
**Heft:** 24

## Structural connections of prefabricated concrete units – some matters of current concern

By K. G. Bernander, Stockholm

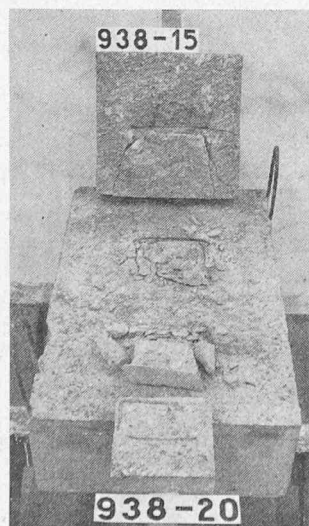
Fig. 10. Types of anchor rupture of stirrups cast into a thin concrete topping. Note the difference in type of rupture for smaller ( $15 \times 15 \text{ cm}^2$ ) and larger ( $30 \times 30 \text{ cm}^2$ ) surfaces. When size was ( $61.5 \times 61.5 \text{ cm}^2$ ) the rupture was a pure tension cone around the stirrup

Fig. 10 shows the mode of failure. In all cases here presented the anchor of the stirrup in the topping became critical, however, often at displacements beyond the maximum load.

Where small contact surface the anchor failure was due to splitting of the topping. Where large contact surface the failure in the topping formed a tensile rupture cone around the stirrup.
