Zeitschrift: Schweizerische numismatische Rundschau = Revue suisse de numismatique = Rivista svizzera di numismatica
Herausgeber: Schweizerische Numismatische Gesellschaft
Band: 97 (2019)

Artikel: A stave church revisited : Ringebru stave church, Ringebru municipality, Oppland county
Autor: Masterud Hellan, Terje
DOI: <https://doi.org/10.5169/seals-869547>

A STAVE CHURCH REVISITED.
RINGEBU STAVE CHURCH, RINGEBU MUNICIPALITY,
OPPLAND COUNTY

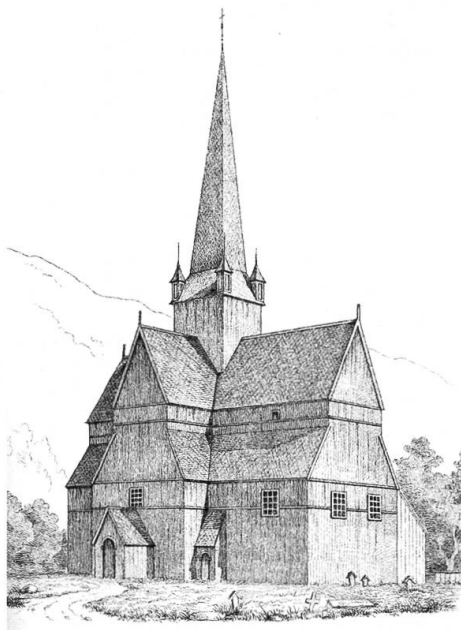
Fig. 1 Drawing of Ringebu stave church by J. FRICH, Foreningen
til norske fortidsmindesterkers bevaring Årbok (Oslo 1855), pl. IV.

Ringebu stave church is situated on a small plain at the steep eastern valley side of the river Gudbrandsdalslågen, roughly 2 kilometers south of the present-day township's centre (*Fig. 1*).¹ Gudbrandsdalen is one of the great valley districts in Eastern Norway, stretching from the town of Lillehammer (124 masl) in the south, to lake Lesjaskogvatnet (612 masl) in the north. One of the main pilgrimage routes to the Nidaros Cathedral in Trondheim, and later also the king's road, passed through Gudbrandsdalen. The church is today a parish church and was originally a stave church with a raised roof above the central space of the nave. Architecturally this type is one of the more advanced kind of stave churches. It is one of the largest of the preserved stave churches,² and one of few that probably

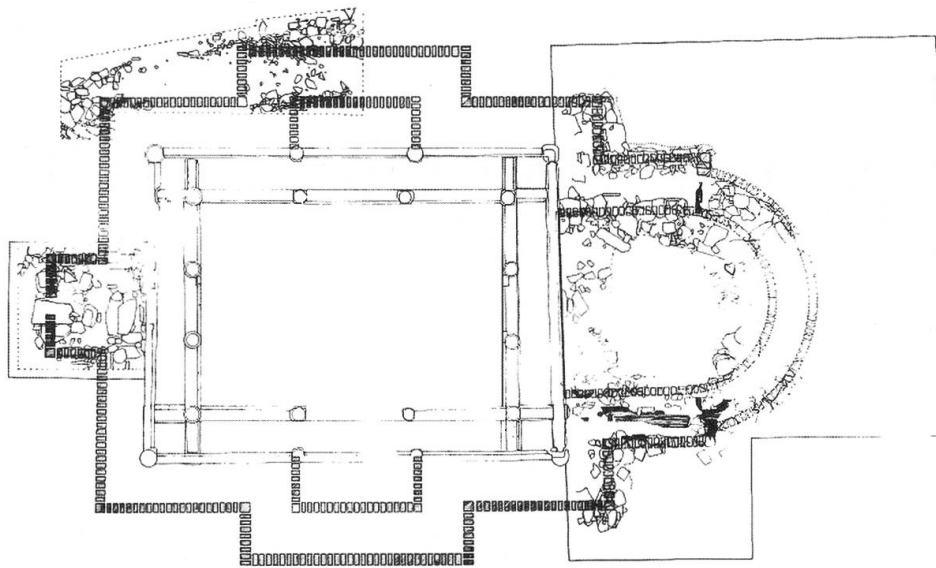
Fig. 2 Drawing of Ringebu schematics from the excavations with an interpretation of the shape of the 1200s church as well as an outline of the 1630 additions. JENSENIUS – SKRE 1983 (note 6), p. 19.

Ringebu stave church was excavated by Riksantikvaren⁴ in cooperation with Universitetets Oldsaksamling⁵ in the period 1980–82 (*Fig. 2*). The reasons for the excavations were decay and circulation of air beneath the floors and the load-bearing constructions in the lower parts of the church. The extent of the alterations was comprehensive. They decided to open up all the floors and remove as much soil as possible, and restore the broken construction parts.⁶ The work was initiated in May 1980 and finished in April 1982. The archaeological field work took place, effectively, over a period of five to six months.

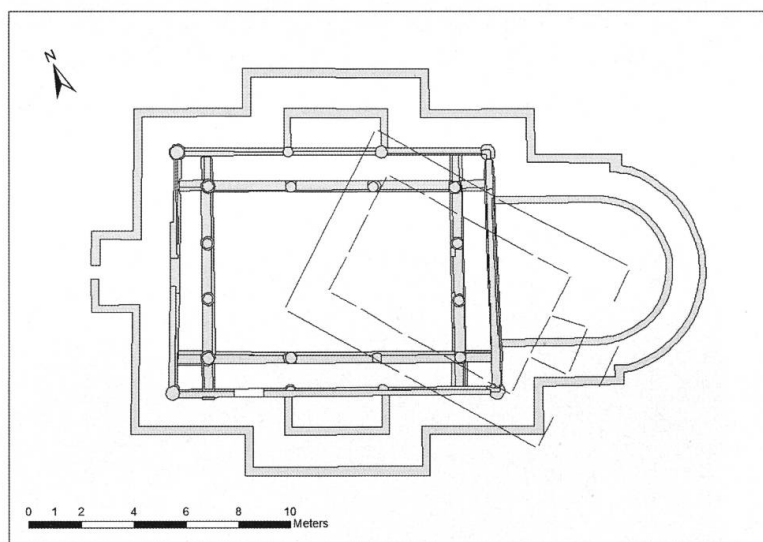
Fig. 4 Possible shape of the 1200s church with outline of the 1000s church.
Map: Terje Masterud Hellan.

nave²⁵ and a small chancel in the east,²⁶ and while in most of its extent it was overlapped by the 1200s church, the buildings were not constructed on the same axis.²⁷ The excavations also showed that the posthole church was probably burnt down before the stave church was built (*Fig. 4*).²⁸

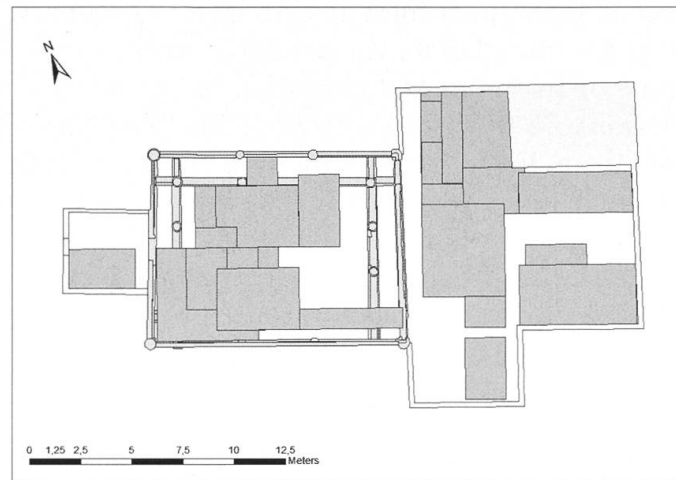
Fig. 6 Demonstration of different kind of polygons finds are plotted in, exceeding 4 m².
Map: Terje Masterud Hellan and Steinar Kristensen, Museum of Cultural History.

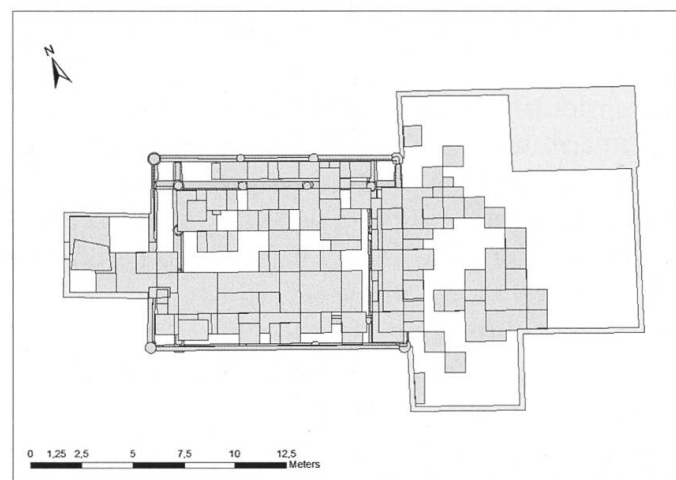
Fig. 7 Demonstration of different kind of polygons finds are plotted in, smaller than 4 m².
Map: Terje Masterud Hellan and Steinar Kristensen, Museum of Cultural History.

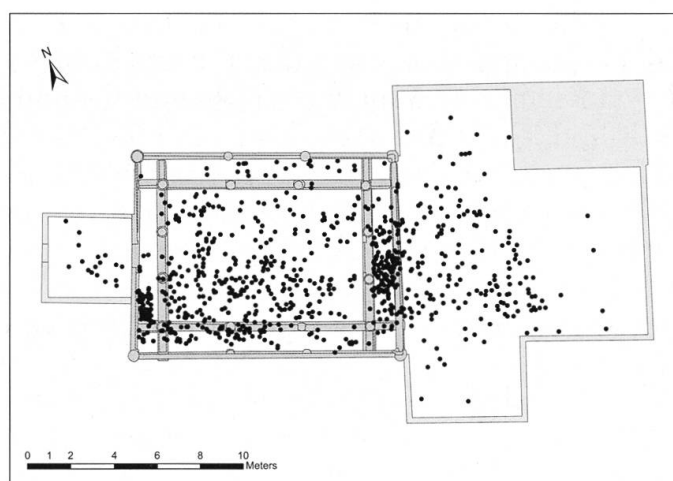
Fig. 8 Map of the plotted coin finds in Ringebu. Map: Terje Måsterud Hellan and Steinar Kristensen, Museum of Cultural History.

4. Money use and liturgy (Fig. 8 and Tab. 1)

The majority of the coins in Ringebru were found in the nave of the current church. As can be observed in figure 8 there is a concentration of significant numbers of coin finds in the southern half. Traditionally this has been understood as the male side, although the view have recently been problematized and presented as more complex than previously thought.⁷¹ Of the coins in the nave there are two or three areas that stands out: The western aisle, the eastern aisle, both areas undisturbed by post-Reformation burials, and maybe the southern aisle close to where there once was a southern door. In the following these will be presented. The eastern aisle will be compared to its nearby medieval chancel. It will also be looked at the remarkable change in find patterns in the post-medieval period.

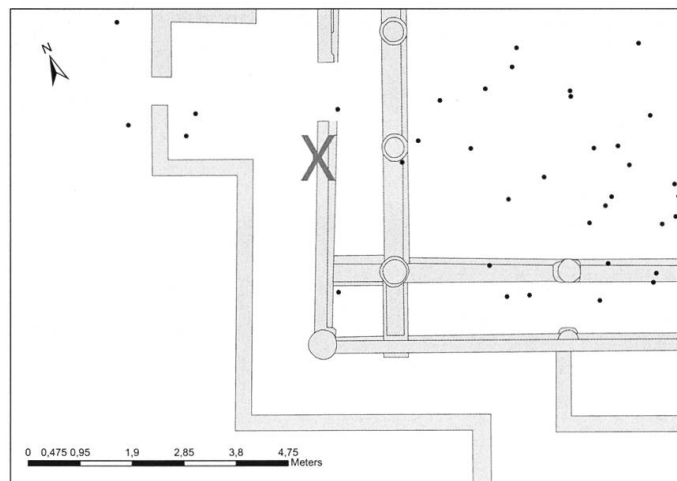
Fig. 11 Map of the western aisle with post 1630 coins. Approximate spot of truncus concavus marked with an X near the entrance. Map: Terje Masterud Hellan and Steinar Kristensen, Museum of Cultural History.

By the south-western post, in the aisle, a distinctive composition in layer 1 was observed in a concentrated area. Wooden splinters, dust and sand lay in different stratas with a varying degree of compactness. Inside this area, in addition to several other artefacts, 64 coins were found. Dagfinn Skre suggests that this was a hatch or a larger crack in the floor into which materials have been swept down.⁷² Jørgen Jensenius was also of the opinion that the floor boards had larger cracks in this area and describes a tilted pile beneath the aisle with dried wool fluff, coins and sand in different stratas.⁷³ The possibility that this was the location for a baptismal font has been mentioned,⁷⁴ but as already mentioned this one was presumably in the other half of the nave. The font could be placed different places at different times. However, the use of coins in the baptismal liturgy is not a widely recognized phenomenon. The art historian Mona Bramer Solhaug recently made a study further excluding any connection between coin finds and baptismal fonts.⁷⁵ The possibility that the earth ended up there after being dug away from another part of the church also seem slim given that the most obvious place this could come from is interpreted as a medieval grave chamber, and the north-south oriented floor boards⁷⁶ would have to be removed on both parts of the western sill for it to happen (*Fig. 10 and 11*).

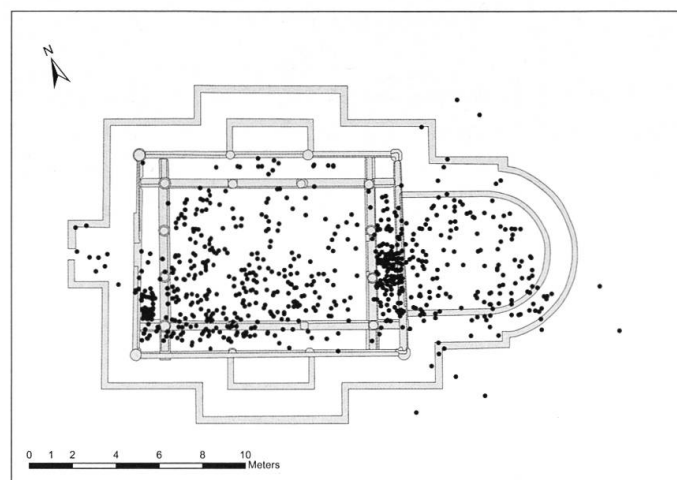
Fig. 16 Map of the entire church with pre 1630 coins. Unidentified medieval fragments included. Map: Terje Masterud Hellan and Steinar Kristensen, Museum of Cultural History.

4.3 Pre- and post-Reformation finds patterns (Fig. 16 and 17)

There is a significant change in the find patterns between the 1200s church and the church after the 1630 rebuilding. In general, it is hard to detect changes immediately after the Reformation due to the limited amount of information about coin use in this period. This, of course, is for a large part a consequence of fewer coins from that period in circulation, and a significant decrease in the number of coin finds in most Norwegian churches.⁹⁵ In fact, very few coins were minted in Norway between 1387 and 1628, but as already pointed out, foreign

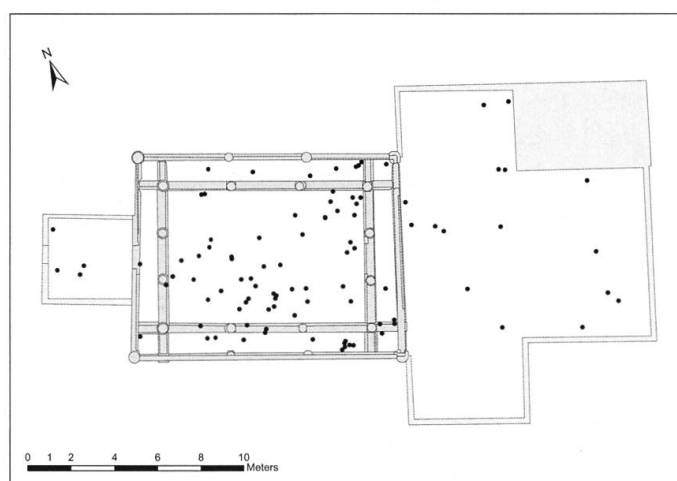
Fig. 17 Map of the entire church with post 1630 coins. Map: Terje Masterud Hellan and Steinar Kristensen, Museum of Cultural History.
