Artikel: The accident at Aigle CFF station

THE ACCIDENT AT AIGLE CFF STATION

By Ian Edwards

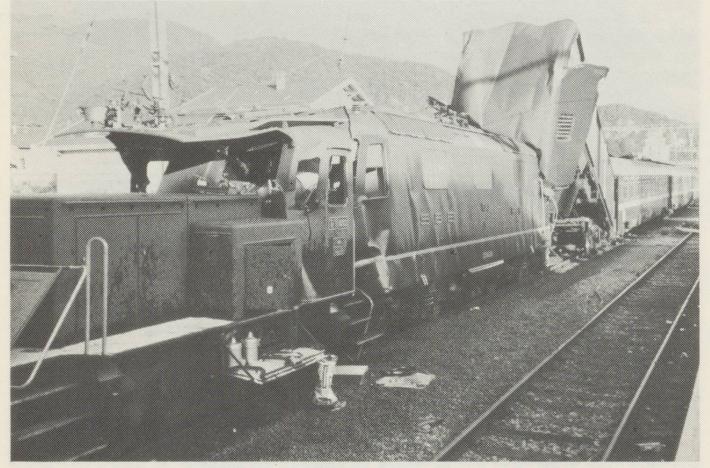
A local pickup freight train hauled by locomotive type Ae4/7 No. 11953 was stationary on the track at platform three, while a shunter type TeIV No. 8203 removed two of the parcel wagons and reversed down to the south end of the loop. In the meantime the main line route through the station was signalled for the passage of the 105 Kmph Milan to Geneva Eurocity express hauled by locomotive Re4/4 No. 11343. The initial impact at between 60 to 80 Kmph was between the express and the shunting locomotive, in which the TeIV and its two baggage wagons was pushed all the way back up the loop into the rear of the pickup freight. The second impact was between the express/shunter and the pickup freight.

Collision of EC "Lemano" with freight train at Aigle.

The impact with the pickup freight caused the destruction of a closed freight wagon, and forced one of the open wagons type Fs-u No. 987 up onto the overhead catenary gantry in doing so unloading vegetables onto both track and platform. The shunting engine was badly damaged both front and back and lost its pantograph in the accident. On the express train the damage consisted of; the locomotive was badly crushed in the front and the rear, the RIC Baggage coach Type D No. 51 85 92 70 107 located

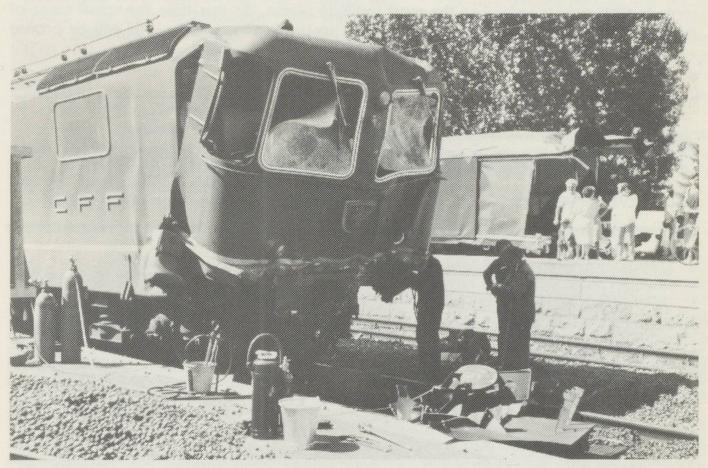
just behind the Re4/4 was bent double as it was pushed upwards through the front of the platform canopy before coming to rest above the locomotive, the first of the C.F.F. type Bpm coaches was damaged where the baggage coach had crumpled the front area, and the restaurant coach lost its pantograph as the overhead wires were dragged down. The rest of the coaches of the express appeared to be undamaged and remained on the track. Catenary wires through a large part of the station area were brought down. Amazingly, when the rescue teams arrived just minutes later they found that nobody was seriously hurt but about fifty people required treatment for minor injuries and shock. Fortunately the driver of the express escaped injury, as he could be seen walking around inside the locomotive looking for an exit as both doors had been crushed, eventually leaving via one of the side windows.

Re4/411 locomotive No. 11343, showing damage to front area.

The next morning when I returned to the station at 1000 hours, I found that during the night the double slip points at the entrance to the loop had been replaced. The RIC baggage coach had been cut into two pieces and deposited along with the remains of the freight wagon - which had ended up on the catenary gantry - on the goods platform. The coaches of the "Lemano" had been towed away during the night to St. Triphon just 5 kilometres south of Aigle. The two locomotives remained locked together until about 1400 hours, as they were parted the full extent of the damage to the Re4/4II locomotive could be seen. The pantograph was missing, the rear cab was completely crushed by the baggage coach, the front cab was pushed back by the impact

with the shunting locomotive, and the front bogie had been pushed back about 400 mm. Before the Re4/4 locomotive could be moved the buffers had to be cut away along with all equipment below the cab floor including the front part of the bogie itself. When this had been done the locomotive was jacked up to enable the bogie to be replaced onto the track, it was then towed away. Just after 1400 hours the remains of the pickup freight had been checked and any repairs that were required prior to moving it had been done, it was then taken away closely followed by the TeIV shunting locomotive.
