Artikel: The accident at Aigle CFF station
Autor: Edwards, Ian
DOI: <https://doi.org/10.5169/seals-855295>

THE ACCIDENT AT AIGLE CFF STATION

By Ian Edwards

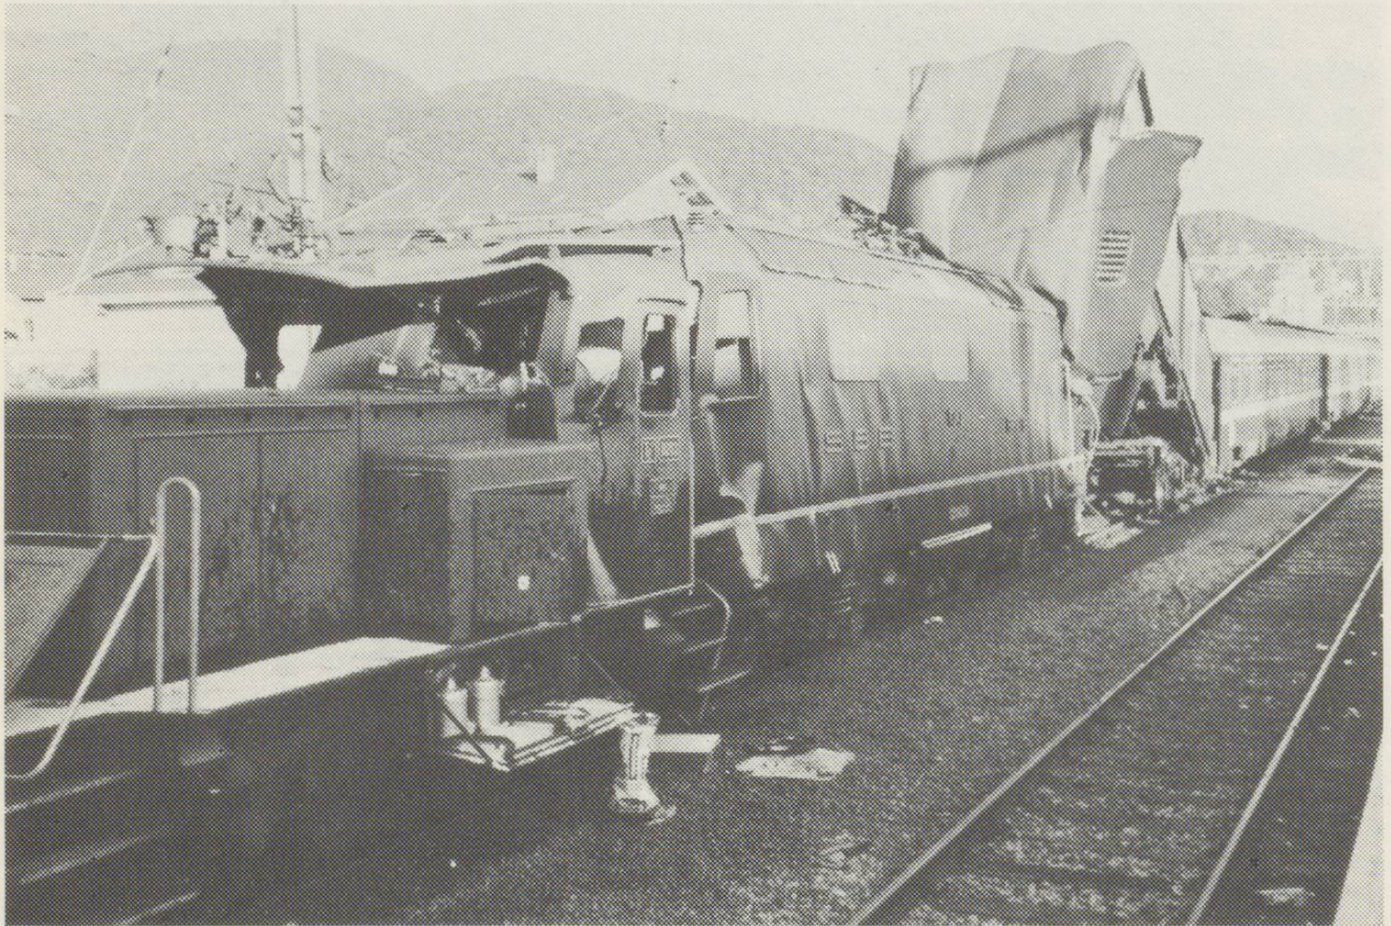
A local pickup freight train hauled by locomotive type Ae4/7 No. 11953 was stationary on the track at platform three, while a shunter type TeIV No. 8203 removed two of the parcel wagons and reversed down to the south end of the loop. In the meantime the main line route through the station was signalled for the passage of the 105 Km/h Milan to Geneva Eurocity express hauled by locomotive Re4/4 No. 11343. The initial impact at between 60 to 80 Km/h was between the express and the shunting locomotive, in which the TeIV and its two baggage wagons was pushed all the way back up the loop into the rear of the pickup freight. The second impact was between the express/shunter and the pickup freight.

Collision of EC "Lemano" with freight train at Aigle.
