Zeitschrift: Swiss express : the Swiss Railways Society journal
Herausgeber: Swiss Railways Society
Band: 2 (1988-1990)
Heft: 4

THE ACCIDENT AT AIGLE CFF STATION

By Ian Edwards

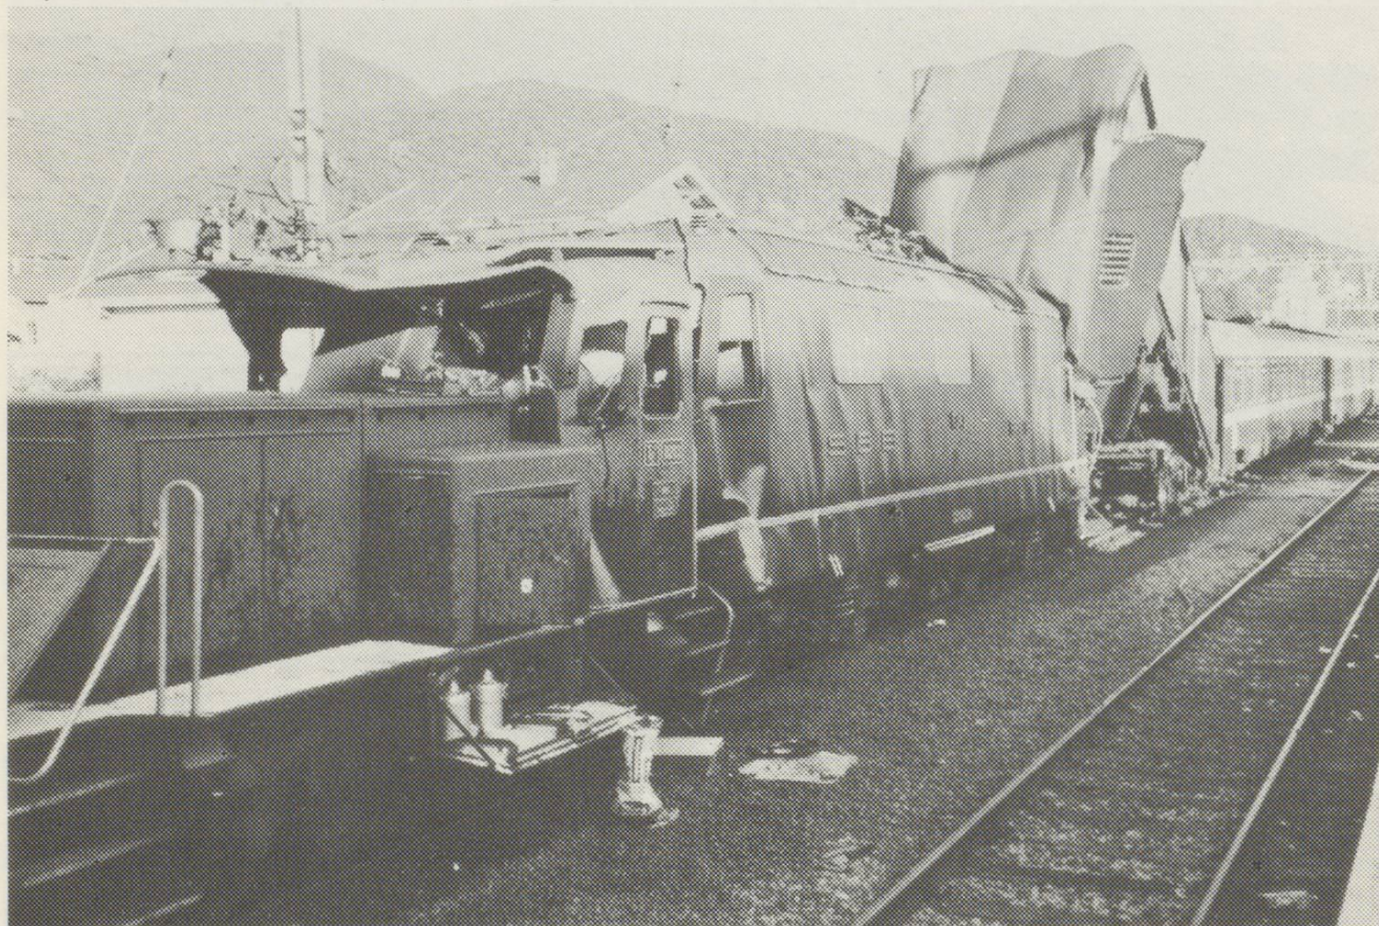
A local pickup freight train hauled by locomotive type Ae4/7 No. 11953 was stationary on the track at platform three, while a shunter type TeIV No. 8203 removed two of the parcel wagons and reversed down to the south end of the loop. In the meantime the main line route through the station was signalled for the passage of the 105 Kmph Milan to Geneva Eurocity express hauled by locomotive Re4/4 No. 11343. The initial impact at between 60 to 80 Kmph was between the express and the shunting locomotive, in which the TeIV and its two baggage wagons was pushed all the way back up the loop into the rear of the pickup freight. The second impact was between the express/shunter and the pickup freight.

Collision of EC "Lemano" with freight train at Aigle.

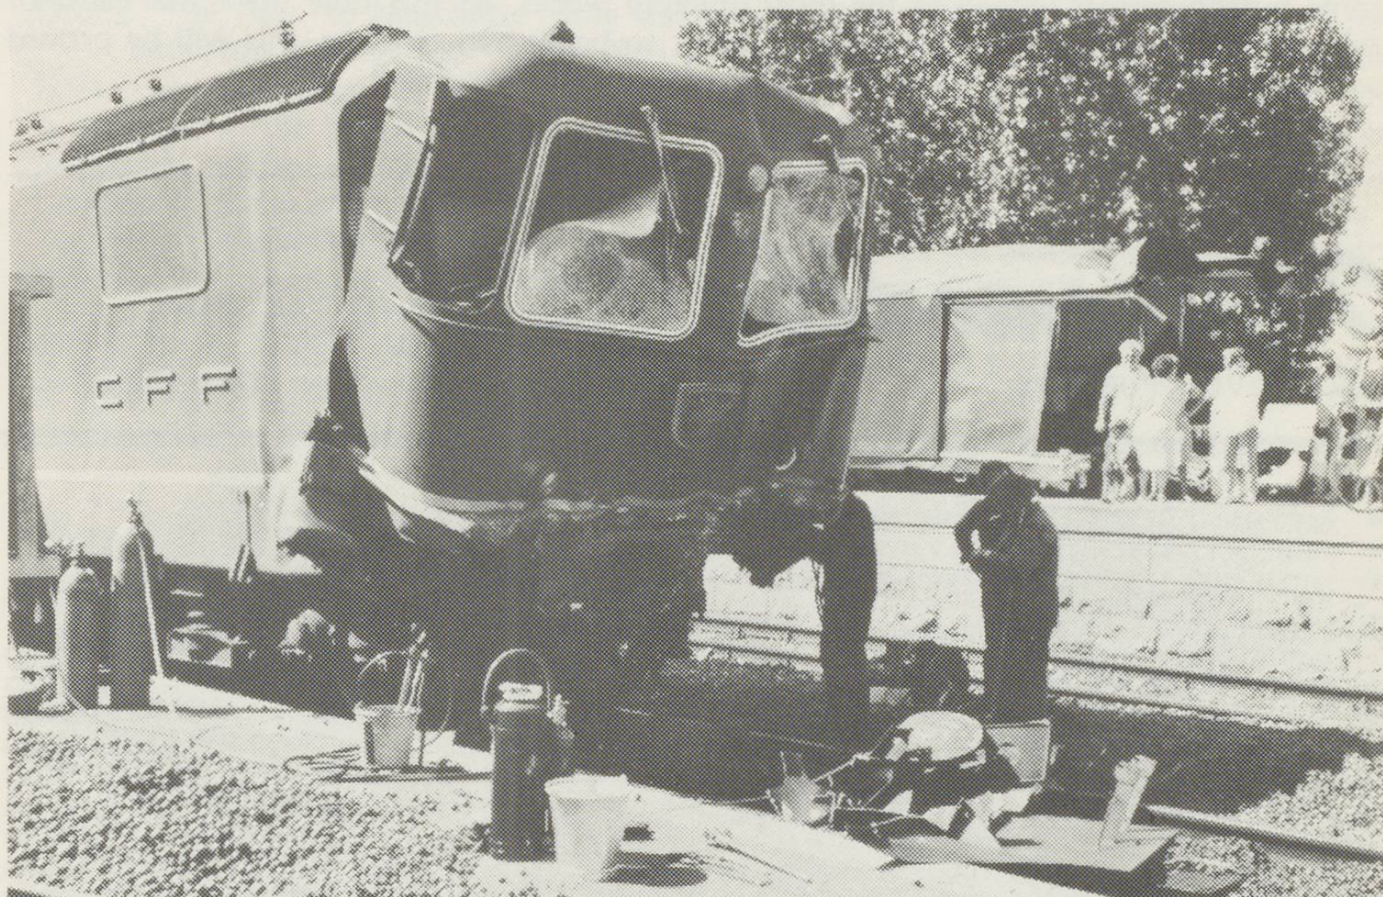
The impact with the pickup freight caused the destruction of a closed freight wagon, and forced one of the open wagons type Fs-u No. 987 up onto the overhead catenary gantry in doing so unloading vegetables onto both track and platform. The shunting engine was badly damaged both front and back and lost its pantograph in the accident. On the express train the damage consisted of; the locomotive was badly crushed in the front and the rear, the RIC Baggage coach Type D No. 51 85 92 70 107 located

just behind the Re4/4 was bent double as it was pushed upwards through the front of the platform canopy before coming to rest above the locomotive, the first of the C.F.F. type Bpm coaches was damaged where the baggage coach had crumpled the front area, and the restaurant coach lost its pantograph as the overhead wires were dragged down. The rest of the coaches of the express appeared to be undamaged and remained on the track. Catenary wires through a large part of the station area were brought down. Amazingly, when the rescue teams arrived just minutes later they found that nobody was seriously hurt but about fifty people required treatment for minor injuries and shock. Fortunately the driver of the express escaped injury, as he could be seen walking around inside the locomotive looking for an exit as both doors had been crushed, eventually leaving via one of the side windows.

Re4/4II locomotive No. 11343, showing damage to front area.

The next morning when I returned to the station at 1000 hours, I found that during the night the double slip points at the entrance to the loop had been replaced. The RIC baggage coach had been cut into two pieces and deposited along with the remains of the freight wagon - which had ended up on the catenary gantry - on the goods platform. The coaches of the "Lemano" had been towed away during the night to St. Triphon just 5 kilometres south of Aigle. The two locomotives remained locked together until about 1400 hours, as they were parted the full extent of the damage to the Re4/4II locomotive could be seen. The pantograph was missing, the rear cab was completely crushed by the baggage coach, the front cab was pushed back by the impact

with the shunting locomotive, and the front bogie had been pushed back about 400 mm. Before the Re4/4 locomotive could be moved the buffers had to be cut away along with all equipment below the cab floor including the front part of the bogie itself. When this had been done the locomotive was jacked up to enable the bogie to be replaced onto the track, it was then towed away. Just after 1400 hours the remains of the pickup freight had been checked and any repairs that were required prior to moving it had been done, it was then taken away closely followed by the TeIV shunting locomotive.
