Track relaying on the MOB (Montreux-Oberland-Bernois)

Zeitschrift: **Swiss express : the Swiss Railways Society journal**

by Les Heath Photographs by author

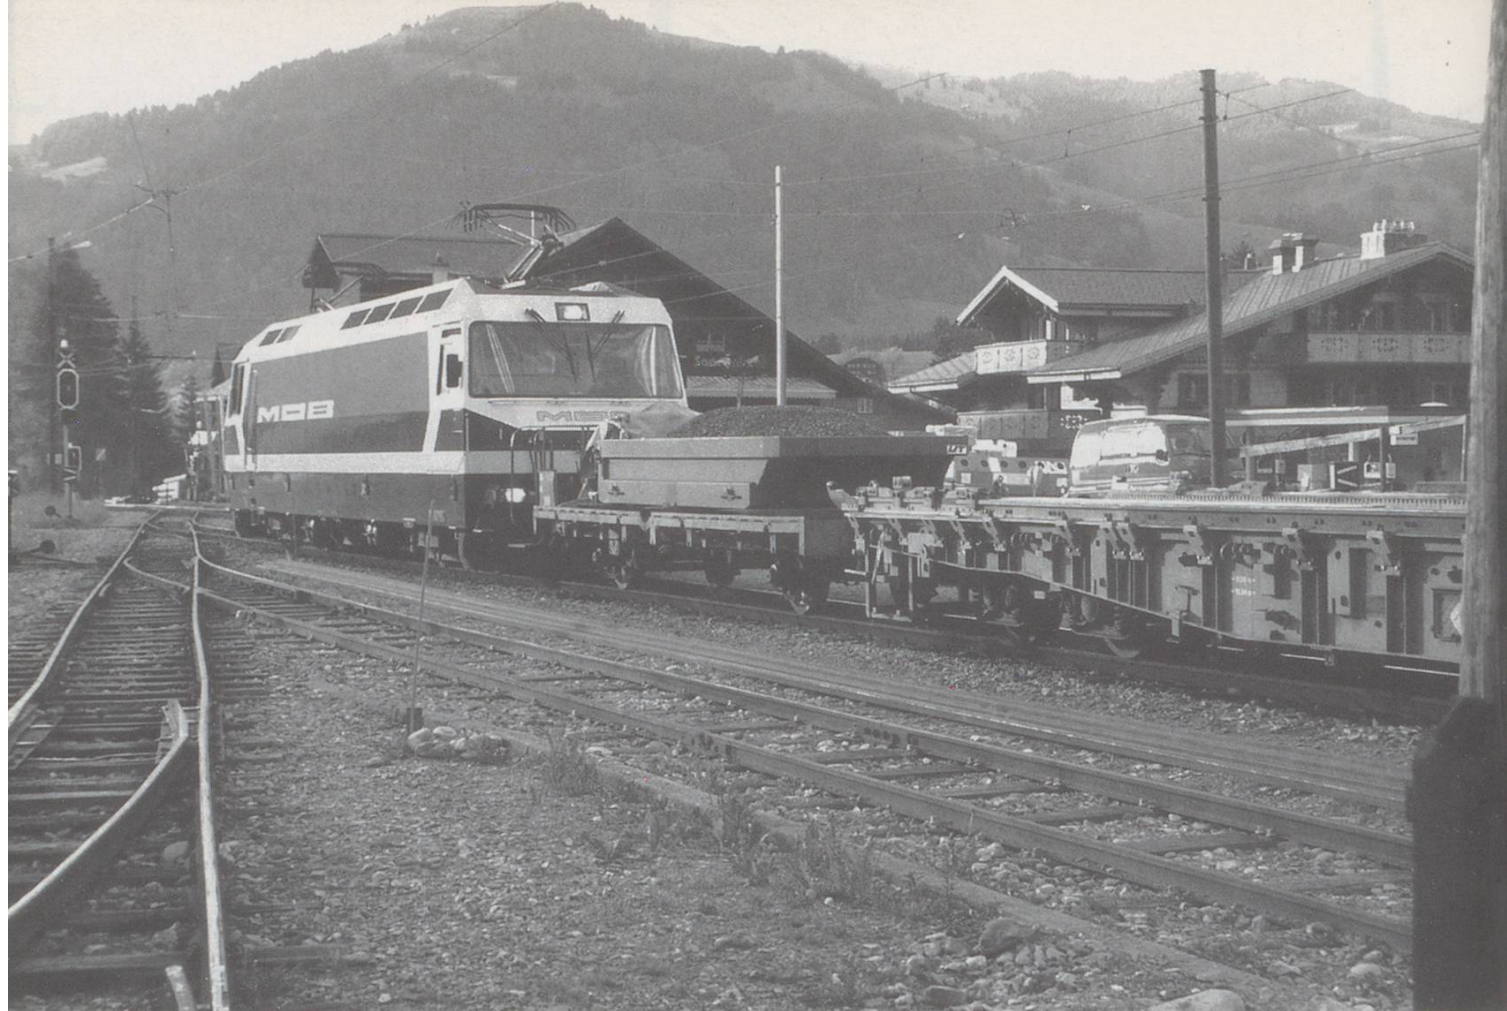
Opposite page: Ge4/4 8001 at Gstaad station with work train, the short 4-wheel flat has a Rhb coupling one end and a MOB the other, the skip is full of gravel to act as ballast.

On arrival at Gstaad station at 6.30pm the first noticeable unusual rolling stock was nine bogie flat cars from the Rhb and FO plus an MOB flat truck, of the bogie wagons four were empty and four with concrete sleepers with track fixings in place. The ninth one had a moving crane assembly looking like a crab with a long spar hanging beneath it. Attached to rear of this wagon was in simple terms a small crane with wide caterpillar tracks, it was raised above the rails for transportation. At the other end of it was Ge4/4 8001 with the MOB flat wagon loaded with a skip full of gravel being used as ballast. This wagon has MOB couplings one end and RhB/FO

couplings at the other. The track laying train was hired from the RhB/FO and travelled from the RhB to the MOB on thirty-two rollschimmel wagons.

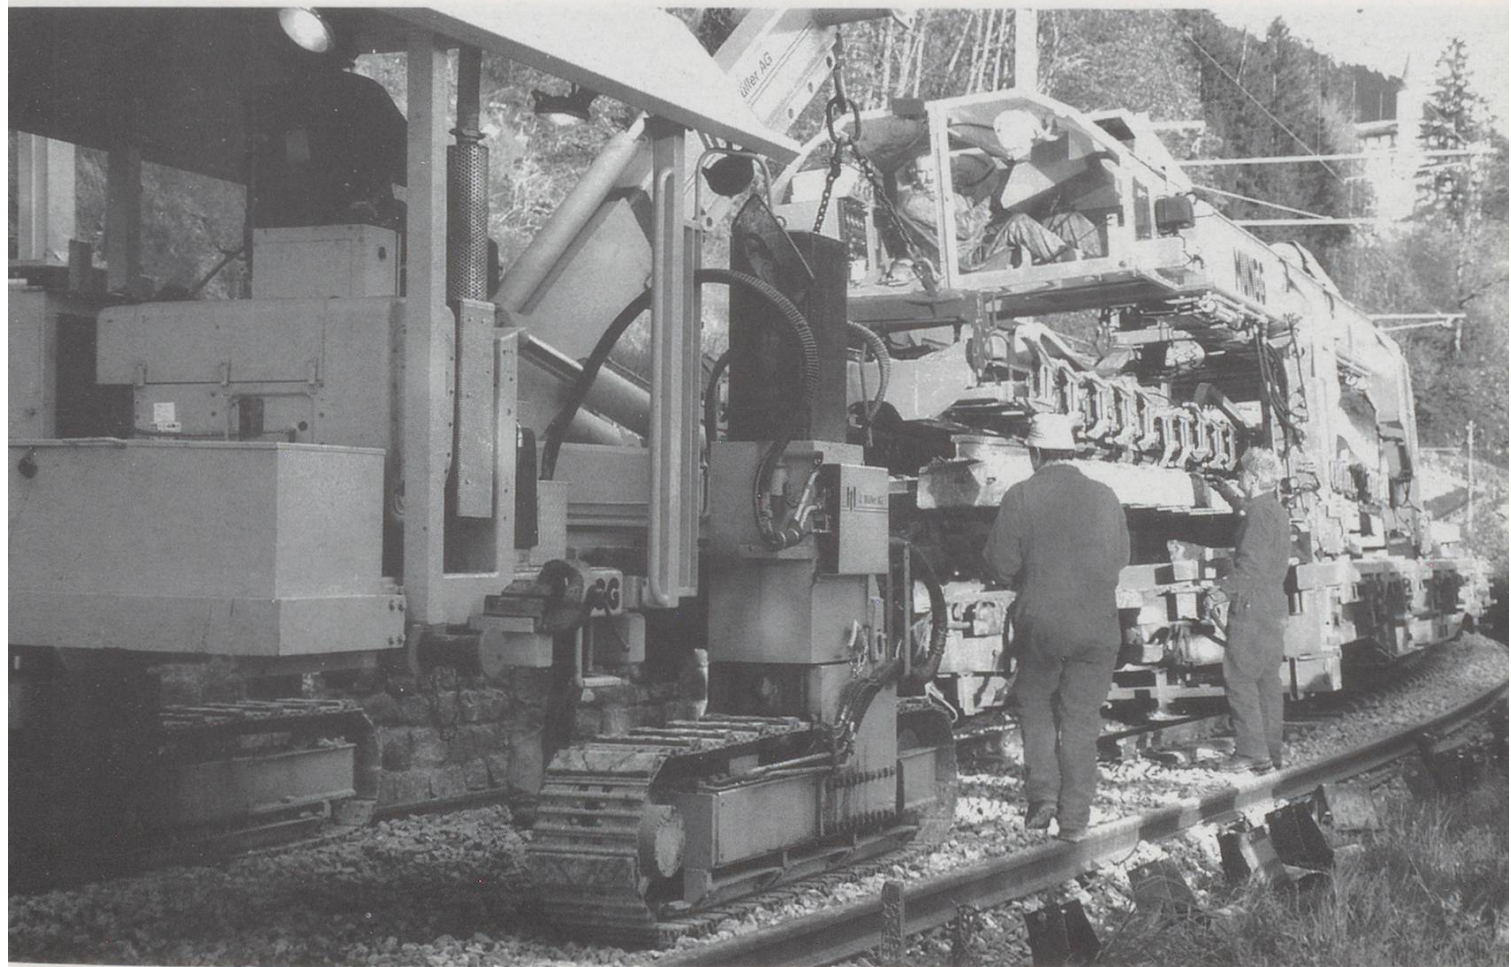
Below: A clear view of the tracked crane manoeuvring the spar under the wagon crane, the driver of the wagon crane is visible above spar in a semi-lying position, access is via the glass doors.

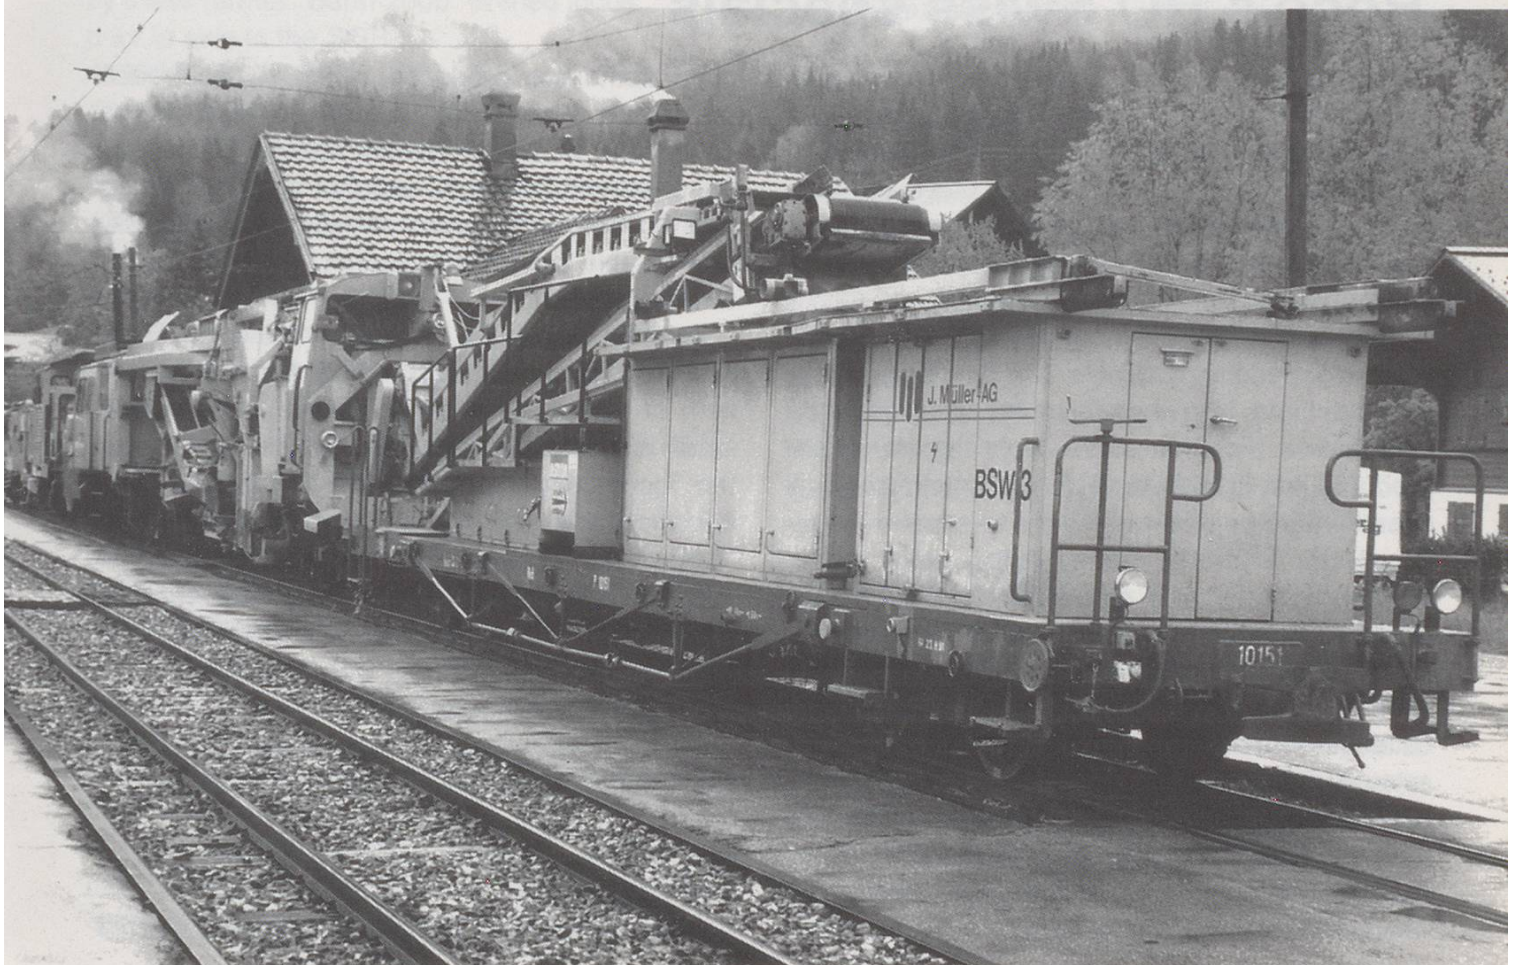
Below: The ballast cleaning and replacing train waits to follow on behind when the track crews have finished.

accomplished with a motley looking series of small machines that appeared to be precariously balanced on the track that had already been replaced. The placing of the new rail sections used a lot of manual pushing and lifting with large iron bars to manoeuvre the long lengths of rail into place, its surprising how flexible the rails appear to be. The small hydraulic machines lift and move the track to attain the correct distances from the retaining walls. Following along were two machines were used to tighten the bolts retaining the wire loops that hold down the rails. Finally the ballast cleaning train passes over the completed section settling the sleepers in place.
