Landslip disrupts the Brienz Rothorn Bahn

Mike Ellis

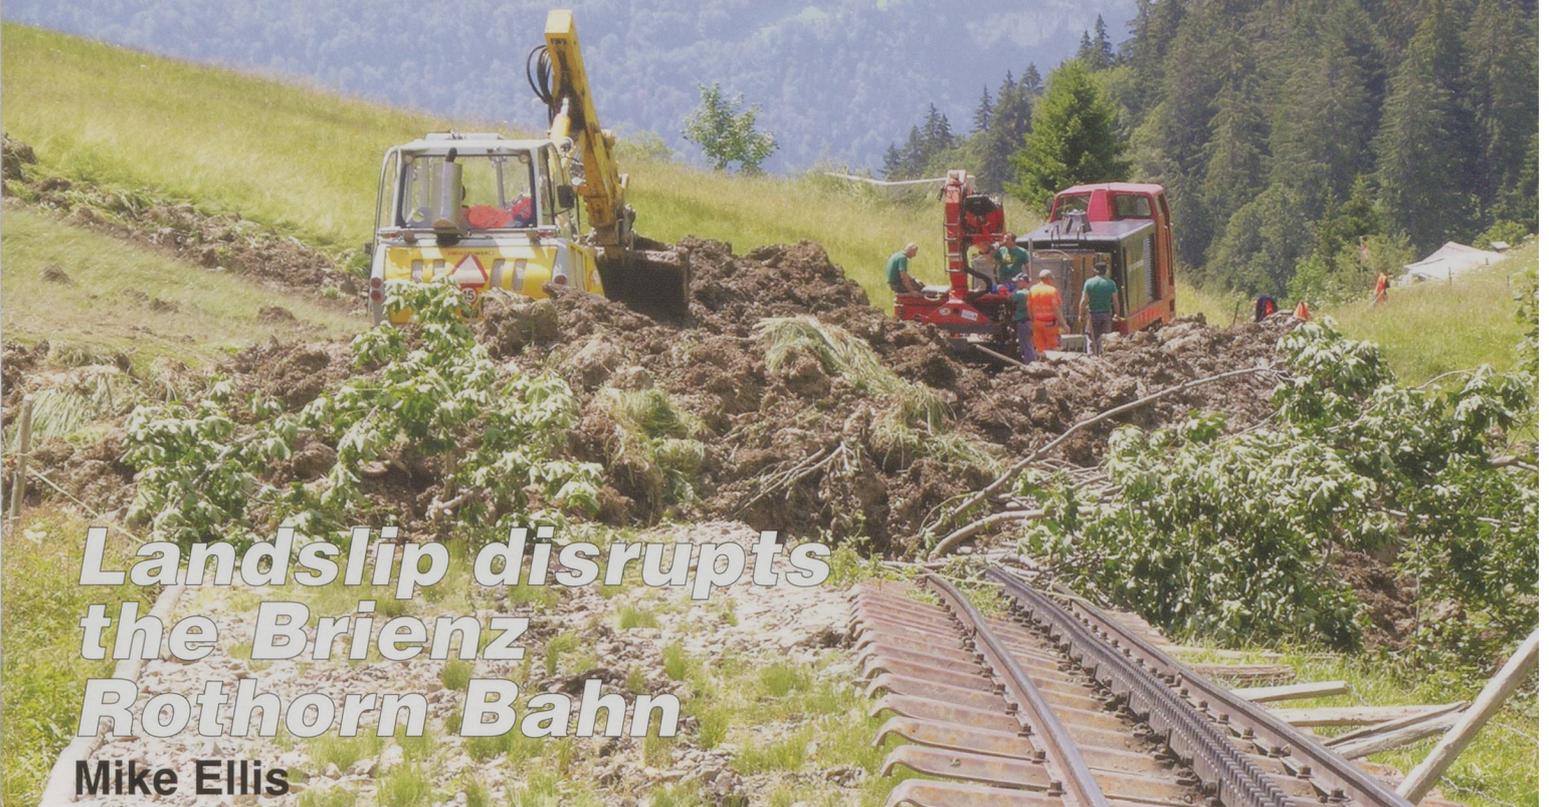
A clear view of just what has happened. The track, is some 3-4m out of alignment, completely free of the trackbed and now buried under a thick layer of clay, trees and boulders.

On the 24th July severe summer storms and extended rainfall resulted in a major mudslide taking place on the Brienz Rothorn Bahn (BRB) just below the 4km marker on the section immediately above Planalp. The ensuing damage included 70m of track work swept away from the track bed and a layer of debris 2m thick deposited onto, and around, the route. This, together with completely blocked storm drains and an interrupted service, has had quite a detrimental impact on the railway's short summer season. The clearance work naturally took priority over other duties and BRB staff from all disciplines were drafted-in to work on re-establishing the infrastructure to enable services to resume to Rothorn Kulm. Whilst a reduced steam service was maintained for visitors between Brienz and Planalp, works trains, along with imported heavy equipment, were in use to remove the debris and enable an assessment of necessary repair work to be undertaken. The preliminary clearance operation took about a week before service could be resumed to the railway's isolated mountain hotel at 2255m above sea level. With improved weather after the incident the trains resumed timetable running again and were well patronized. The accompanying photos give a good idea of just what confronted the civil engineering team and indicate what had to be done to regain normality on this popular railway in the heart of the Bernese

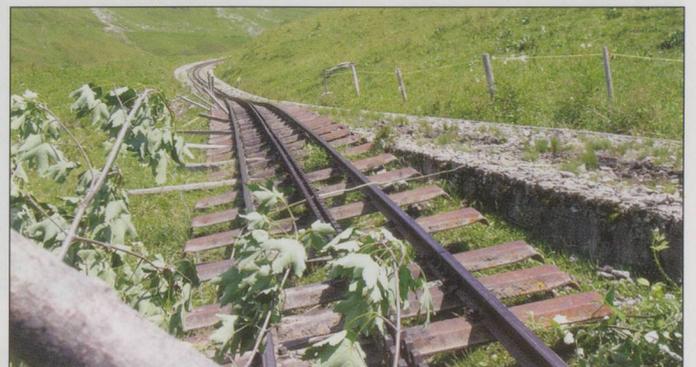
BELOW: Amazingly the fishplate bolts have held and this despite the considerable stress upon them. The damage has therefore been unwittingly extended either side of the actual slip area.
