**Zeitschrift:** Swiss express : the Swiss Railways Society journal  
**Herausgeber:** Swiss Railways Society  
**Band:** - (2014)  
**Heft:** 120

# Landslip disrupts the Brienz Rothorn Bahn

Mike Ellis

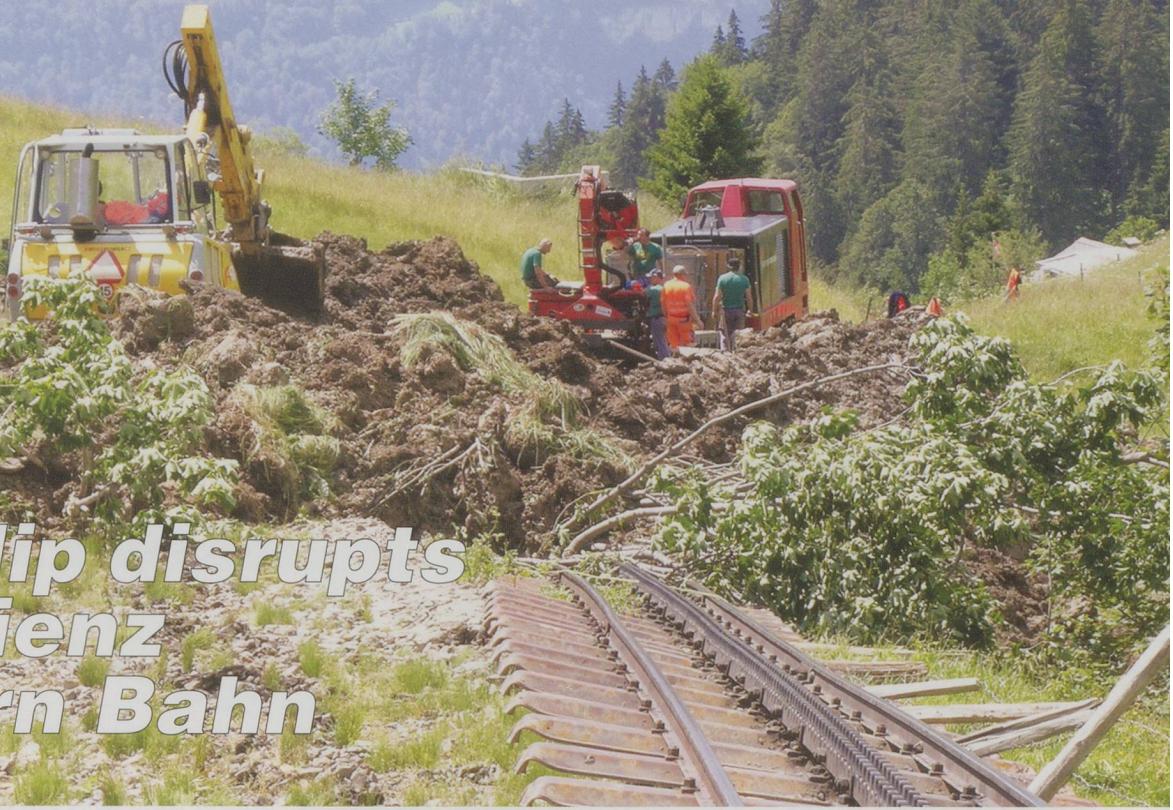
A clear view of just what has happened. The track, is some 3-4m out of alignment, completely free of the trackbed and now buried under a thick layer of clay, trees and boulders.

On the 24th July severe summer storms and extended rainfall resulted in a major mudslide taking place on the Brienz Rothorn Bahn (BRB) just below the 4km marker on the section immediately above Planalp. The ensuing damage included 70m of track work swept away from the track bed and a layer of debris 2m thick deposited onto, and around, the route. This, together with completely blocked storm drains and an interrupted service, has had quite a detrimental impact on the railway's short summer season. The clearance work naturally took priority over other duties and BRB staff from all disciplines were drafted-in to work on re-establishing the infrastructure to enable services to resume to Rothorn Kulm. Whilst a reduced steam service was maintained for visitors between Brienz and Planalp, works trains, along with imported heavy equipment, were in use to remove the debris and enable an assessment of necessary repair work to be undertaken. The preliminary clearance operation took about a week before service could be resumed to the railway's isolated mountain hotel at 2255m above sea level. With improved weather after the incident the trains resumed timetable running again and were well patronized. The accompanying photos give a good idea of just what confronted the civil engineering team and indicate what had to be done to regain normality on this popular railway in the heart of the Bernese

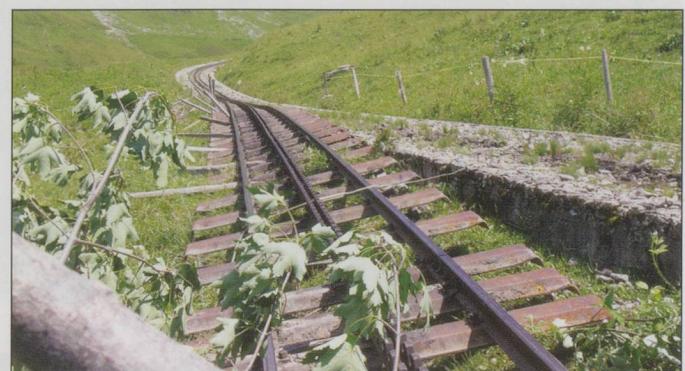
**BELLOW:** Amazingly the fishplate bolts have held and this despite the considerable stress upon them. The damage has therefore been unwittingly extended either side of the actual slip area.

However, as is often the case in such situations, positive aspects are to be found: the affected area is, as luck would have it, not yet refurbished under the project to renew the entire track infrastructure. The railway was also able to maintain, as mentioned, a reduced timetable to Planalp during the immediate aftermath of the incident. Of higher importance of course is the knowledge that no injuries occurred and, that there was no damage to locomotives and rolling stock. Writing in the middle of August the site looks a mess both above the line, and below it where several hundred cubic metres of mud, debris and rock have been deposited. The track though has been replaced, re ballasted enabling normal service to be resumed.
