Zeitschrift: Swiss express : the Swiss Railways Society journal
Herausgeber: Swiss Railways Society
Band: - (2015)
Heft: 122

Crossed wires – and surviving the consequences

John Jesson is intrigued by some complex electrical engineering

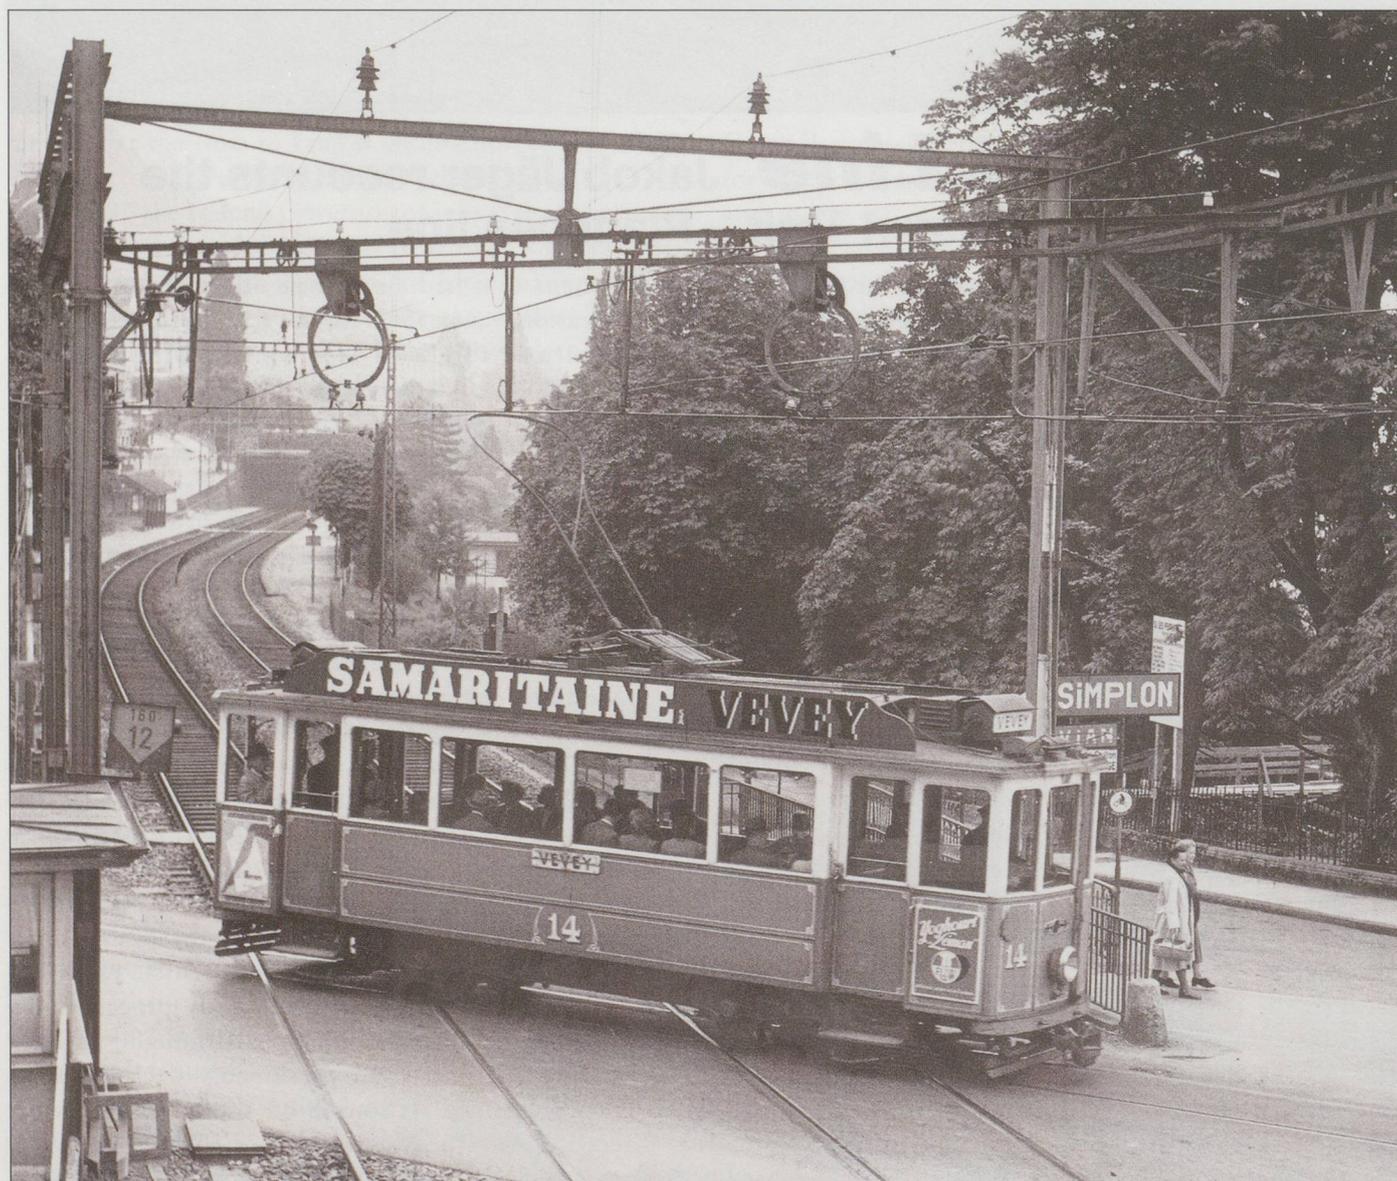
Tramways crossing railway lines are not particularly common, but this old photograph taken of a Vevey-Montreux-Chillon-Villeneuve (VMCV) tram at Territet, shows the problem that arises when the railway line is electrified. On the one hand, there is the CFF main line railway with 15,000V ac running through its wires, on the other the tram route that was electrified at 600V dc with its overhead providing the power. In this case some engineering ingenuity solved the problem by installing a moveable tram wire.

Across the level crossing, the tram overhead contact is not a wire, but four contact bars, each bent up at both ends to allow a smooth transition by the tram current collector. Two semi-circular hoops that are pivoted at their top ends surround each of the railway overhead contact wires. When the crossing is required for railway use, the hoops can be pivoted so that the tram contact bars are raised away from and above the railway contact wire. The four contact bars are each supported at one end by the semi-circular hoops and at the other by a long hanging support. From here on though the operation is less clear. The action of pivoting the hoop pushes one end of the contact bar away from the 15 kV contact wire and raises it above the level of the railway pantograph. The hanging support at the other end appears to be pivoted so that the bottom end (connected to the contact bar) is also pushed away from the 15 kV wire. However, as this hanging support is nearly twice as long as the depth of the hoop, the end result is that the end of the contact bar is dropped below its normal level. There seems to be some sort of operating mechanism connected to the hanging supports, but what this does is unclear. Although there is another known photograph of a tram using the crossing, it would be very helpful to see what the tram contact bars looked like when the crossing was set for trains. I have tried to show the complex layout on the accompanying diagram.

There is quite a lot of ironmongery involved in the whole set-up, something that would not please today's environmental lobby! The high-voltage lines for the railway are supported by a cross girder, itself carried by two masts on opposite sides of the road. There are two additional masts (one out of the picture) at the other two corners of the junction. These are connected to the other masts on the same side of the railway by other girders and these, in-turn, support a long diagonal girder, supported halfway by supports from the first cross-girder. There seems to be additional ironwork across the road at the left of the picture and this is probably for the operating mechanism. The small cabin on the left probably contains the controls.

The tramline at this point was re-electrified in 1913 to the system shown, when the complex original 1888 electrical system of the Vevey-Montreux-Chillon tramway was replaced at the time of its merger with the Chillon-Byron-Villeneuve tramway to form the VMCV. This was some eleven years before this section of the CFF main line through Montreux went under-the-wires in 1924, so this photograph must have been taken after this latter event.
