Zeitschrift: Swiss express: the Swiss Railways Society journal

Crossed wires – and surviving the consequences

John Jesson is intrigued by some complex electrical engineering

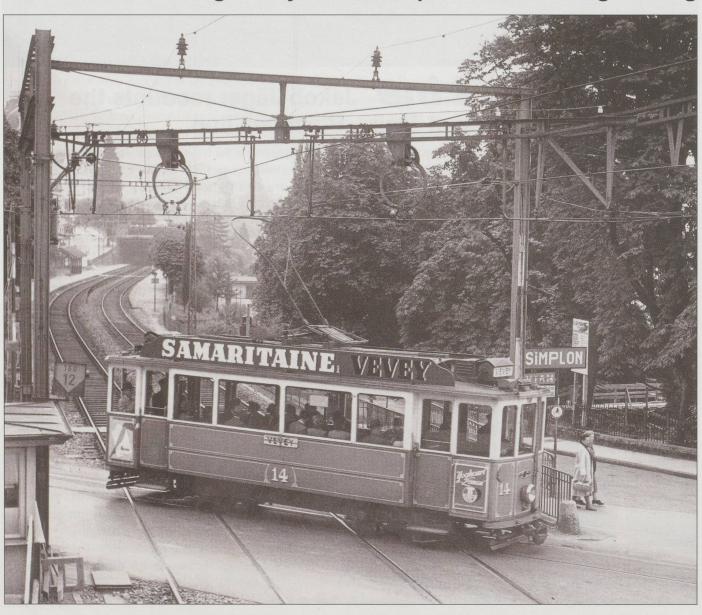
ramways crossing railway lines are not particularly common, but this old photograph taken of a Vevey-Montreux-Chillon-Villeneuve (VMCV) tram at Territet, shows the problem that arises when the railway line is electrified. On the one hand, there is the CFF main line railway with 15,000V ac running through its wires, on the other the tram route that was electrified at 600V dc with its overhead providing the power. In this case some engineering ingenuity solved the problem by installing a moveable tram wire.

Across the level crossing, the tram overhead contact is not a wire, but four contact bars, each bent up at both ends to allow a smooth transition by the tram current collector. Two semi-circular hoops that are pivoted at their top ends surround each of the railway overhead contact wires. When the crossing is required for railway use, the hoops can be pivoted so that the tram contact bars are raised away from and above the railway contact wire. The four contact bars are each supported at one end by the semi-circular hoops and at the other by a long hanging support. From here on though the operation is less clear. The action of pivoting the hoop pushes one end of the contact bar away from the 15 kV contact wire and raises it above the level of the railway pantograph. The hanging support at the other end appears to be pivoted so that the bottom end (connected to the contact bar) is also pushed away from the 15 kV wire. However, as this hanging support is nearly twice as long as the depth of the hoop, the end result is that the end of the contact bar is dropped below its normal level. There seems to be some sort of operating mechanism connected to the hanging supports, but what this does is unclear. Although there is another known photograph of a tram using the crossing, it would be very helpful to see what the tram contact bars looked like when the crossing was set for trains. I have tried to show the complex layout on the accompanying diagram.

There is quite a lot of ironmongery involved in the whole set-up, something that would not please today's environmental lobby! The high-voltage lines for the railway are supported by a cross girder, itself carried by two masts on opposite sides of the road. There are two additional masts (one out of the picture) at the other two corners of the junction. These are connected to the other masts on the same side of the railway by other girders and these, in-turn, support a long diagonal girder, supported halfway by supports from the first cross-girder. There seems to be additional ironwork across the road at the left of the picture and this is probably for the operating mechanism. The small cabin on the left probably contains the controls.

The tramline at this point was re-electrified in 1913 to the system shown, when the complex original 1888 electrical system of the Vevey-Montreux-Chillon tramway was replaced at the time of its merger with the Chillon-Byron-Villeneuve tramway to form the VMCV. This was some eleven years before this section of the CFF main line through Montreux went under-the-wires in 1924, so this photograph must have been taken after this latter event.
