Zeitschrift: Swiss express : the Swiss Railways Society journal
Herausgeber: Swiss Railways Society
Band: - (2015)
Heft: 122

Crossed wires – and surviving the consequences

John Jesson is intrigued by some complex electrical engineering

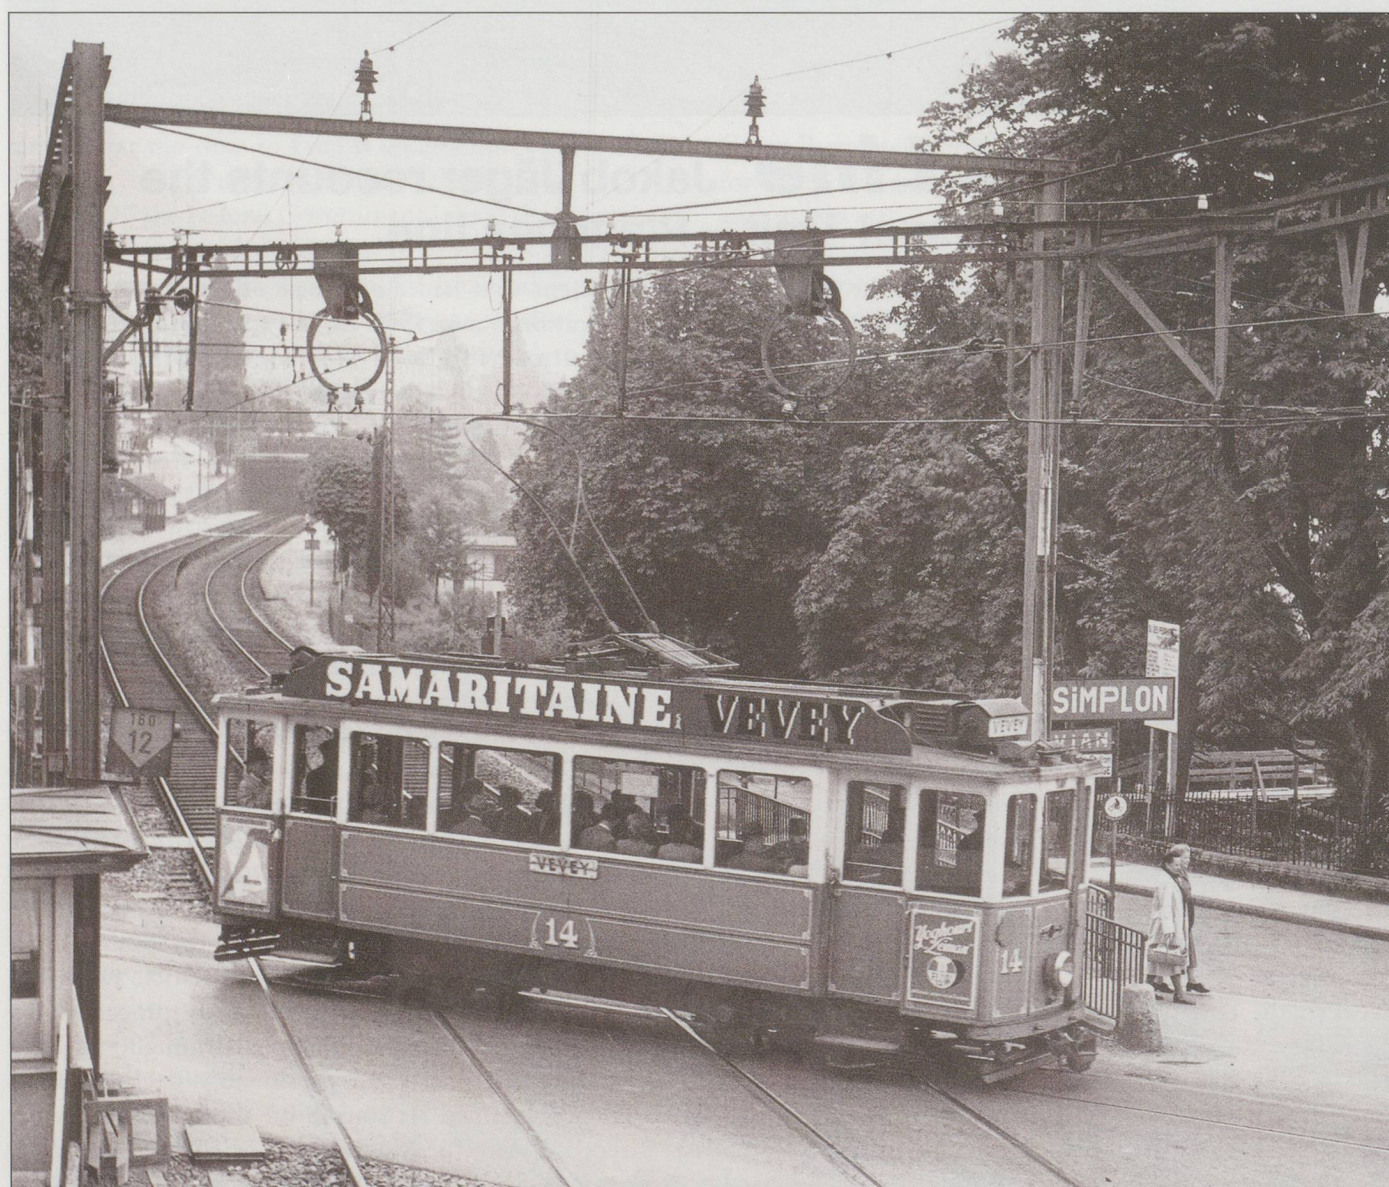
Tramways crossing railway lines are not particularly common, but this old photograph taken of a Vevey-Montreux-Chillon-Villeneuve (VMCV) tram at Territet, shows the problem that arises when the railway line is electrified. On the one hand, there is the CFF main line railway with 15,000V ac running through its wires, on the other the tram route that was electrified at 600V dc with its overhead providing the power. In this case some engineering ingenuity solved the problem by installing a moveable tram wire.

There is quite a lot of ironmongery involved in the whole set-up, something that would not please today's environmental lobby! The high-voltage lines for the railway are supported by a cross girder, itself carried by two masts on opposite sides of the road. There are two additional masts (one out of the picture) at the other two corners of the junction. These are connected to the other masts on the same side of the railway by other girders and these, in-turn, support a long diagonal girder, supported halfway by supports from the first cross-girder. There seems to be additional ironwork across the road at the left of the picture and this is probably for the operating mechanism. The small cabin on the left probably contains the controls.

Across the level crossing, the tram overhead contact is not a wire, but four contact bars, each bent up at both ends to allow a smooth transition by the tram current collector. Two semi-circular hoops that are pivoted at their top ends surround each of the railway overhead contact wires. When the crossing is required for railway use, the hoops can be pivoted so that the tram contact bars are raised away from and above the railway contact wire. The four contact bars are each supported at one end by the semi-circular hoops and at the other by a long hanging support. From here on though the operation is less clear. The action of pivoting the hoop pushes one end of the contact bar away from the 15 kV contact wire and raises it above the level of the railway pantograph. The hanging support at the other end appears to be pivoted so that the bottom end (connected to the contact bar) is also pushed away from the 15 kV wire. However, as this hanging support is nearly twice as long as the depth of the hoop, the end result is that the end of the contact bar is dropped below its normal level. There seems to be some sort of operating mechanism connected to the hanging supports, but what this does is unclear. Although there is another known photograph of a tram using the crossing, it would be very helpful to see what the tram contact bars looked like when the crossing was set for trains. I have tried to show the complex layout on the accompanying diagram.

The tramline at this point was re-electrified in 1913 to the system shown, when the complex original 1888 electrical system of the Vevey-Montreux-Chillon tramway was replaced at the time of its merger with the Chillon-Byron-Villeneuve tramway to form the VMCV. This was some eleven years before this section of the CFF main line through Montreux went under-the-wires in 1924, so this photograph must have been taken after this latter event.

I would like to thank the editor for his contribution to this article. The photo is in the Montreux Public Library Collection.
