Zeitschrift: Swiss express : the Swiss Railways Society journal

Crossed wires – and surviving the consequences

John Jesson is intrigued by some complex electrical engineering

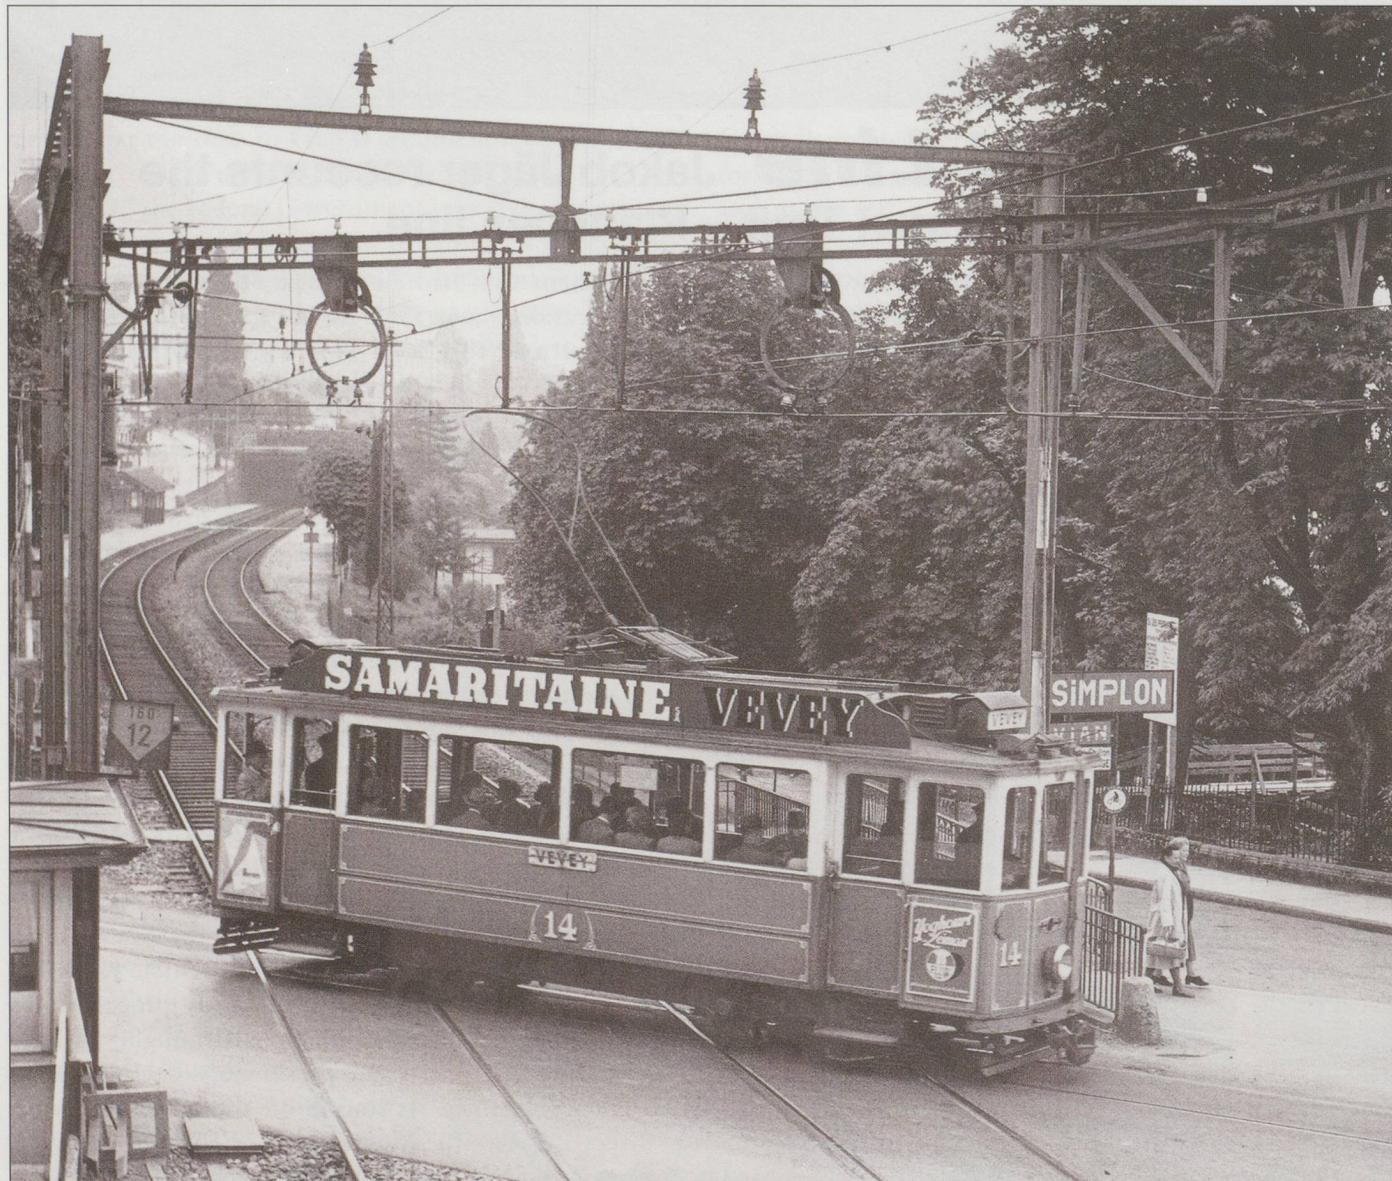
Tramways crossing railway lines are not particularly common, but this old photograph taken of a Vevey-Montreux-Chillon-Villeneuve (VMCV) tram at Territet, shows the problem that arises when the railway line is electrified. On the one hand, there is the CFF main line railway with 15,000V ac running through its wires, on the other the tram route that was electrified at 600V dc with its overhead providing the power. In this case some engineering ingenuity solved the problem by installing a moveable tram wire.

There is quite a lot of ironmongery involved in the whole set-up, something that would not please today's environmental lobby! The high-voltage lines for the railway are supported by a cross girder, itself carried by two masts on opposite sides of the road. There are two additional masts (one out of the picture) at the other two corners of the junction. These are connected to the other masts on the same side of the railway by other girders and these, in-turn, support a long diagonal girder, supported halfway by supports from the first cross-girder. There seems to be additional ironwork across the road at the left of the picture and this is probably for the operating mechanism. The small cabin on the left probably contains the controls.

The tramline at this point was re-electrified in 1913 to the system shown, when the complex original 1888 electrical system of the Vevey-Montreux-Chillon tramway was replaced at the time of its merger with the Chillon-Byron-Villeneuve tramway to form the VMCV. This was some eleven years before this section of the CFF main line through Montreux went under-the-wires in 1924, so this photograph must have been taken after this latter event.

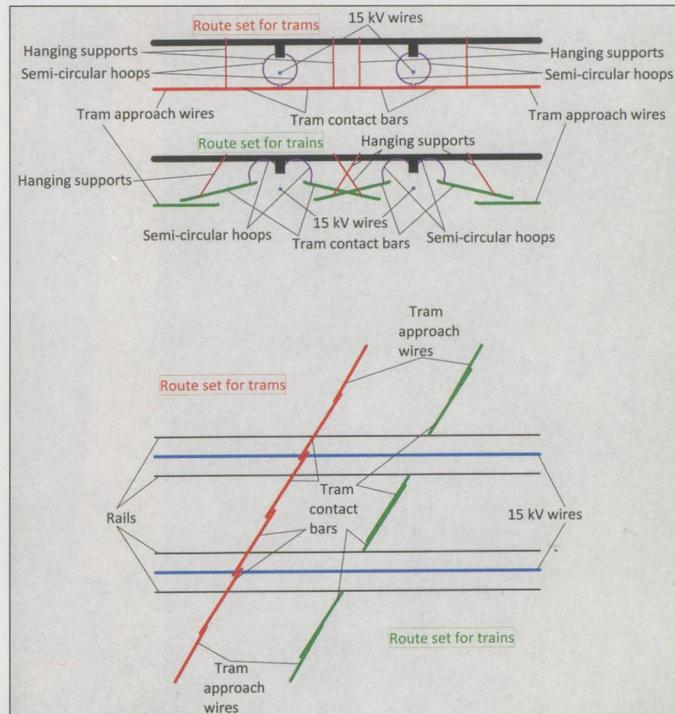
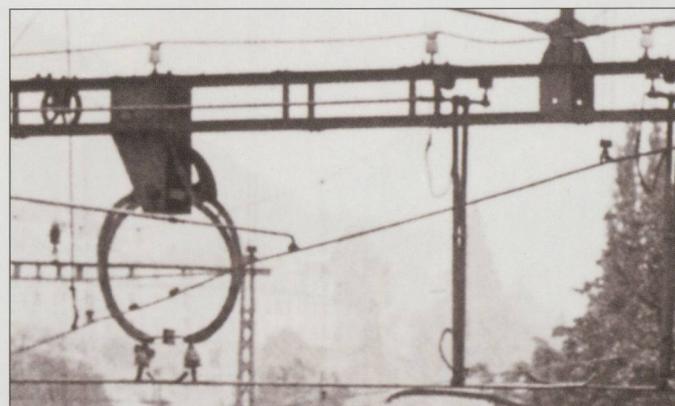
Across the level crossing, the tram overhead contact is not a wire, but four contact bars, each bent up at both ends to allow a smooth transition by the tram current collector. Two semi-circular hoops that are pivoted at their top ends surround each of the railway overhead contact wires. When the crossing is required for railway use, the hoops can be pivoted so that the tram contact bars are raised away from and above the railway contact wire. The four contact bars are each supported at one end by the semi-circular hoops and at the other by a long hanging support. From here on though the operation is less clear. The action of pivoting the hoop pushes one end of the contact bar away from the 15 kV contact wire and raises it above the level of the railway pantograph. The hanging support at the other end appears to be pivoted so that the bottom end (connected to the contact bar) is also pushed away from the 15 kV wire. However, as this hanging support is nearly twice as long as the depth of the hoop, the end result is that the end of the contact bar is dropped below its normal level. There seems to be some sort of operating mechanism connected to the hanging supports, but what this does is unclear. Although there is another known photograph of a tram using the crossing, it would be very helpful to see what the tram contact bars looked like when the crossing was set for trains. I have tried to show the complex layout on the accompanying diagram.
