Crossed wires – and surviving the consequences

John Jesson is intrigued by some complex electrical engineering

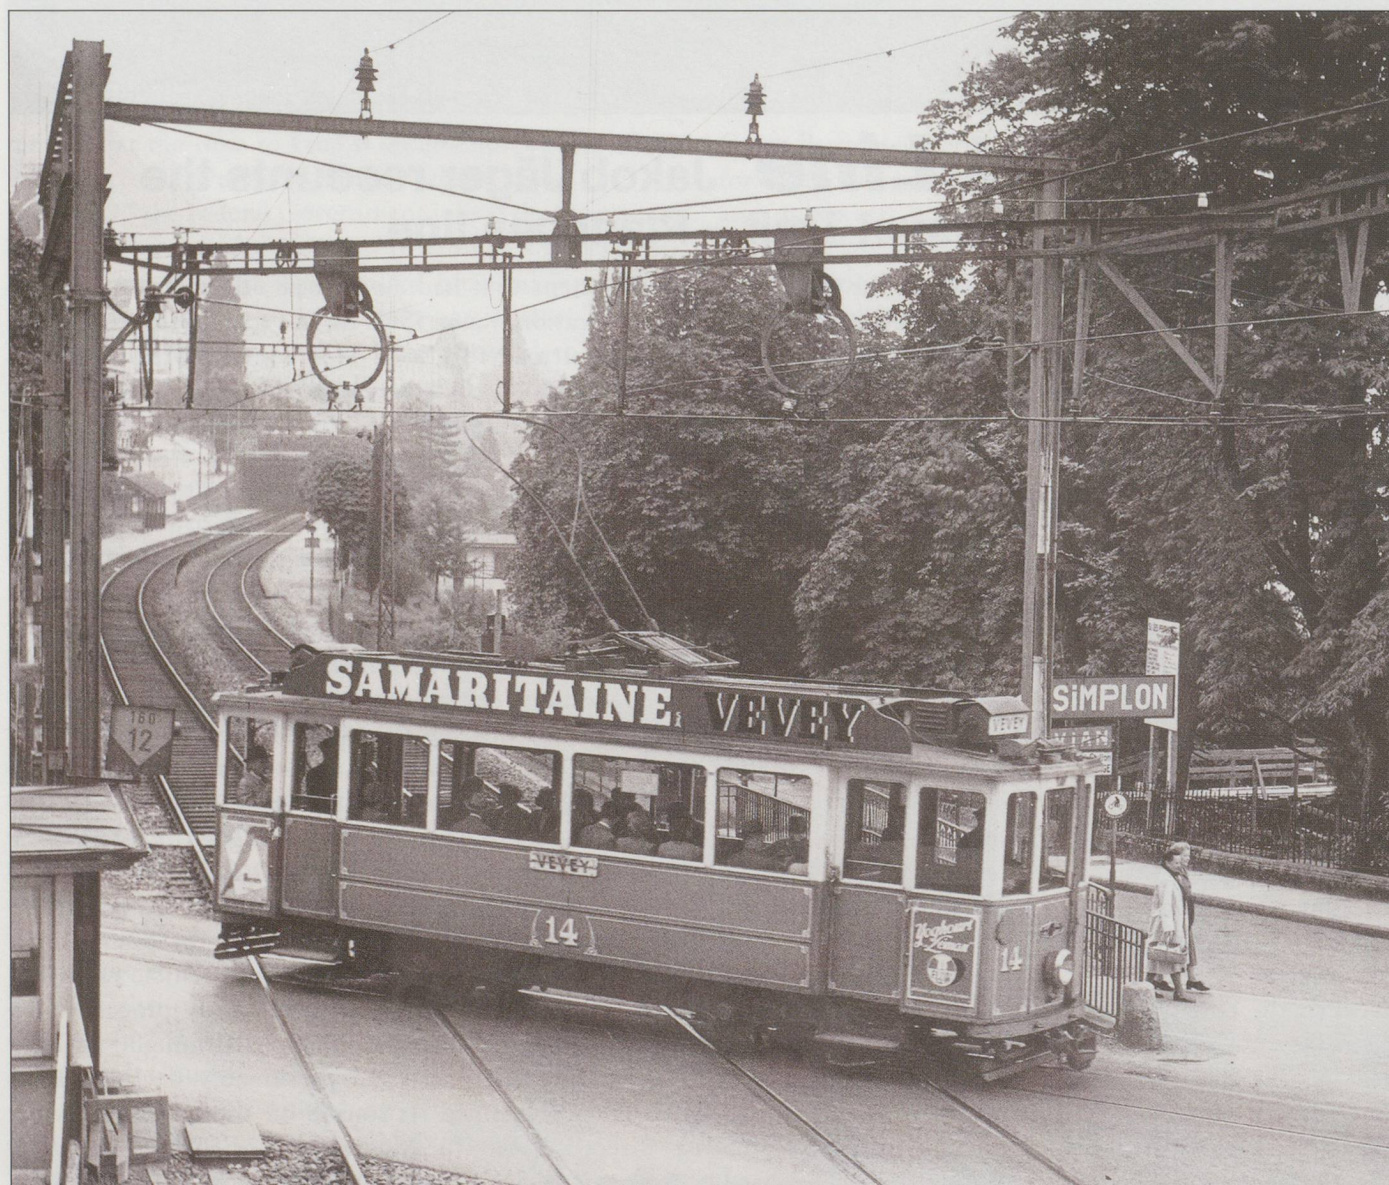
Tramways crossing railway lines are not particularly common, but this old photograph taken of a Vevey-Montreux-Chillon-Villeneuve (VMCV) tram at Territet, shows the problem that arises when the railway line is electrified. On the one hand, there is the CFF main line railway with 15,000V ac running through its wires, on the other the tram route that was electrified at 600V dc with its overhead providing the power. In this case some engineering ingenuity solved the problem by installing a moveable tram wire.

There is quite a lot of ironmongery involved in the whole set-up, something that would not please today's environmental lobby! The high-voltage lines for the railway are supported by a cross girder, itself carried by two masts on opposite sides of the road. There are two additional masts (one out of the picture) at the other two corners of the junction. These are connected to the other masts on the same side of the railway by other girders and these, in-turn, support a long diagonal girder, supported halfway by supports from the first cross-girder. There seems to be additional ironwork across the road at the left of the picture and this is probably for the operating mechanism. The small cabin on the left probably contains the controls.

Across the level crossing, the tram overhead contact is not a wire, but four contact bars, each bent up at both ends to allow a smooth transition by the tram current collector. Two semi-circular hoops that are pivoted at their top ends surround each of the railway overhead contact wires. When the crossing is required for railway use, the hoops can be pivoted so that the tram contact bars are raised away from and above the railway contact wire. The four contact bars are each supported at one end by the semi-circular hoops and at the other by a long hanging support. From here on though the operation is less clear. The action of pivoting the hoop pushes one end of the contact bar away from the 15 kV contact wire and raises it above the level of the railway pantograph. The hanging support at the other end appears to be pivoted so that the bottom end (connected to the contact bar) is also pushed away from the 15 kV wire. However, as this hanging support is nearly twice as long as the depth of the hoop, the end result is that the end of the contact bar is dropped below its normal level. There seems to be some sort of operating mechanism connected to the hanging supports, but what this does is unclear. Although there is another known photograph of a tram using the crossing, it would be very helpful to see what the tram contact bars looked like when the crossing was set for trains. I have tried to show the complex layout on the accompanying diagram.

The tramline at this point was re-electrified in 1913 to the system shown, when the complex original 1888 electrical system of the Vevey-Montreux-Chillon tramway was replaced at the time of its merger with the Chillon-Byron-Villeneuve tramway to form the VMCV. This was some eleven years before this section of the CFF main line through Montreux went under-the-wires in 1924, so this photograph must have been taken after this latter event.

I would like to thank the editor for his contribution to this article. The photo is in the Montreux Public Library Collection.
