Zeitschrift: Swiss bulletin für angewandte Geologie = Swiss bulletin pour la géologie appliquée = Swiss bulletin per la geologia applicata = Swiss bulletin for applied geology

Artikel: Ground improving injections underneath historical buildings : five case histories as an overview of a technique

Ground improving injections underneath historical buildings: five case histories as an overview of a technique

Valentina Berengo¹

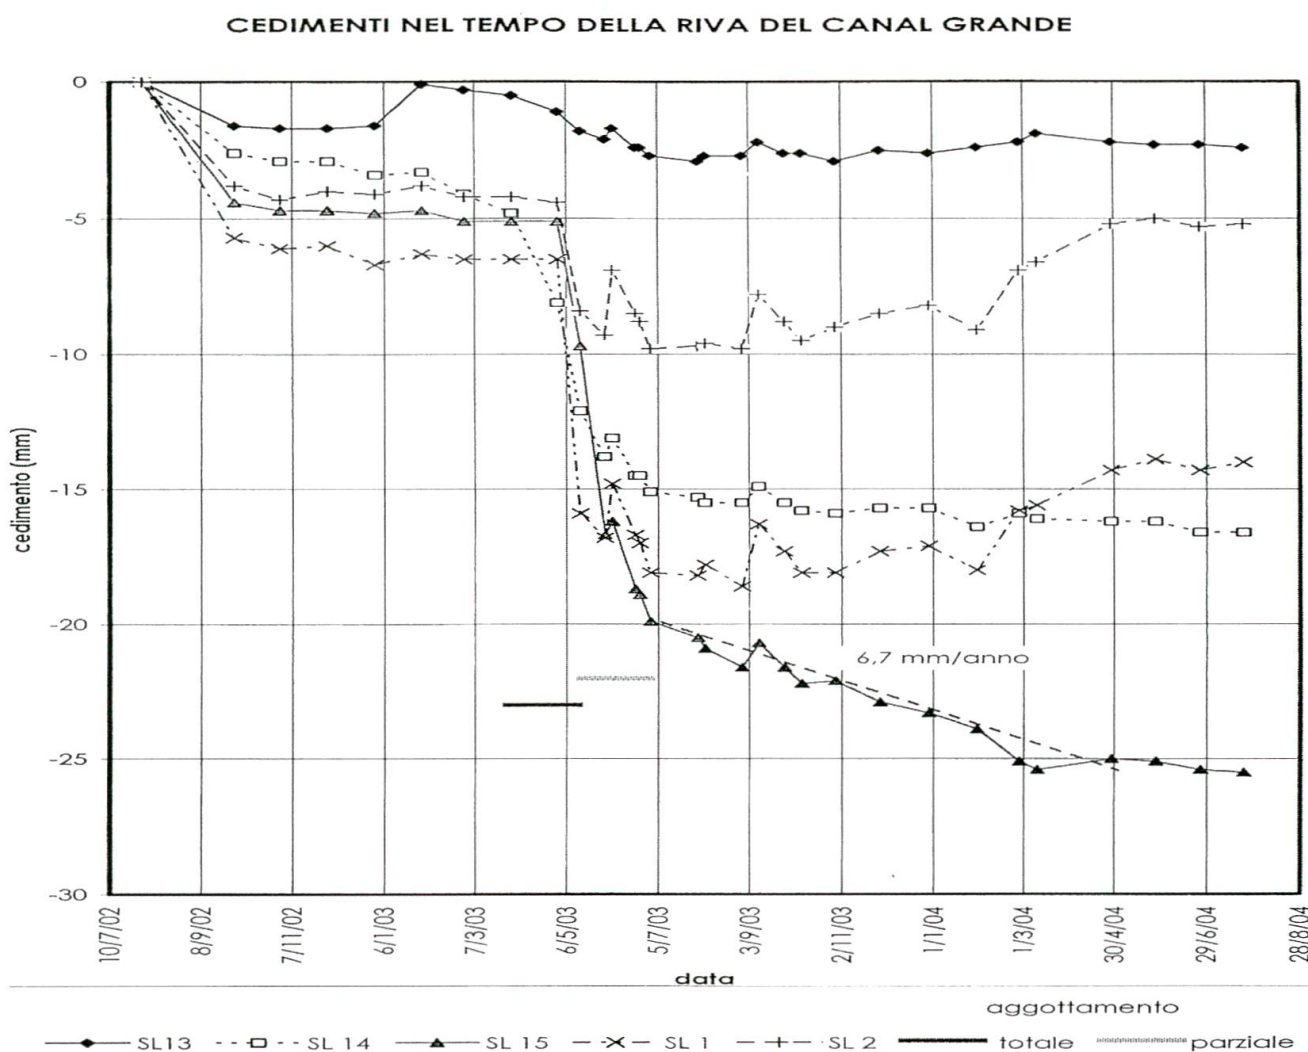
Fig. 8: Time-settlement curves of several anchorages (x-axis: date, y-axis: settlement in mm).

In May 2003, during the restoring of the «Canal Grande» shore walls (the main channel in Venice) by means of micropiles, settlements of the wall near the «Punta della Dogana» together with settlements of the building itself occurred. These caused old cracks to open again, and new ones to be created. Three mechanisms were responsible for this: vertical differential settlements, elongation in the direction of the internal walls, and rotation of the facades, especially the one towards the «Canal Grande». At that time the shore walls were already being monitored and the monitoring was continued after the episode, highlighting a settling trend. Assuming the zero corresponding to the measurement of 31.07.2002, the settlement-time curve plotted in Fig. 8 shows a sharp increase in terms of settlements between 30th April, and 15th May for all the anchorages, especially SL15 that is in corre-

spondence of the «Canal Grande» and continues settling even the year later whilst the others stop.

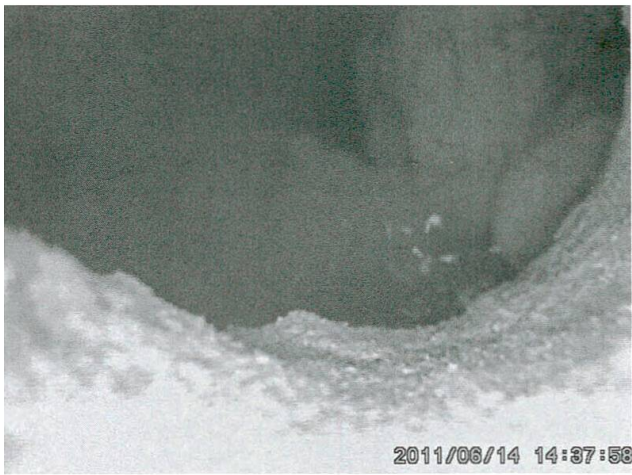
Fig. 13: Cavities in Geneva subsoil.

Visible differential settlements had already occurred at the time of construction, since the side laying directly on the soil started settling immediately. The first measurements go back to 1976 and now the maximum differential settlement between the two sides reaches 20 cm, while the rate of settlement is eight times faster than the initial one. The subsoil was also found to be constituted by several cavities, as detected during geotechnical preliminary surveys (Fig. 13).

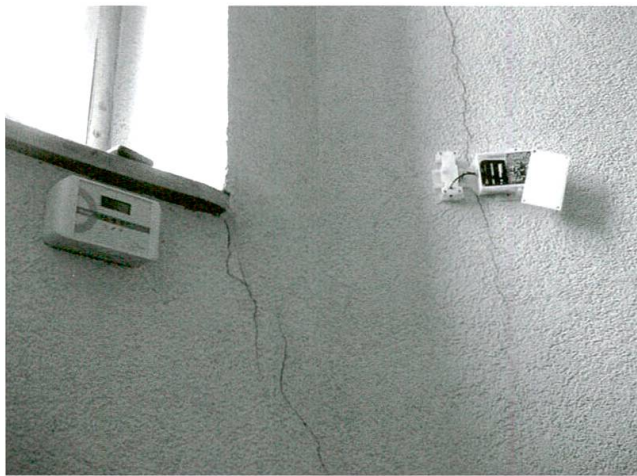
Fig. 15: Easy Crack Monitor System®.

between two stiff portions along two orthogonal directions at regular time intervals. The reading of the movements is made at the same point for both directions, with a precision not greater than 0.5 mm. Each system is also equipped with a temperature sensor. The control unit has the function of collecting data from several reading devices and to transmit them by means of GPRS protocol, at regular intervals, to a server for storage and display.
