Zeitschrift: Swiss bulletin für angewandte Geologie = Swiss bulletin pour la géologie appliquée = Swiss bulletin per la geologia applicata = Swiss bulletin for applied geology

Artikel: Ground improving injections underneath historical buildings : five case histories as an overview of a technique

Ground improving injections underneath historical buildings: five case histories as an overview of a technique

Valentina Berengo¹

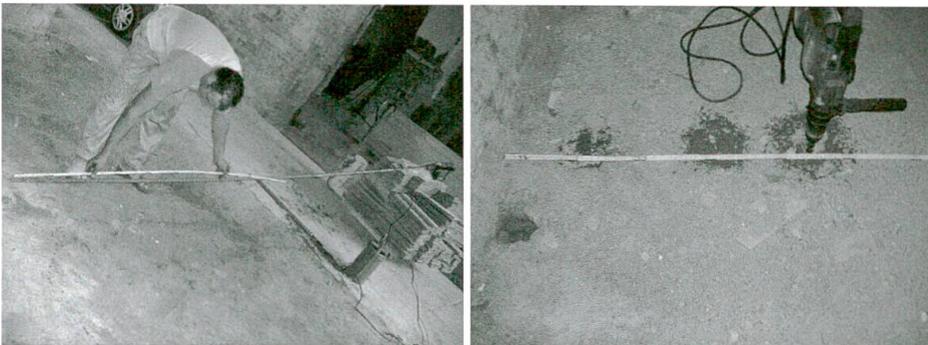
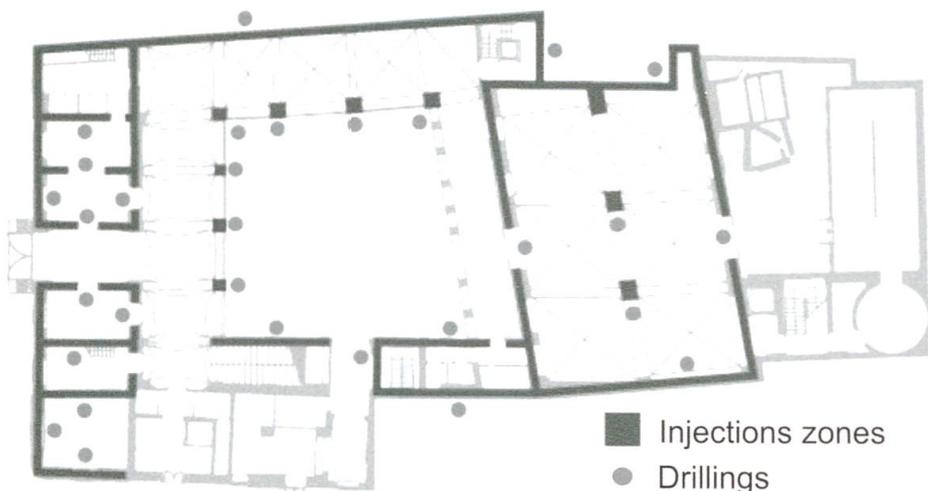
Fig. 2: Above: foundation survey at Palatium Vetus. Below: survey and intervention map.

bished and enlarged so many times that the soil stress state has changed under the foundation system. The final configuration is constituted by only one body with two levels, lying on several types of foundations. To investigate the foundation system a series of drillings were performed. A manual boring machine was used (max energy per bump: 12–14 Joule, frequency: 1.200–2.800 bumps per minute), making holes of 26 mm diameter (Fig. 2). Drillings were performed along-

Fourteen different areas around the entire building were investigated (Fig. 2): walls were found to be constituted by bricks and binder with no discontinuities, the foundation base level varies from 0.5 m to 3.2 m depth and a 10–15 cm layer of crushed stones lies under the foundation system.

side the perimetral wall to identify the base level of the foundations and also at increasing distance from the wall to investigate the presence of enlargements or connecting beams among the plinths.

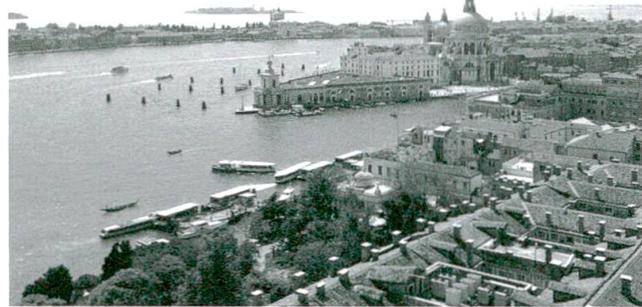
Fig. 7: Punta della Dogana view (above), map (below).

The main building has a width that varies from 16 m to 75 m and floors lie on ten brick walls, parallel to one another, as described in Fig. 7. Foundations are constituted by bricks and binder walls laying on four different substrates: directly on the soil, on a rigid shelf laid on the ground, on a shelf that lies on wooden piles or on the foundations of an existing tower. The foundation base level varies from 0.69 m to 2.84 m depending on the position.

«Punta della Dogana» is a historical place in Venice where trade occurred. The trapezium-shaped buildings were built in 1677 on the basis of the design of the architect Giuseppe Benoni (Fig. 7).

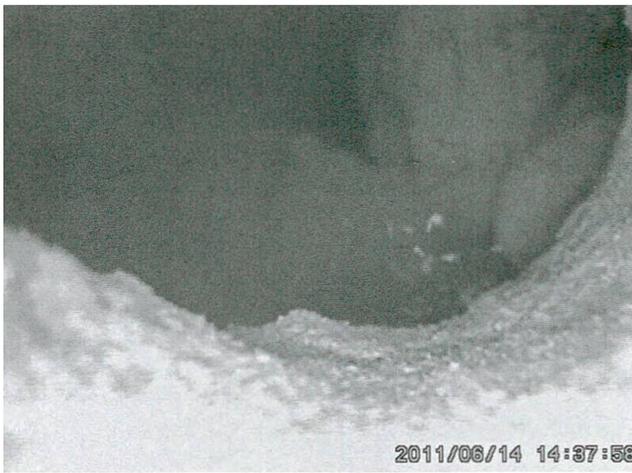
Fig. 13: Cavities in Geneva subsoil.

Visible differential settlements had already occurred at the time of construction, since the side laying directly on the soil started settling immediately. The first measurements go back to 1976 and now the maximum differential settlement between the two sides reaches 20 cm, while the rate of settlement is eight times faster than the initial one. The subsoil was also found to be constituted by several cavities, as detected during geotechnical preliminary surveys (Fig. 13).

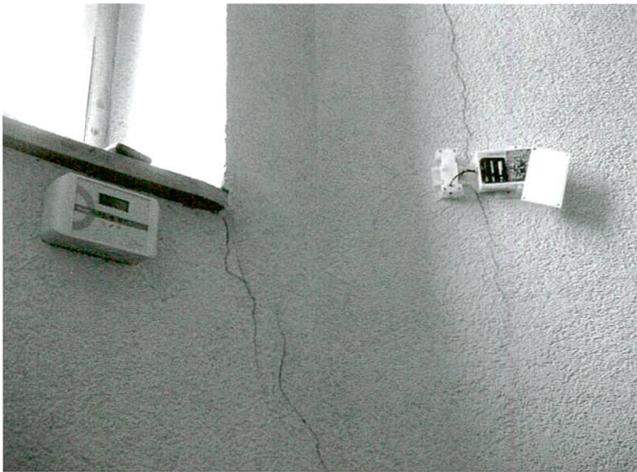
Fig. 15: Easy Crack Monitor System®.

After the intervention a monitoring system called Easy Crack Monitor System® was installed in order to check the crack stabilization. The system allows for the automated and continuous reading of any relative displacement between two lips of a lesion and/or two buildings and/or two structural elements, along two orthogonal directions. It is composed of one or more reading devices in correspondence of the lesions to be monitored and by a central acquisition and transmission of data (Fig. 15). The reading device, rigidly connected to the masonry, detects the relative displacement

between two stiff portions along two orthogonal directions at regular time intervals. The reading of the movements is made at the same point for both directions, with a precision not greater than 0.5 mm. Each system is also equipped with a temperature sensor. The control unit has the function of collecting data from several reading devices and to transmit them by means of GPRS protocol, at regular intervals, to a server for storage and display.
