Ground improving injections underneath historical buildings: five case histories as an overview of a technique

Valentina Berengo¹

Abstract

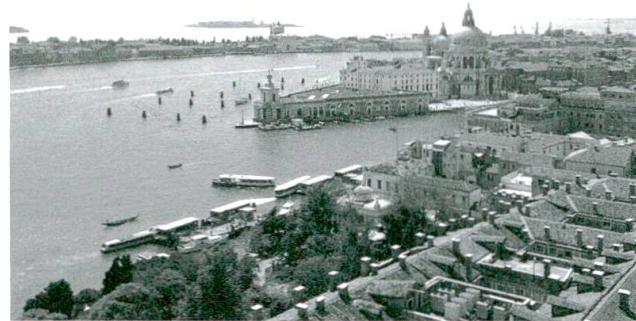
Fig. 7: Punta della Dogana view (above), map (below).

The main building has a width that varies from 16 m to 75 m and floors lie on ten brick walls, parallel to one another, as described in Fig. 7. Foundations are constituted by bricks and binder walls laying on four different substrates: directly on the soil, on a rigid shelf laid on the ground, on a shelf that lies on wooden piles or on the foundations of an existing tower. The foundation base level varies from 0.69 m to 2.84 m depending on the position.

«Punta della Dogana» is a historical place in Venice where trade occurred. The trapezium-shaped buildings were built in 1677 on the basis of the design of the architect Giuseppe Benoni (Fig. 7).

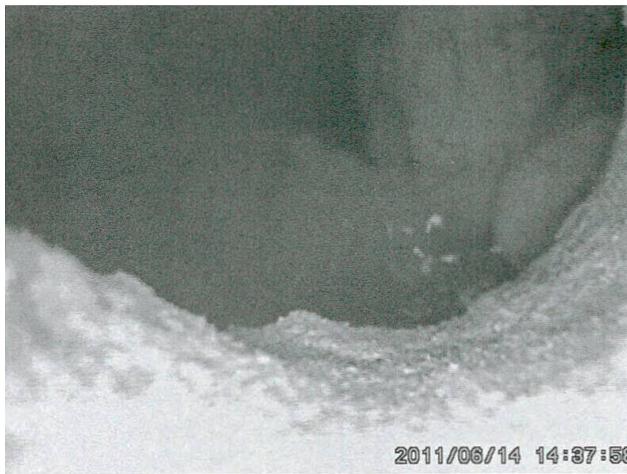
Fig. 13: Cavities in Geneva subsoil.

Visible differential settlements had already occurred at the time of construction, since the side laying directly on the soil started settling immediately. The first measurements go back to 1976 and now the maximum differential settlement between the two sides reaches 20 cm, while the rate of settlement is eight times faster than the initial one. The subsoil was also found to be constituted by several cavities, as detected during geotechnical preliminary surveys (Fig. 13).

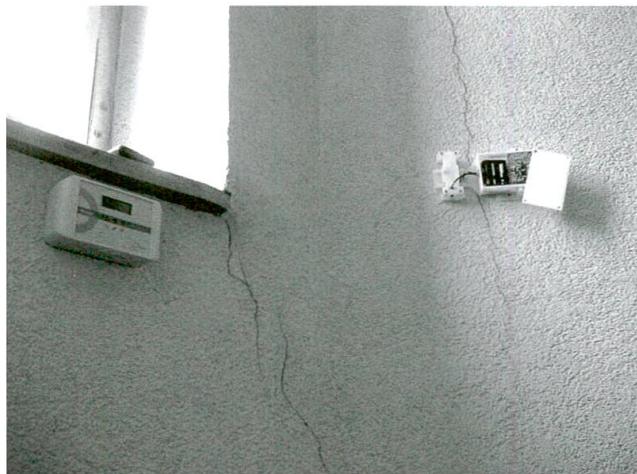
Fig. 15: Easy Crack Monitor System®.

After the intervention a monitoring system called Easy Crack Monitor System® was installed in order to check the crack stabilization. The system allows for the automated and continuous reading of any relative displacement between two lips of a lesion and/or two buildings and/or two structural elements, along two orthogonal directions. It is composed of one or more reading devices in correspondence of the lesions to be monitored and by a central acquisition and transmission of data (Fig. 15). The reading device, rigidly connected to the masonry, detects the relative displacement

between two stiff portions along two orthogonal directions at regular time intervals. The reading of the movements is made at the same point for both directions, with a precision not greater than 0.5 mm. Each system is also equipped with a temperature sensor. The control unit has the function of collecting data from several reading devices and to transmit them by means of GPRS protocol, at regular intervals, to a server for storage and display.
